SUMMARY ACCIDENT REPORT	<i>COLLISION BETWEEN THE FV O.231-DEN HOOPE AND THE OIL TANKER SEASONG</i>	Date
7		30-06-2023

A collision between the Belgian fishing vessel O.231-DEN HOOPE and the Maltese oil tanker SEASONG occurred on 21 March 2023 around 11:07 hours. The collision occurred in the Channel, approximately 6 nm south of the Greenwich Light Vessel, at position N 50° 48' 44", E 000° 01' 13", as shown in Figure 1.

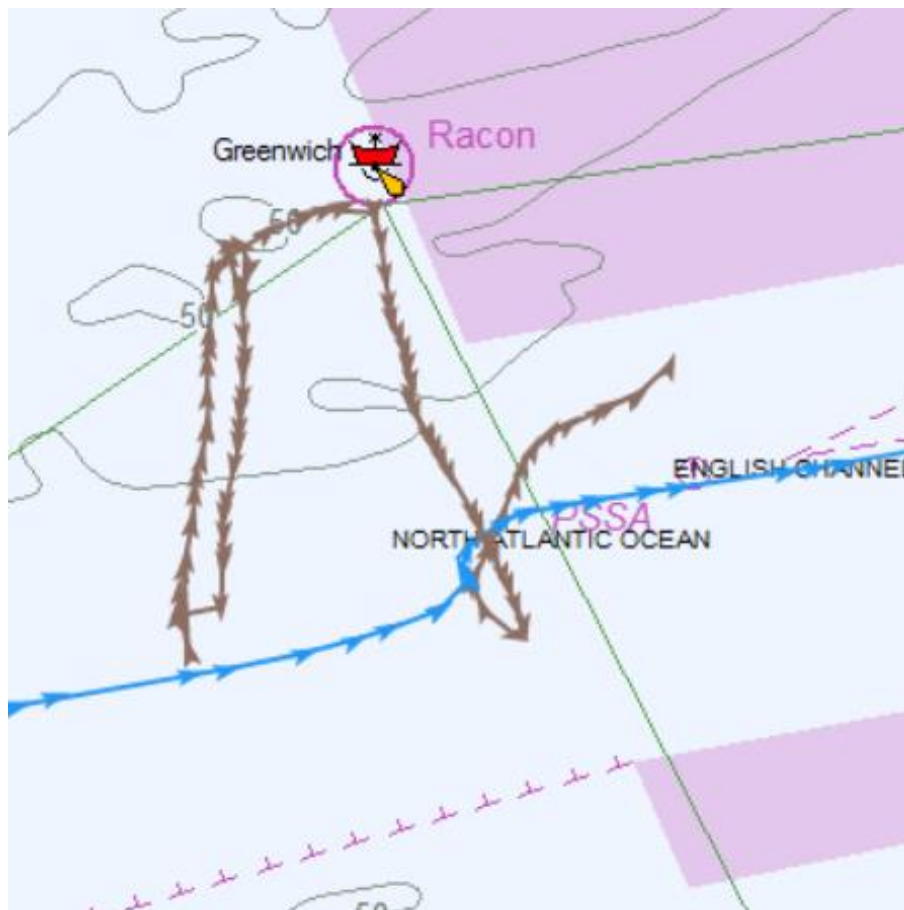
Figure 1 - Location of collision

The track of the MT SEASONG is shown in blue, the track of the FV O.231-DEN HOOPE is shown in brown.

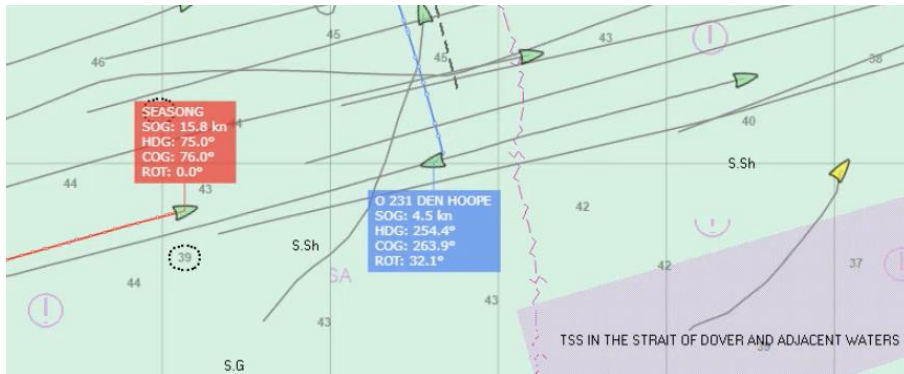
Figure 2 - Positions at about 09:56 am

At about 10:56 hours, both vessels sailed on an opposite heading, as shown in Figure 2.

On the radar on board the MT SEASONG the target of the FV O.231-DEN HOOPE was shown in red indicating a danger of collision, as the CPA was 0,08 nm. The distance between both vessels was about 3 nm at that time.

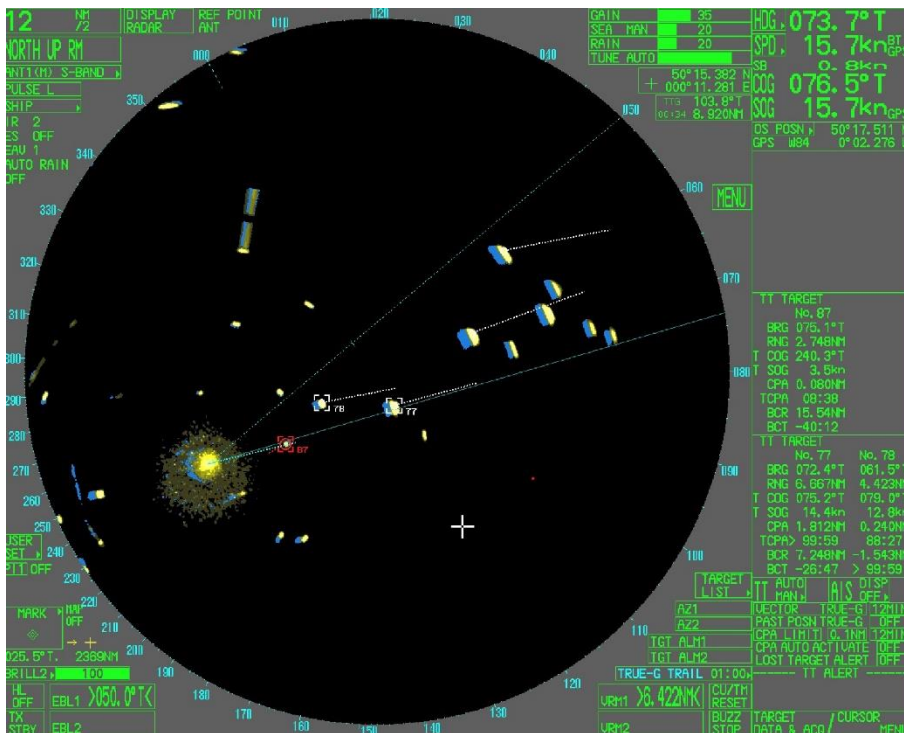
Figure 3 - Radar on board MT SEASONG

Subsequently, on board the MT SEASONG, it was decided to swerve to port to keep out of the way of the fishing vessel and to keep out of the way of an overtaking vessel on the SB side, as shown in Figure 3.

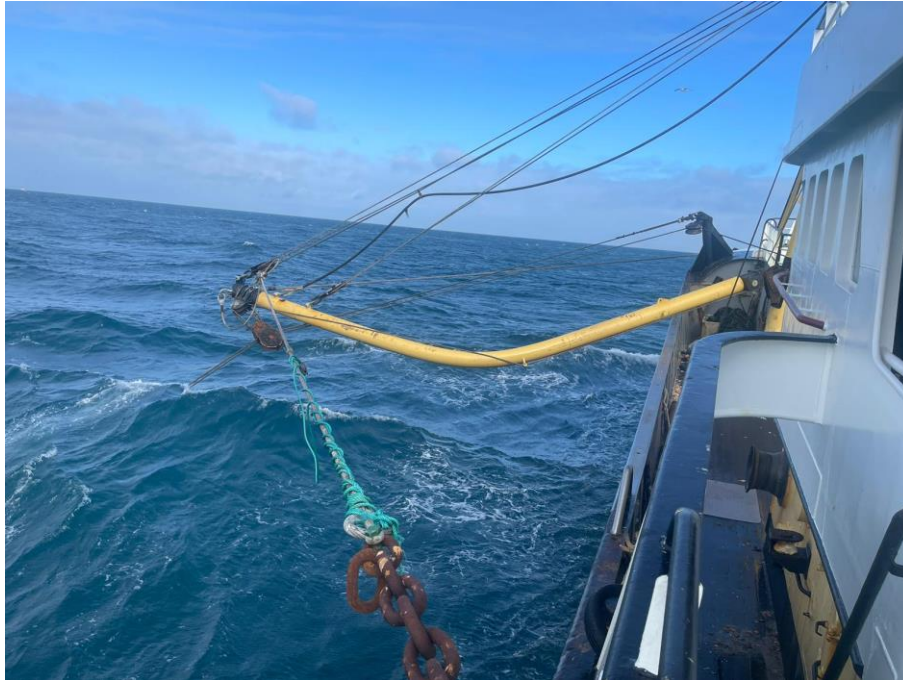
Figure 4 - Damage to PS derrick

At 11:07 hours, the MT SEASONG collided with the top of the derrick of the FV O.231-DEN HOOPE. The MT SEASONG still had a speed of 7,5 kn at that time. Shortly thereafter, the PS stern of the FV O.231-DEN HOOPE was also hit by the turning MT SEASONG. The FV O.231-DEN HOOPE briefly hailed MT SEASONG on VHF 16, but this call was not answered.

The visible damage on board the FV O.231-DEN HOOPE was mainly limited to the derrick, as shown in Figure 4. No damage was found on board the MT SEASONG.
