Report on the joint investigation of the collision
between the LNG Carrier

mts **AL ORAIQ** and the mv **FLINTERSTAR** off
the coast of Belgium on 6 October 2015 with the
total loss of the mv **FLINTERSTAR**

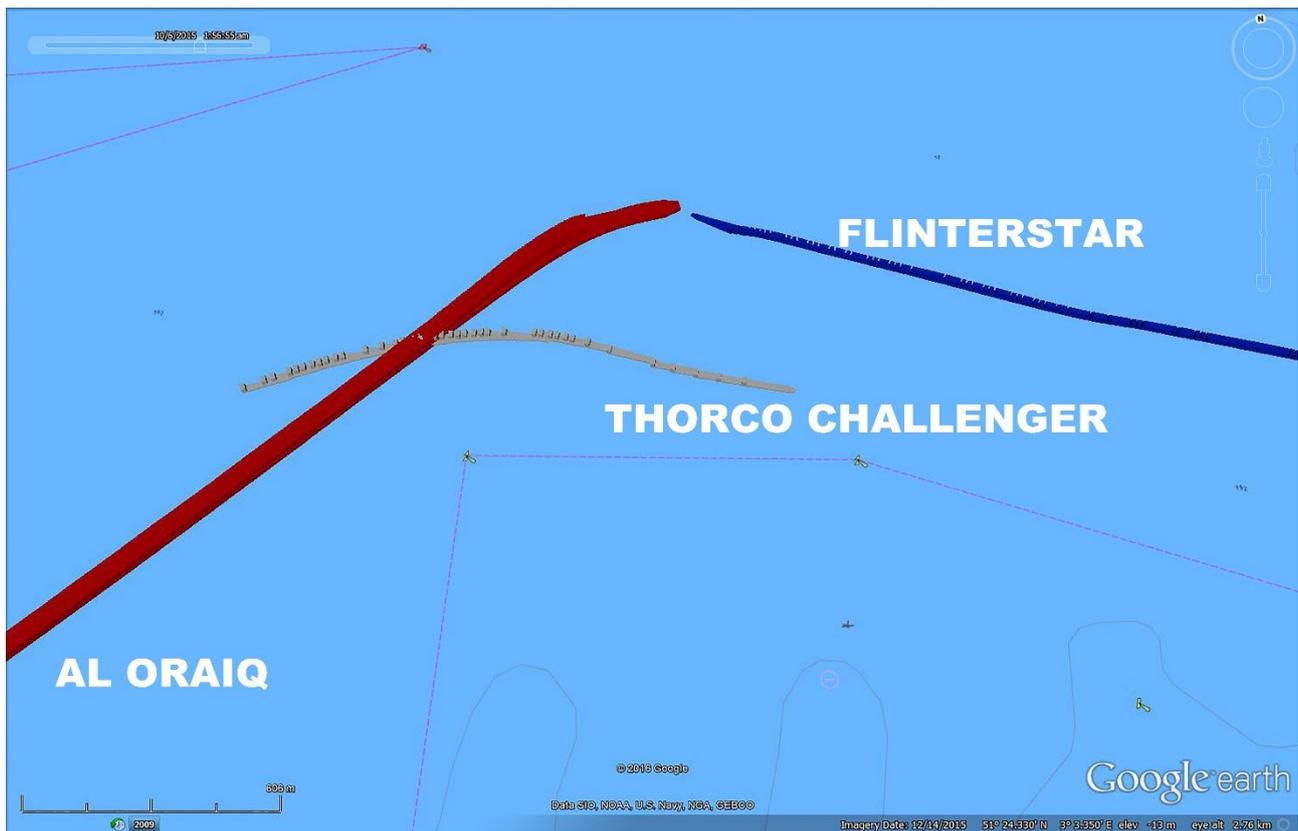
Figure 2 - Tracks of last minutes before the collision

When the S3 buoy was abaft the beam of the mts AL ORAIQ the Acting Coastal Pilot on board subsequently ordered the ship's rudders to starboard 5. By this time the mv FLINTERSTAR was less than 5 cables off the ship's starboard bow. Ten seconds after ordering starboard 5, the mts AL ORAIQ's Pilot ordered starboard 10. Ten seconds later the rudders were at starboard 10. After a period of approximately 30 seconds, the Pilot ordered starboard 20. At about the same time the mts AL ORAIQ's Master, officer of the watch and Pilots first became aware that the mv FLINTERSTAR was very close off the starboard bow. At 0357 Traffic centre Zeebrugge hailed the mts AL ORAIQ, however the call was not answered. Seconds later at approximately 0357 the mts AL ORAIQ and the mv FLINTERSTAR collided.

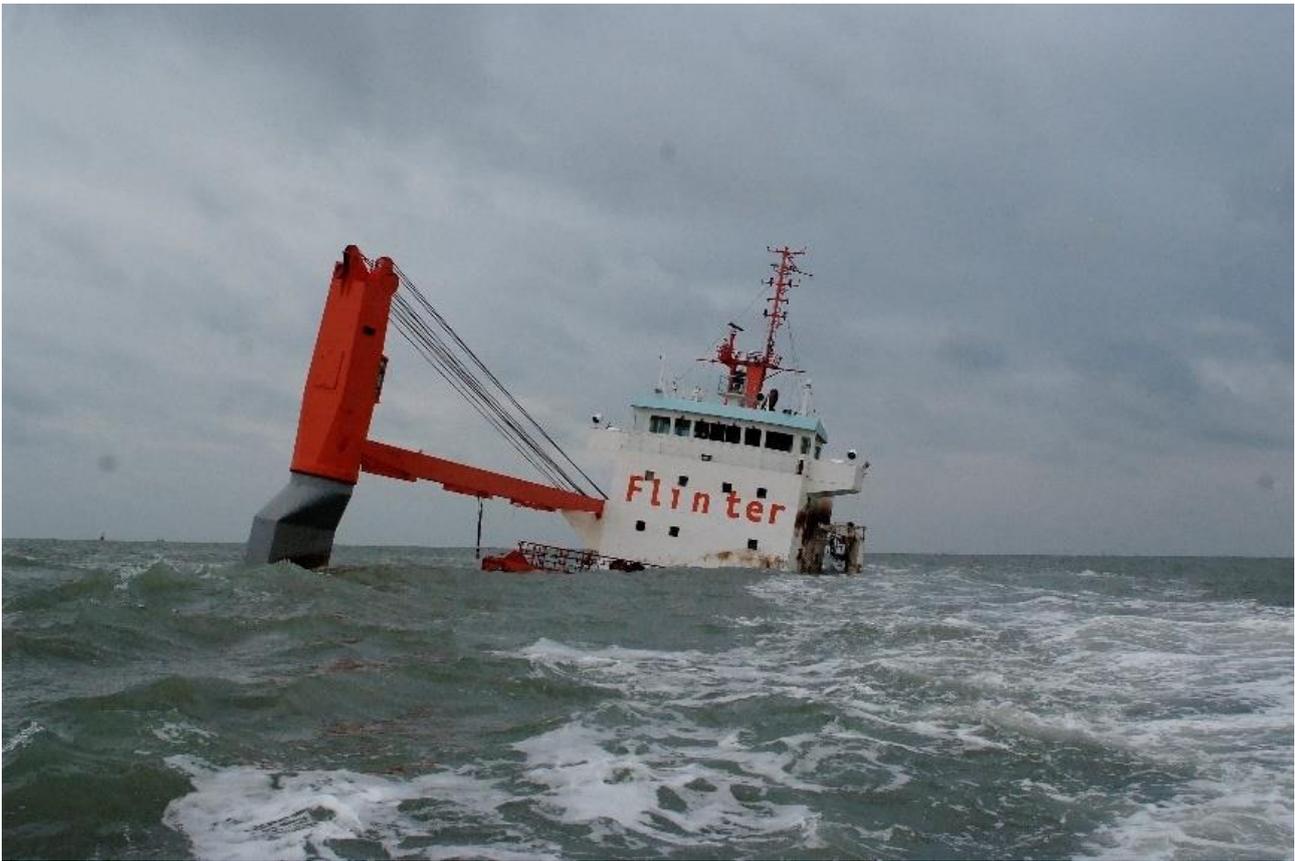
Figure 3 - Mv FLINTERSTAR after the collision lying on a sand bank

The damage to the mv FLINTERSTAR was to such an extent that the vessel sunk almost immediately after the collision onto a sand bank. Only the superstructure of the mv FLINTERSTAR remained above water level, after the vessel had sunk.

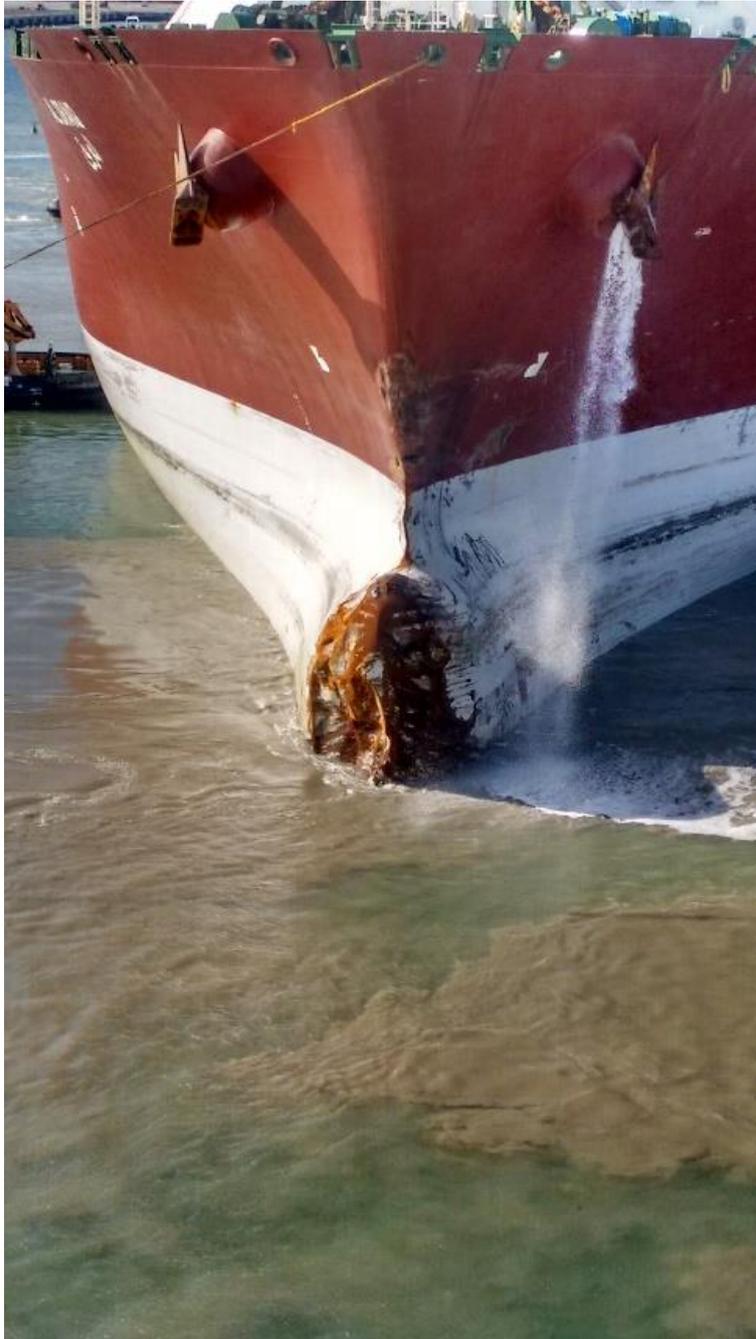
Figure 4 - Damage to the mts AL ORAIQ after the collision

The mts AL ORAIQ, which had suffered relatively minor damage, proceeded, after the collision, to an anchorage off the Port of Zeebrugge and was later that day allowed to proceed to its intended berth, quay 615, at the Port of Zeebrugge to unload the cargo of LNG, where the vessel safely berthed in the afternoon of 6 October 2015.

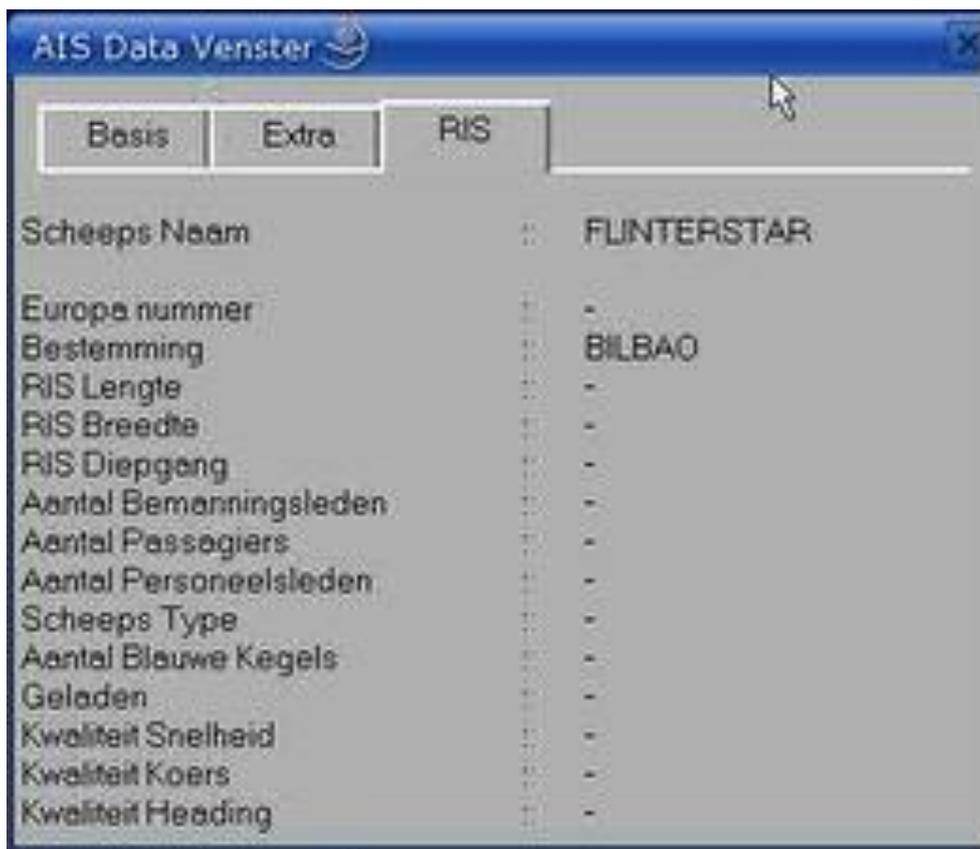
Figure 7 - Detailed Automatic Identification System data from mv FLINTERSTAR not filled out as seen on VTS radar screen

On 6 October 2015 at 0451, Traffic Centre Zeebrugge announced over VHF radiotelephone Channel 69 that the rescue helicopter was 2 to 3 minutes away from the scene. Soon thereafter at 0452 the skipper of another vessel, participating in the rescue mission, inquired with Traffic Centre Zeebrugge via VHF radiotelephone Channel 69, whether or not, all persons on board the mv FLINTERSTAR prior to the collision with the mts AL ORAIQ had been rescued from the water in the meantime. Traffic Centre Zeebrugge could not confirm nor deny since the total number of people on board the mv FLINTERSTAR prior to the collision with the mts AL ORAIQ was still not confirmed. Various sources were being consulted. Thereupon the Pilot on board the mv SCOTT PIONEER requested Traffic Centre Zeebrugge to consult the more detailed Automatic Identification System information from the mv FLINTERSTAR from which the total number of people on board, excluding the Pilot, could be derived. Traffic Centre Zeebrugge replied that they were just then busy doing that. Seconds later Traffic Centre Zeebrugge came back to the Pilot of the mv SCOTT PIONEER stating that the more detailed information page of the Automatic Identification System of the mv FLINTERSTAR had not been filled out.

- The Gemeenschappelijke Nautische Autoriteit are recommended to have the Automatic Identification System data of in and outbound vessels checked so that, in case emergency actions need to be undertaken, a correct assessment of the

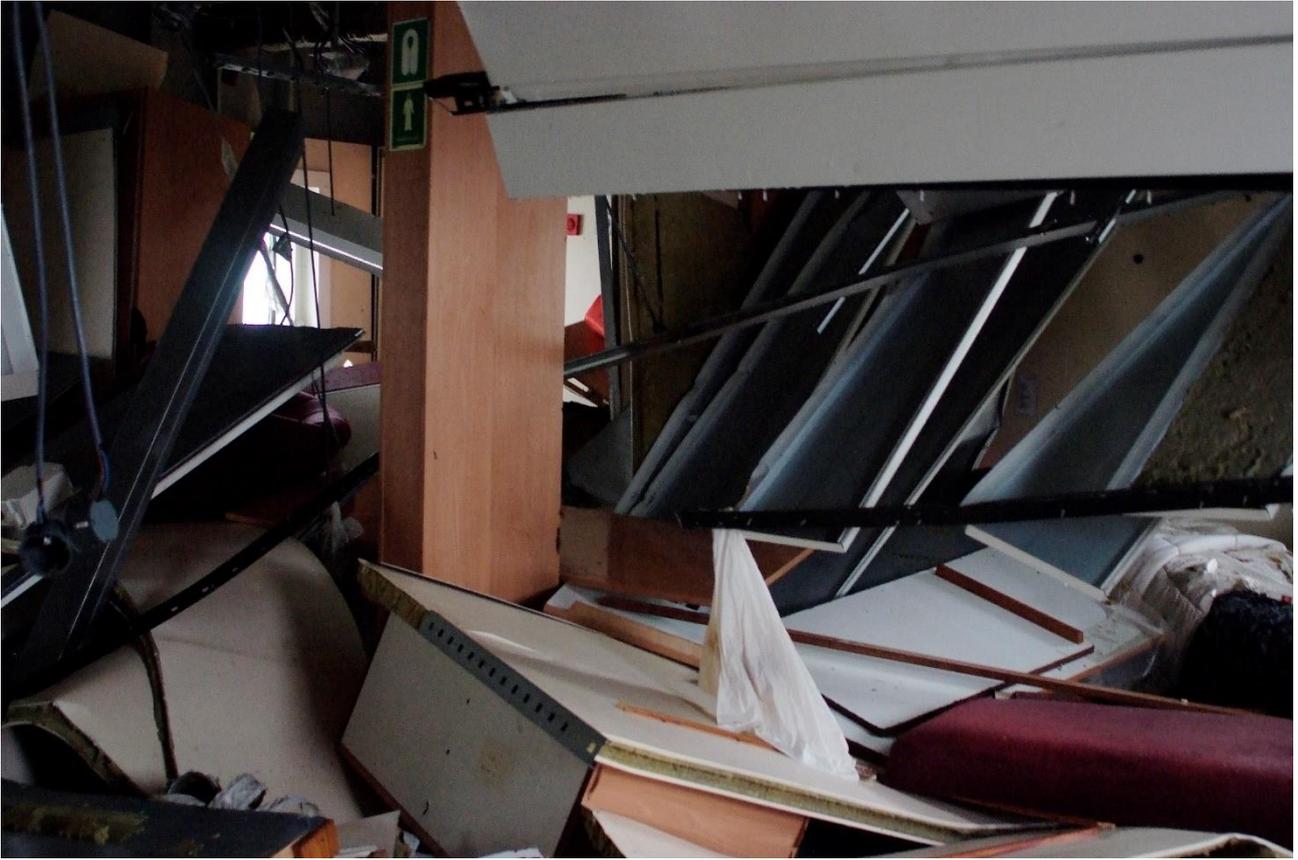
Figure 8 - Inside of the accommodation of the mv FLINTERSTAR after the collision

The inside of the accommodation of the mv FLINTERSTAR had been destroyed on impact. Most of the non-structural bulkheads had collapsed. Most of the doors were removed from their door frames. The suspended ceilings all came loose and fell down.

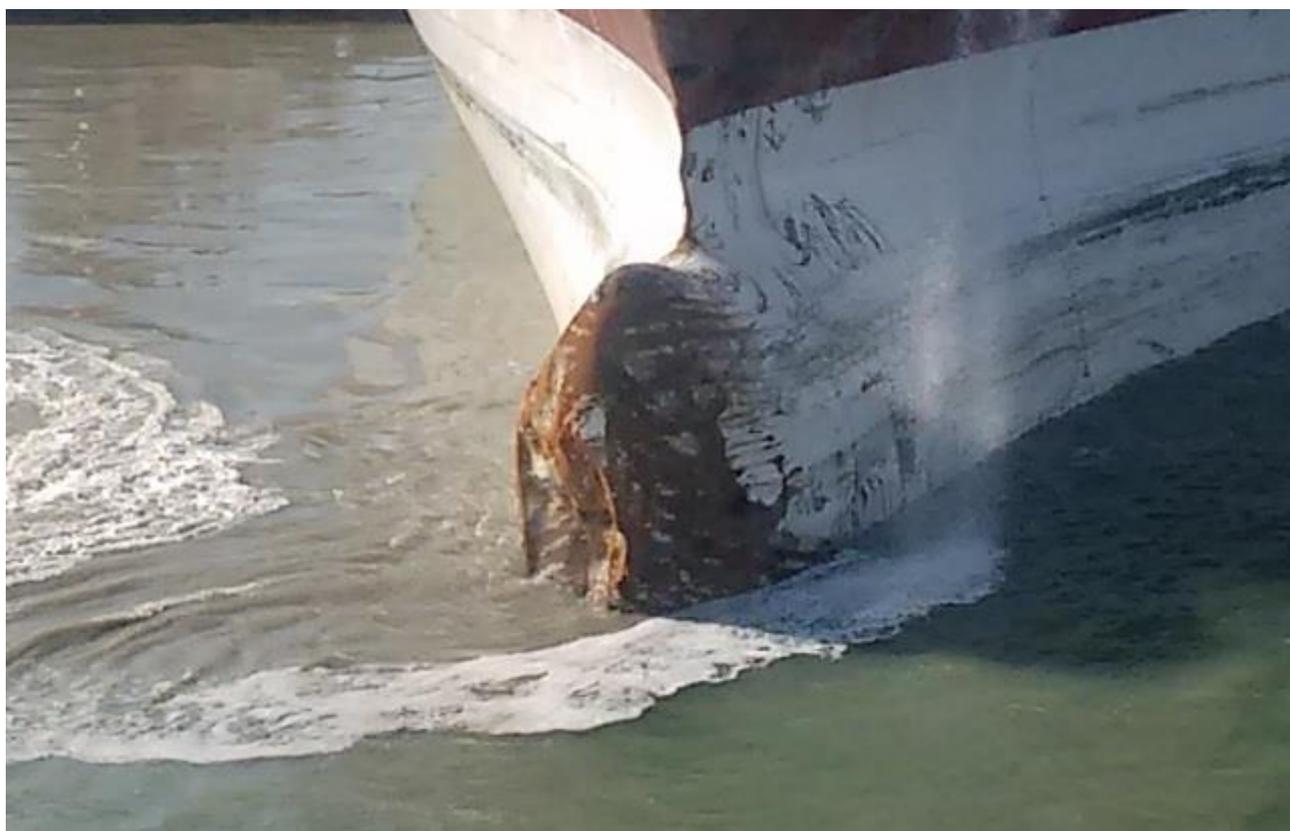
Figure 9 - Damaged bulbous bow of the mts AL ORAIQ after the collision

The bulbous bow of the mts AL ORAIQ was deformed and punctured. The mts AL ORAIQ was able to proceed under own power after the collision, first to the Port of Zeebrugge and consequently to a repair yard in Belfast, Northern Ireland.

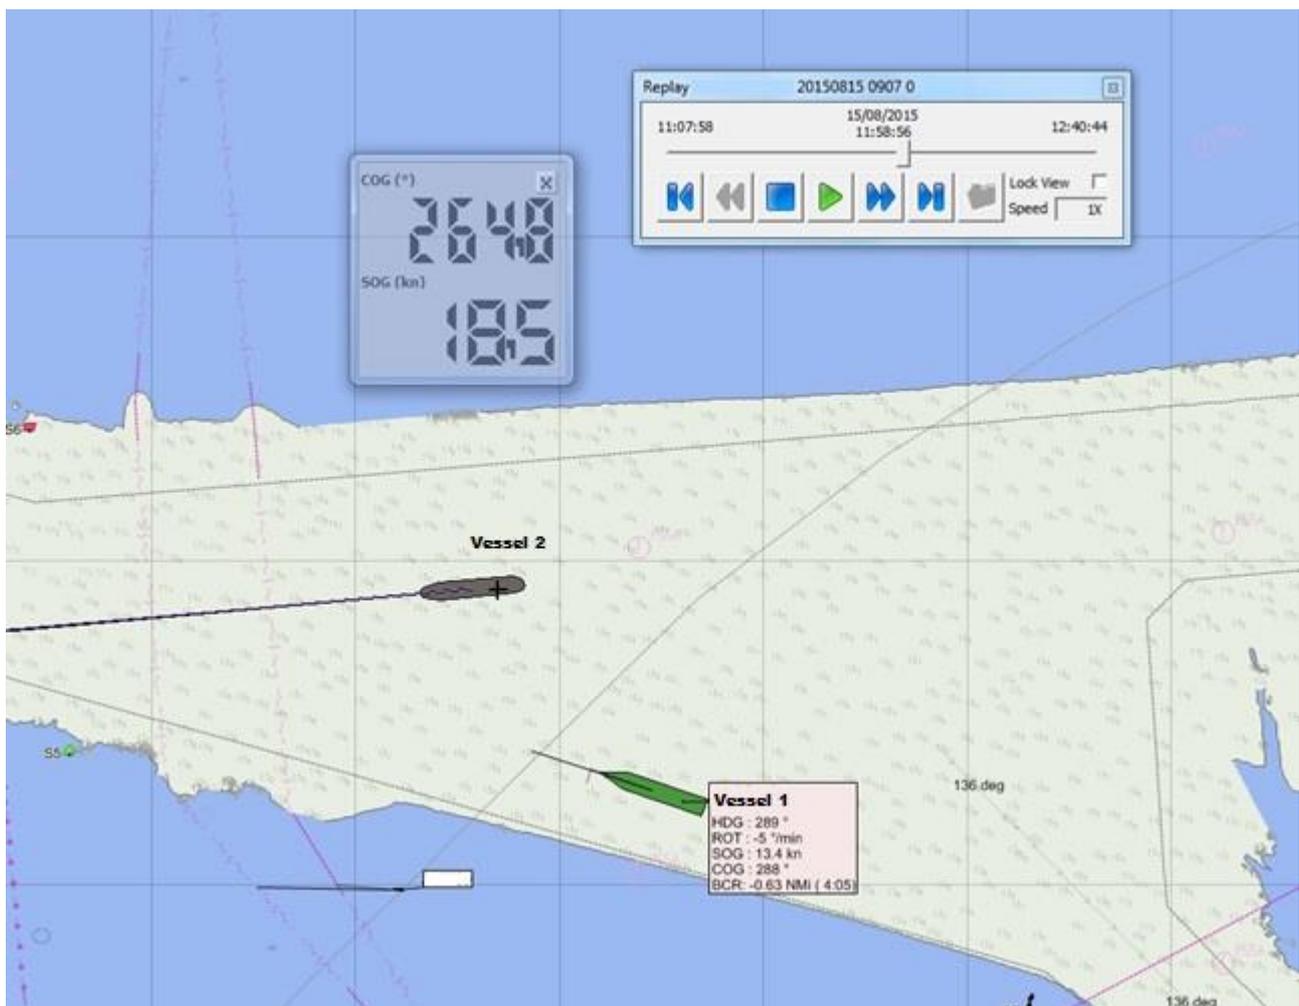
Figure 11 - Incident between VESSEL 1 and VESSEL 2 on 15/08/2015

VESSEL 1 was overtaking the mv VESSEL 2. The Pilot on board the mv VESSEL 2 did not advise the master of the mv VESSEL 2 accordingly and the speed of the mv VESSEL 2 was not reduced to allow for a bow passage with a safe distance of minimum 2 cables of the mts VESSEL 1 in front of the mv VESSEL 2. Instead, the speed of the mts VESSEL 1 had to be reduced to avoid a collision between the mts VESSEL 1 and the mv VESSEL 2, and to allow for the mv VESSEL 2 to pass safely in front of the mts VESSEL 1 as seen on Figure 11 on page 46.

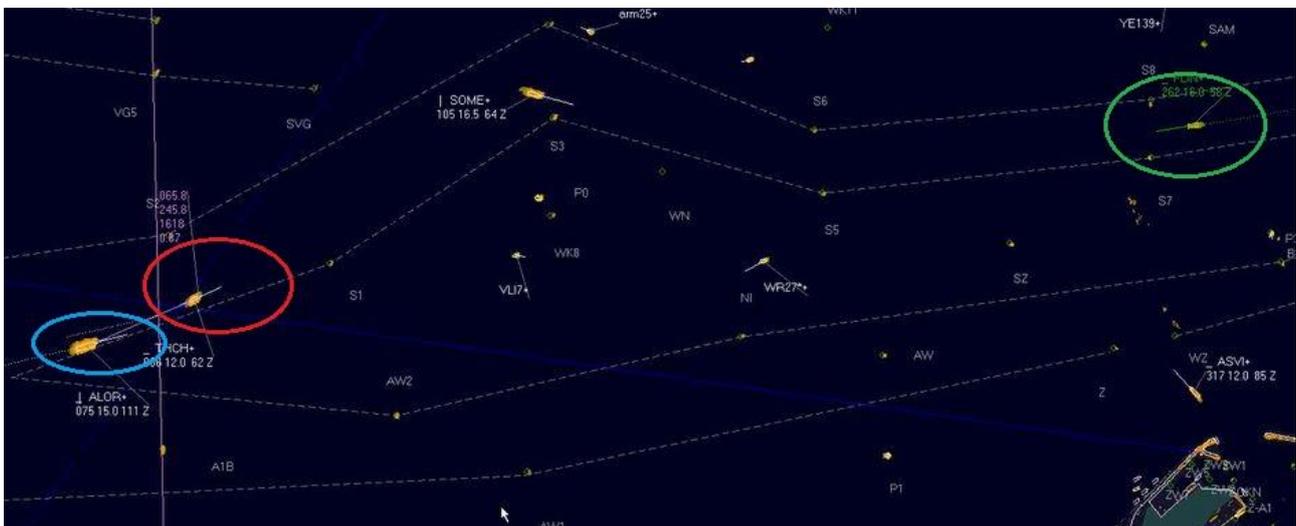
Figure 13 - Beginning of overtaking manoeuvre of mts AL ORAIQ in blue of the mv THORCO CHALLENGER in red and mv FLINTERSTAR in green

From the moment that the mts AL ORAIQ hailed to mv THORCO CHALLENGER to inform the latter that the mts AL ORAIQ would be overtaking the mv THORCO CHALLENGER on its starboard side, it was clear for the trained radar at observer at the VTS coastal station that the intended overtaking manoeuvre from the mts AL ORAIQ could not be completed before either of the vessels would reach the S3 buoy as seen in Figure 13.

The true vectors of both vessels only differ very little in length. Mts AL ORAIQ 's speed over ground is only slightly higher than the speed over ground of the mv THORCO CHALLENGER. The VTS-Operators of the VTS coastal station Traffic Centre Zeebrugge have at their disposal several message markers which could have been used to inform both vessels that their intentions could lead to an unsafe situation. The VTS-Operators at the VTS coastal station, Traffic Centre Zeebrugge, could also have informed both vessels that they would encounter the mv FLINTERSTAR in the vicinity of the buoy S3, if both vessel, the mts AL ORAIQ and the mv THORCO CHALLENGER all three proceeded at the current speed.
