Report on the investigation into the capsizing of the
fishing vessel

Z 582 ASSANAT

off the British coast near Margate with the loss of two lives
on 27 December 2016

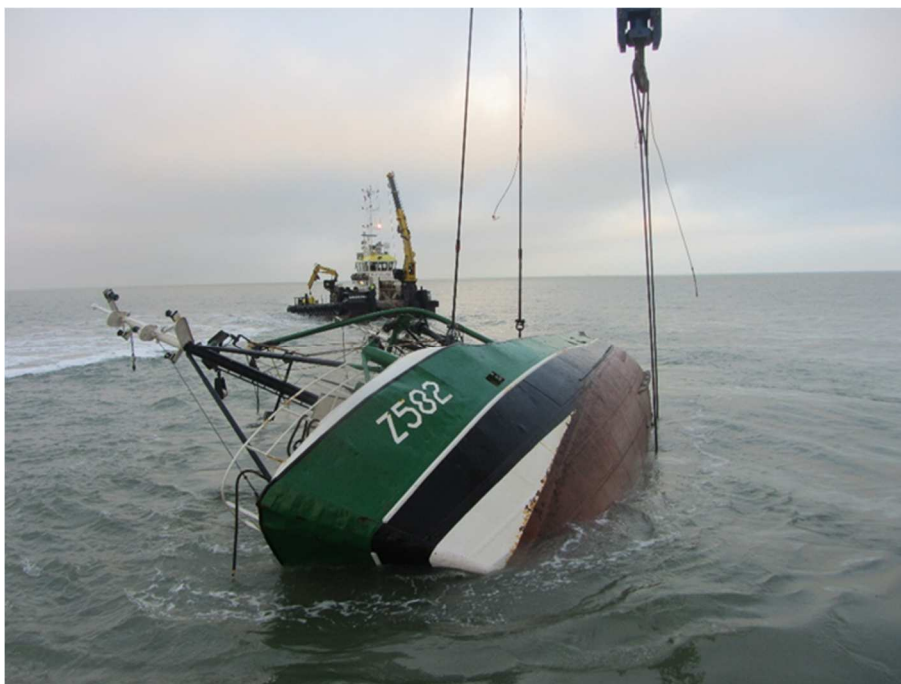
Figure 7 – Z582 ASSANAT Being turned right side up

During the turning right side up of the fv Z582 ASSANAT, the bulwark of the vessel got damaged by the hoisting cables of the crane barge.

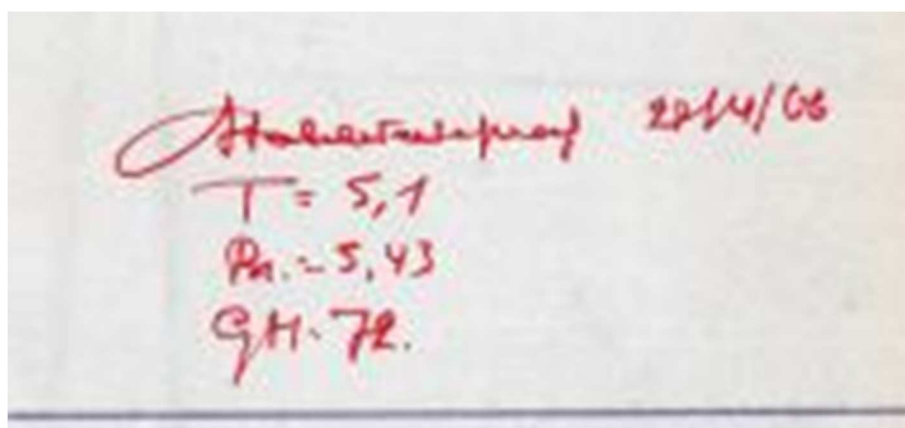
Figure 13 – Close up of note indicating GM

On Figure 11 on page 19 a handwritten note from 1966 was found indicating that the initial GM was 72 after an inclining test. No unit was indicated, however, it was assumed to be in centimetres. The origin of said values could not be determined.

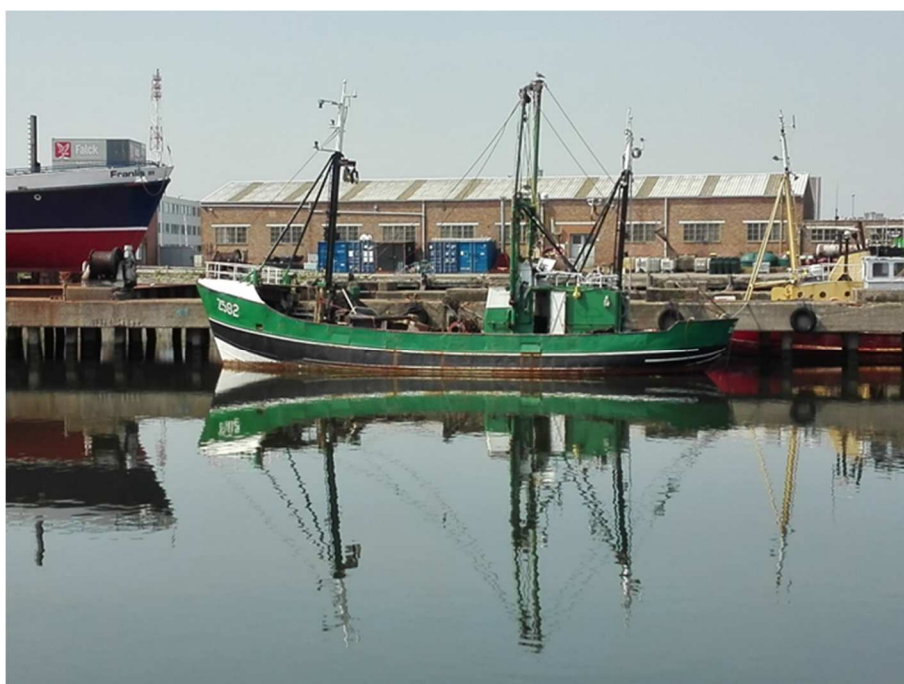
*Figure 27 - fv Z582 ASSANAT afloat in the port of Ostend
after having being salvaged and turned right side up*

No apparent damage to the hull was noted, however, when the vessel was found floating upside down in the North Sea, the appointed salvage company reportedly had found some weak spots in the hull. Before placing a hot tap, a salvage worker tapped the hull with a hammer in order to find the most suitable place for placing the hot tap, and reportedly the salvage worker punched holes into the hull. The holes were reportedly provisionally plugged in order to prevent the sinking of the fv Z582 ASSANAT after it would have been turned right side up.

During the survey of 21 June 2017 the actual condition of the hull could not be assessed from the outside since the vessel was afloat, and for security reasons it was decided not to assess the condition of the hull from the inside.

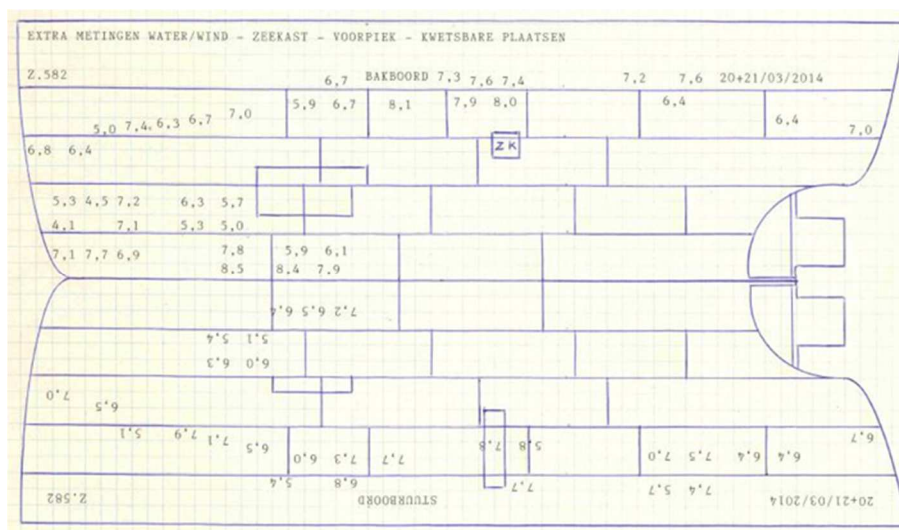
Figure 29 - Additional hull plate thickness measurement of 2014

The Federal Public Service Mobility and Transport, DG Shipping, Belgian Maritime Inspectorate performed an out of the water survey in march of 2014, same time the hull plate thickness was measured and it was noted that the frames, hull plating and stern and stem were not in sound condition as seen in Appendix 5.

The salvage company had found some weak spots in the hull while tapping the hull with a hammer in search of places where a hot tap could be inserted. The salvage worker tapping the hull hit a few holes in the hull, indicating that in the tapped area the hull was rather weak. After the hull had been temporarily fixed, hot taps had been installed and air had been blown into the hull of the fv Z582 ASSANAT the vessel remained afloat.

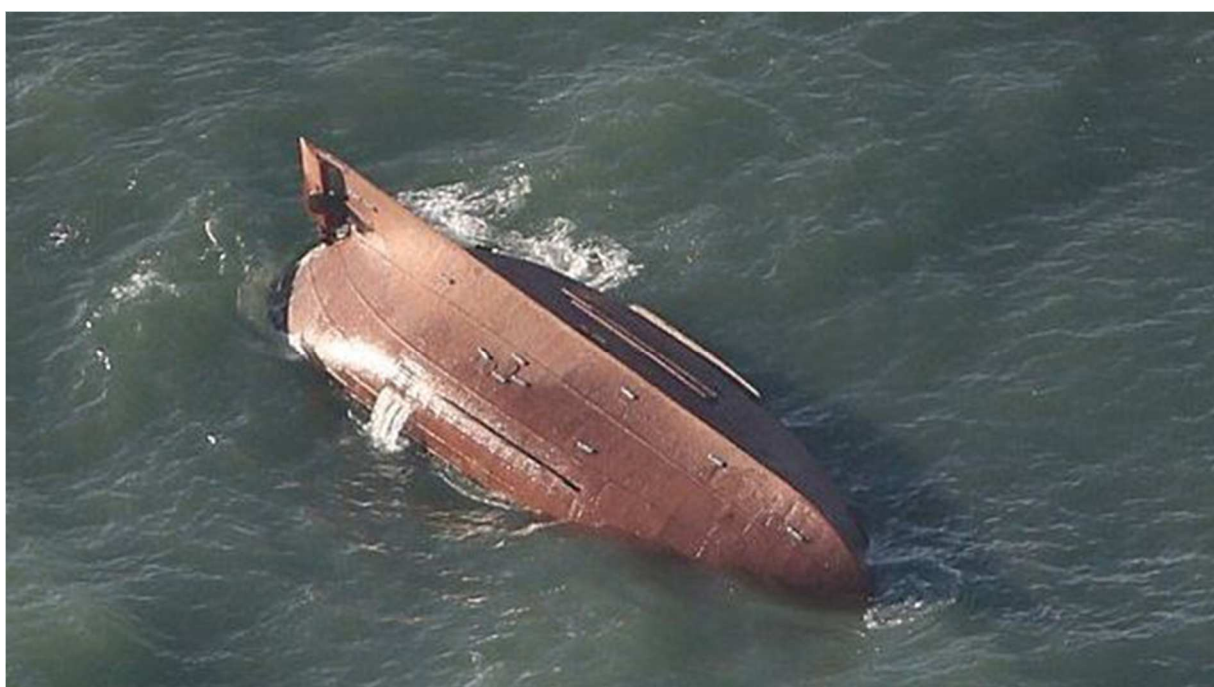
Figure 30 - No apparent damage to hull

Although there were some areas of the hull that were reason for concern with respect to hull integrity, since the salvage worker tapping the hull, punctured it, damage to the hull and consequential flooding leading to loss of stability of the Z582 ASSANAT could be excluded as cause of the capsizing since *no structural damage to the hull was apparent after the capsizing*.

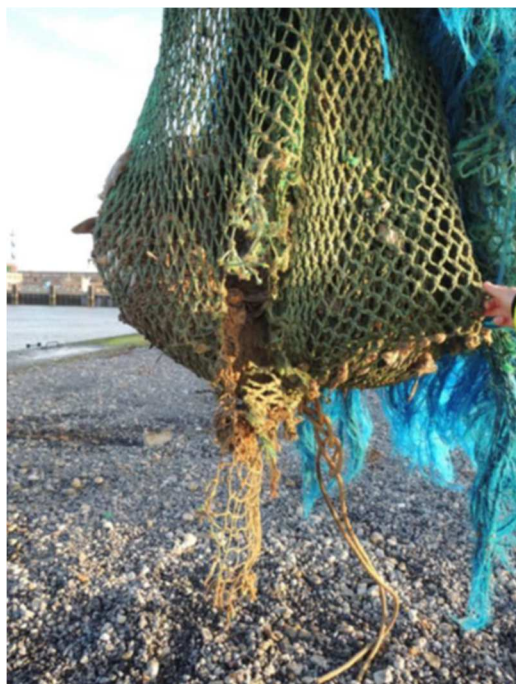
Figure 31 – Damaged Starboard Fishing Net

During a survey by a court appointed investigator, it was noted that the starboard fishing net had been damaged.

Reported close observation of the damage learned that the tear did not occur as a result of wear but the tear reportedly appeared to be a cut in the net.

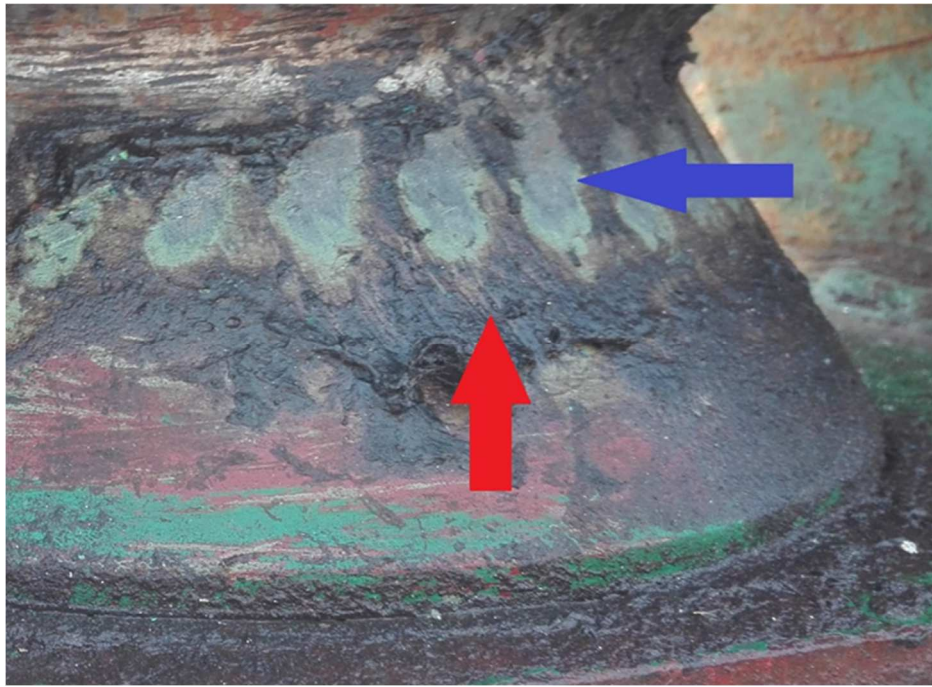
Figure 34 - Scratch marks on fairlead

Further, on the portside fairlead on deck of the fv Z582 ASSANAT, several marks left by the warp of the portside fishing net, were found.

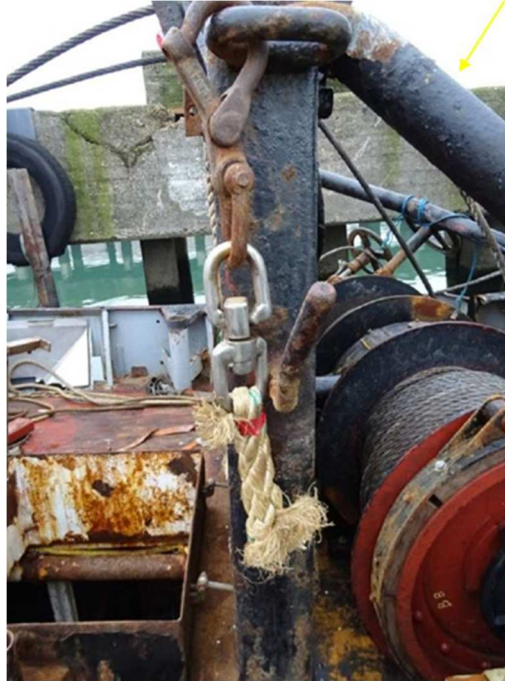
Figure 37 - Port side spring line snap hook in stowed position

The spring line of the port side net had not been fastened to the cod end of the portside net and was found still in stowed position after the Z582 ASSANAT had been turned right side up. Reportedly salvage workers had cut the port side spring line during salvage operations. The snap hook and part of the port side spring line were left in stowed position.

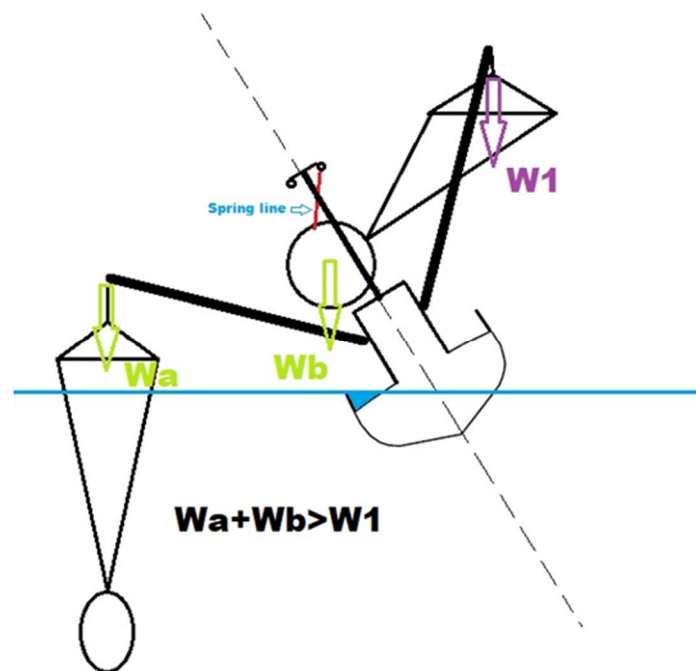
Figure 38 - Situation whereby Z582 ASSANAT capsized

the centre of the vessel had such detrimental effect on the vessel's stability that, the Z582 ASSANAT capsized over port side as seen in Figure 38.

Figure 38 indicates that at the time of capsizing both moments caused by the mass of the fishing gear and the distance from the centre of the vessel were not equal one to the other causing a list to Portside. Simulation, using the vessel's approved stability book, indicated that at the time of the capsizing the aforementioned particular situation caused a theoretical list to portside of approximately 27° whereby water could have entered the vessel.

Once the Z582 ASSANAT was listing to port, consequential water ingress on portside caused the vessel to list even more. At a certain stage, the beam of the starboard swung to portside and smashed into the wheel house thereby again increasing the list and finally topping over the vessel.
