Report on the investigation into the
Marine Casualty
on board the LPG Carrier mts “EUPEN”

with the loss of life of a crew member, at
PORT KHALIFA, ABU DABI on
12 February 2016

Independent Unit
Rue du Progrès 56
1210 Brussels

September 2016

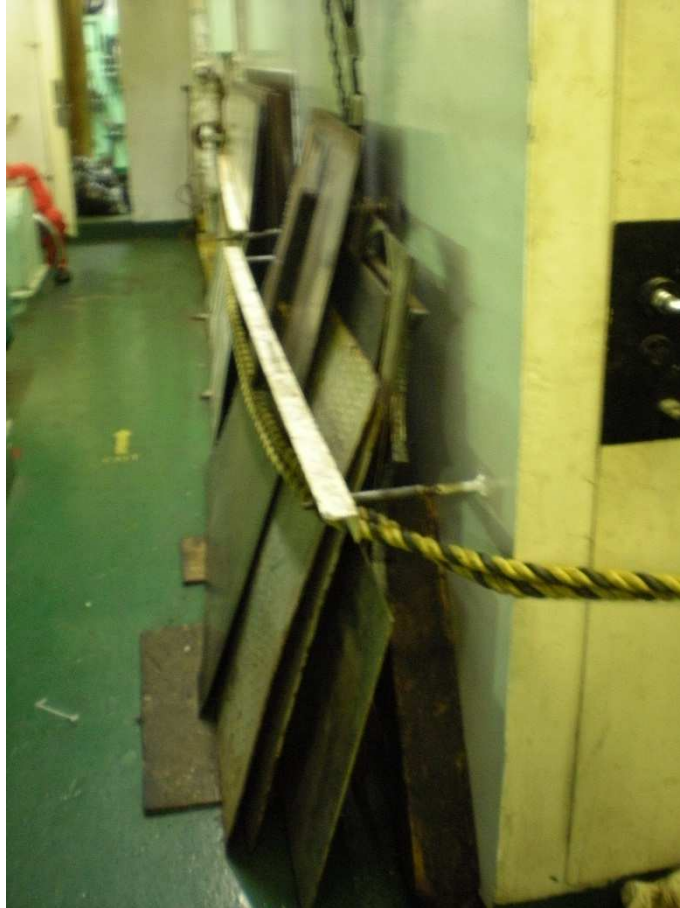
Figure 1 - Normal stowage position of steel plates in engine room

One crew member was tasked to release the angle bar, that was used to secure the metal plates in position, so that the metal plates could be stored with the rest of the metal plates already in place. The crewmember tasked with releasing the angle bar, proceeded alone to the stowage location and, removed the nuts holding the angle bar in position, as seen in Figure 1 on page 6.

A crewmember started to remove a bolted angle bar which is used to keep metal plates secured in place, as seen in Figure 1 on page 6.

The angle bar is secured by means of two threaded rods welded to the bulkhead onto which the angle was slid through two holes, one at each end of the angle bar. Threaded nuts were used to bolt and secure the angle bar tight to the metal plates.

Steel metal plates on board the mts "EUPEN" are stowed against the forward engine room bulkhead which always leans towards the aft of the engine room, due to an always present trim towards the stern of the vessel.

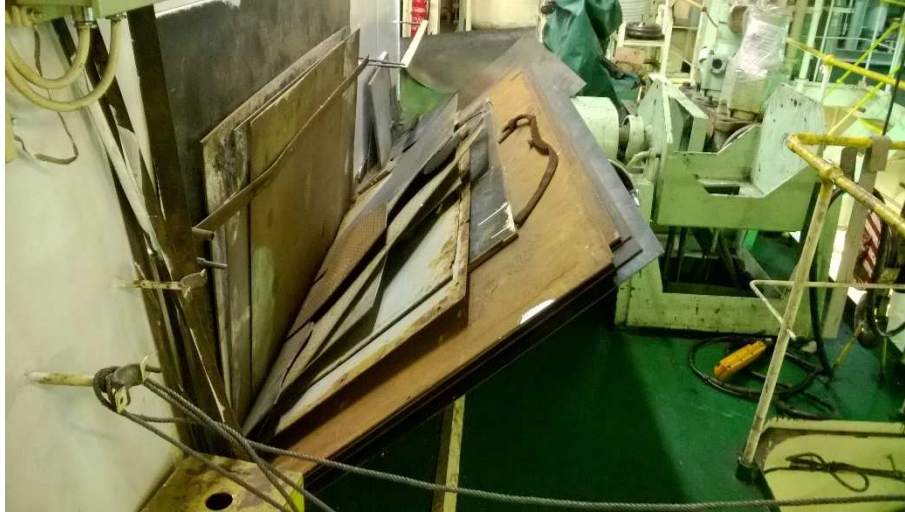
Soon after the securing had been removed the plates fell towards the crewmember.

Figure 2 - Fallen metal plates after securing nuts had been removed

After having removed the PS threaded securing nut, the metal plates and angle bar fell towards the crewmember.

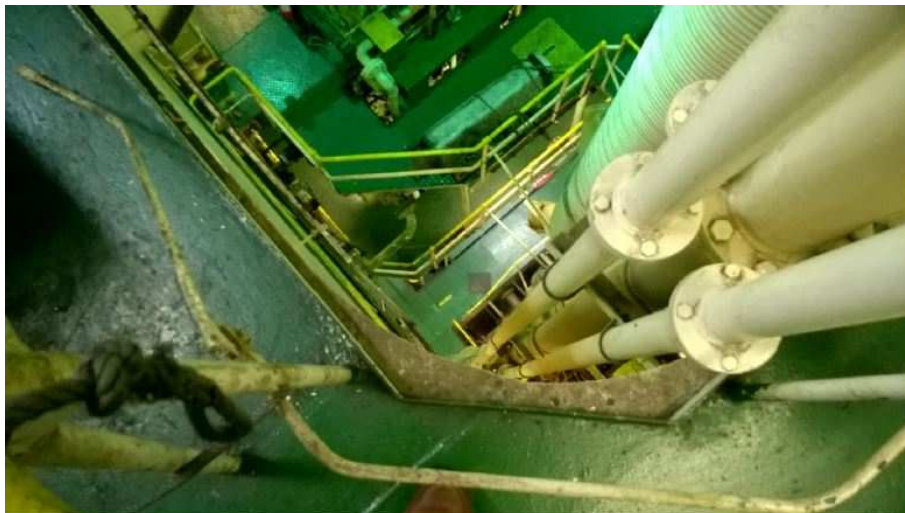
Figure 3 - Downward view of engine from platform

where crewmember fell off

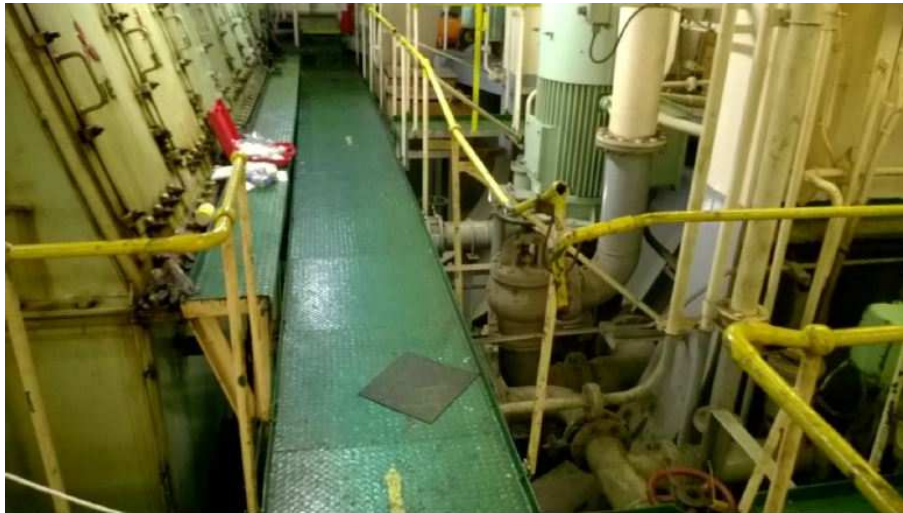
The dismantlable part of the railing gave way and the crewmember fell down into the lower part of the engine room of the mts "EUPEN", onto a railing surrounding a lower platform in the engine room of the mts "EUPEN", some 10 metres below as seen in Figure 4 on page 8.

Figure 4 - Area in lower part of engine room where crewmember fell onto

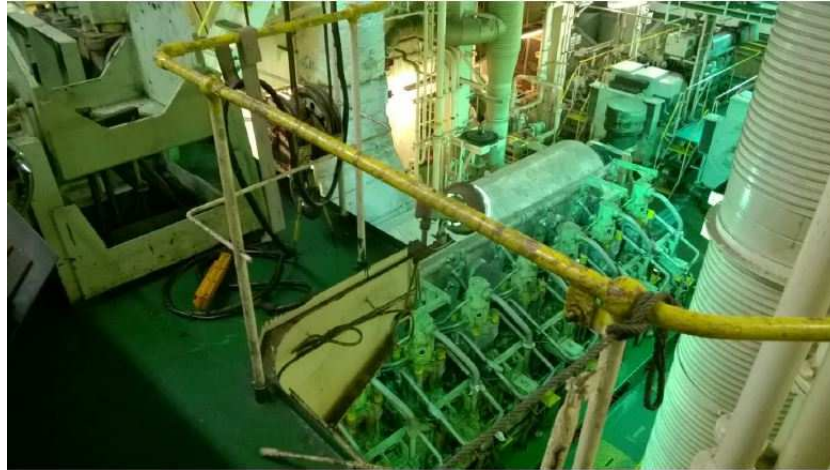
Figure 6 - Lower part of railing (loose) where crewmember fell onto

The lower section of the railing gave way under the impact from the crewmember's motion, and consequently the crew member fell onto a railing in the lower section of the engine room some 10 metres below the place of initial impact onto the dismountable railing.

The crewmember fell onto the lower section of a dismountable railing that gave way under the motion of the crewmember, therefore the failing of the railing contributed to the incident with a loss of life as a consequence.

- EXMAR Shipmanagement had issued a safety bulletin to have the integrity of the railings in the engine room of their managed ships assessed and where necessary repaired or brought back to their initial condition to prevent railings from giving way under the weight of a crewmember, i.e. accidental opening under.
- EXMAR Shipmanagement had the ways of stowing metal plates, on board their managed vessels, re-assessed and had necessary measures taken to prevent metal plates from falling over when being handled, considering the number of stowed plates, the size of the stowed plates, the location where metal plates are stowed and considering the orientation of the stowed plates and means of stowage

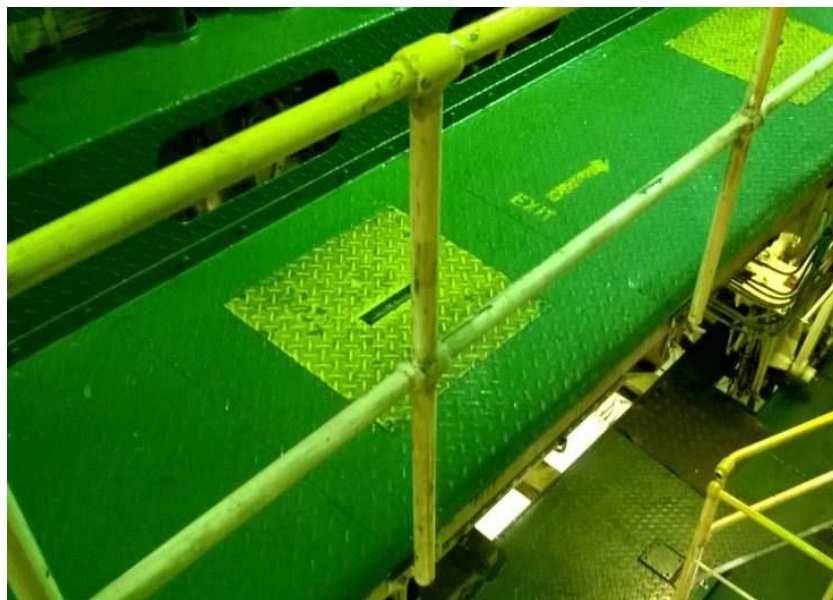
The fixed railings on the various platforms of the engine room of the mts “EUPEN” were all of similar construction. The fixed railing was built up with stanchions and two parallel rails. The top rail at the place of the incident consisted of a metal hollow tube of about 1 inch in diameter.

Both rails passed through holes in the various stanchions and were welded to the stanchions at said locations as seen on Figure 7 on page 6.

Figure 7 - Typical section of fixed railing in engine room of the mts “EUPEN”

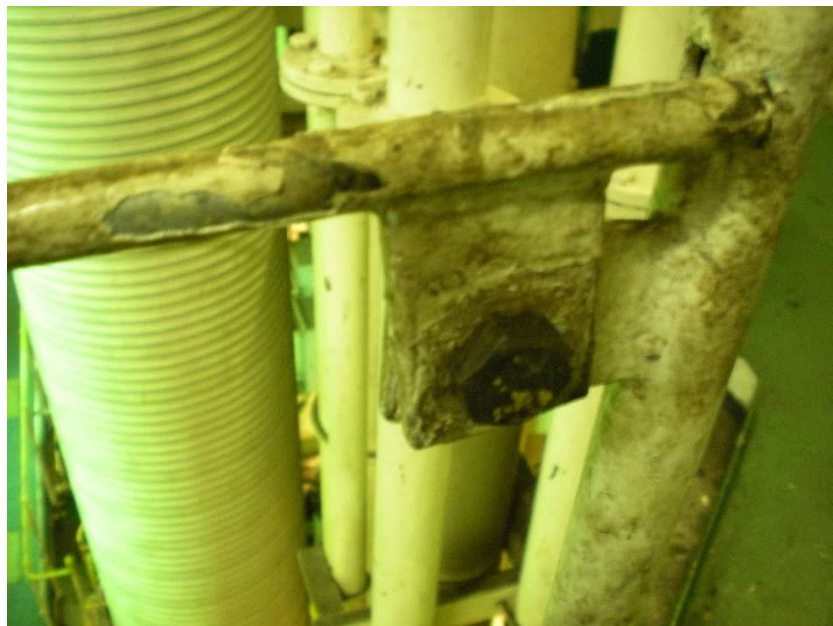
At the location the crew member fell onto the railing, an undersized bolt was being used as spigot for the hinge of the bottom part of the railing, allowing for the bottom part of the railing to move horizontally while being secured. Reportedly the bolt used as spigot was 5 mm undersize in diameter allowing for a consequential movement of 5 mm in the vertical plane.

Figure 8 - Bolt used as spigot for section of railing

The bolt used as spigot for the a section of the railing in way of the place where the metal plates were stowed was undersized, allowing movement of the railing.

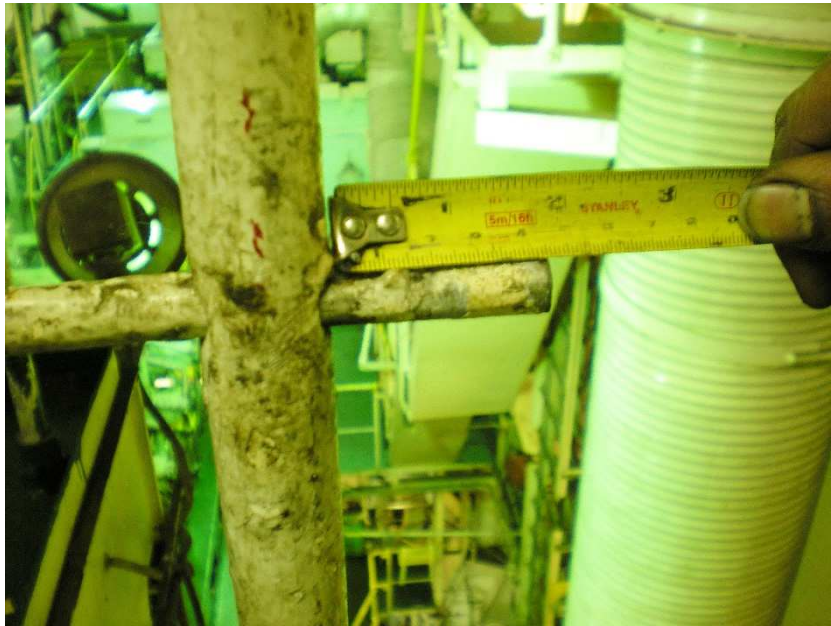
The tack weld, keeping the bottom rail in position had come loose, allowing for the bottom rail to move horizontally through the hole in the stangion over a distance of +/- 3,00 centimetres.

Figure 9 - Broken tack weld allowing for 30 mm horizontal movement

The condition of the railing, i.e. the broken tack weld in way of the removable section of the railing, allowed for excessive movement of the removable section of the railing without same section being loosened for removal.

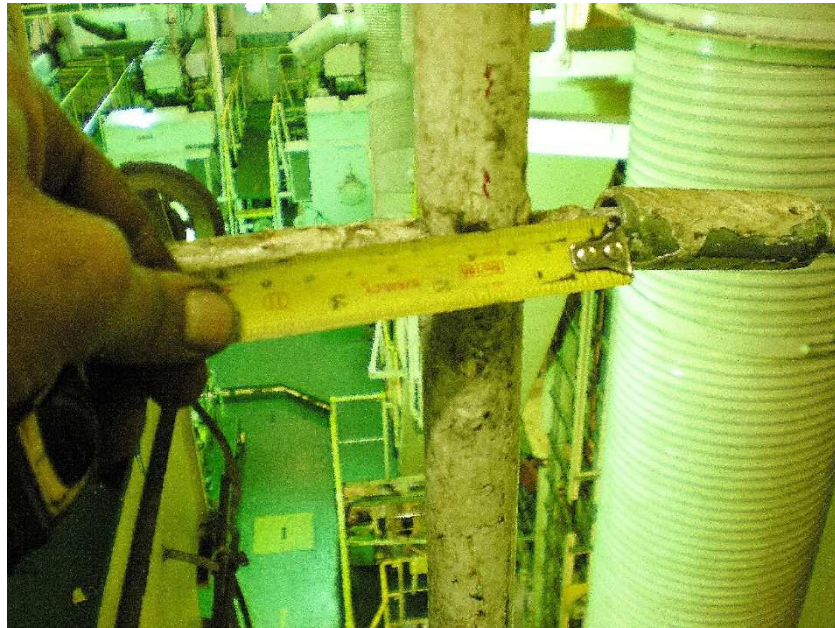
The combination of the usage of an undersized bolt as pivot and the free movement of the lower rod, part of the railing, due to the broken tack weld, allowed for the rod to come out of the male/female connection when the railing was pushed against and the consequential bending of the railing.

Figure 10 - Male/female connection of railing and maximum insert

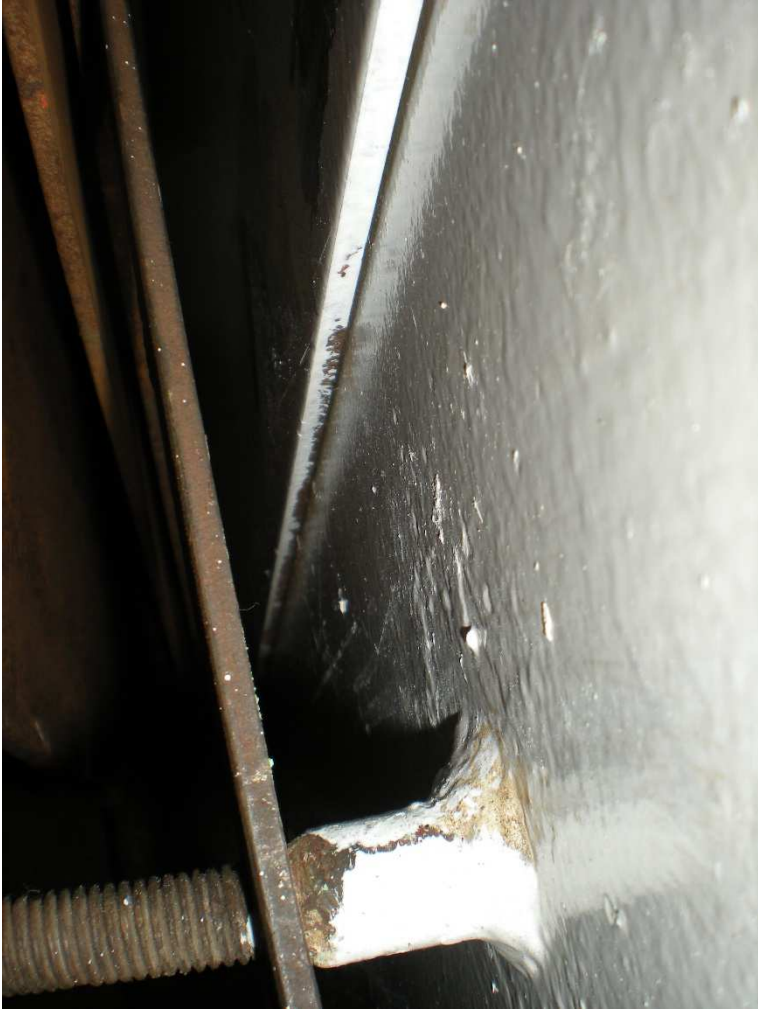
The plates were held in their position by means of an angled steel bar. The steel bar was slid, through two holes, one at each end of the angled steel bar, over two threaded rods that were welded against the bulkhead. The thread, however, did not continue all the way to the bulkhead, as seen on Figure 11 on page 19.

As a consequence, the forward engine room bulkhead will always have a slight angle, towards the aft of the vessel compared to the vertical plane. With a length between perpendiculars of the vessel of 172,02 metres and a trim of 1 metre aft, the bulkhead has a calculated angle of $0,3^\circ$ towards the aft of the vessel, resulting in the steel plates

always leaning aft, and consequentially falling over when the angled steel bar, normally securing the metal plates, is removed.

Figure 11 - Threaded rods that holds steel plates in position

Since the threaded rods are not threaded all the way till the bulkhead, in case only a limited amount of steel plates are stowed, to a thickness of less than the unthreaded part of the threaded rods, plates will move, when stowed, when the vessel is pitching, potentially creating a hazardous situation, especially when the angle bar keeping the plates in position is removed during adverse weather conditions.
