Report 2017-02 on the investigation into the capsizing and subsequent  
rescue mission of the sailing vessel

# CAPELLA

Off the Belgian coast with the loss of three lives on July 1<sup>st</sup> 2017

***Federal Bureau for the Investigation of Maritime Accidents (FEBIMA)***

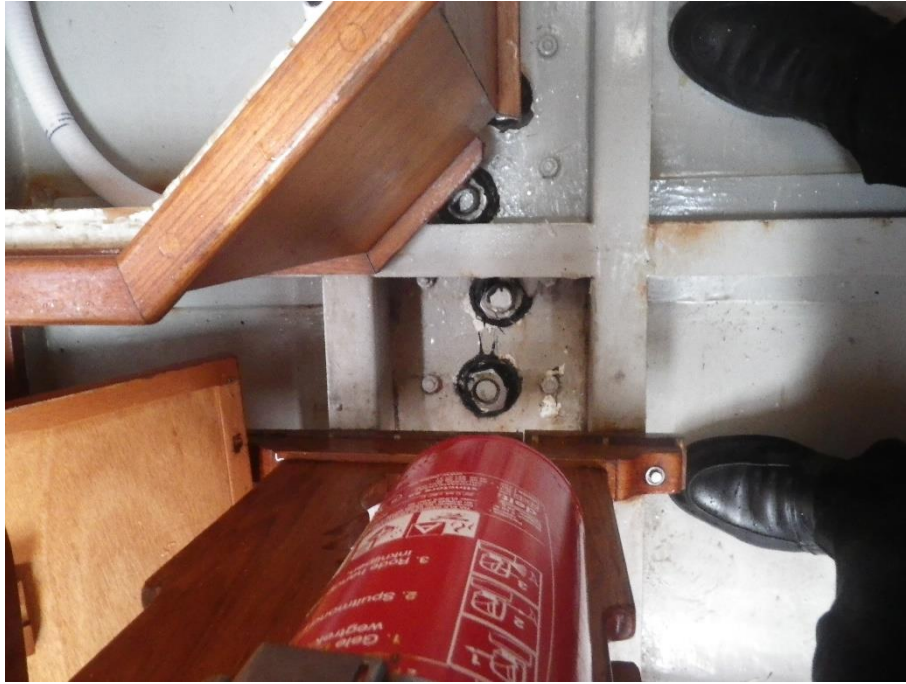
*Figure 8 - Nuts and threaded rods and bolts that hold the keel in place  
seen from inside the sy CAPELLA*

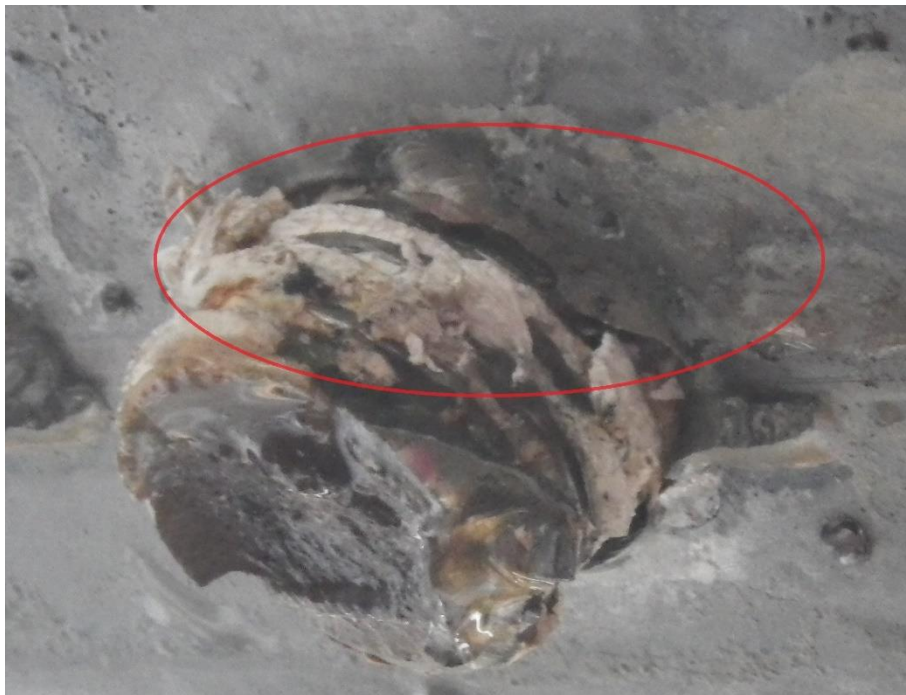
The keel plate was welded perpendicularly to a stainless steel plate in the centre of the keel. The threaded rods were also welded to the bottom of the keel plate.

*Figure 9 - Part of threaded rod welded to keel plate*

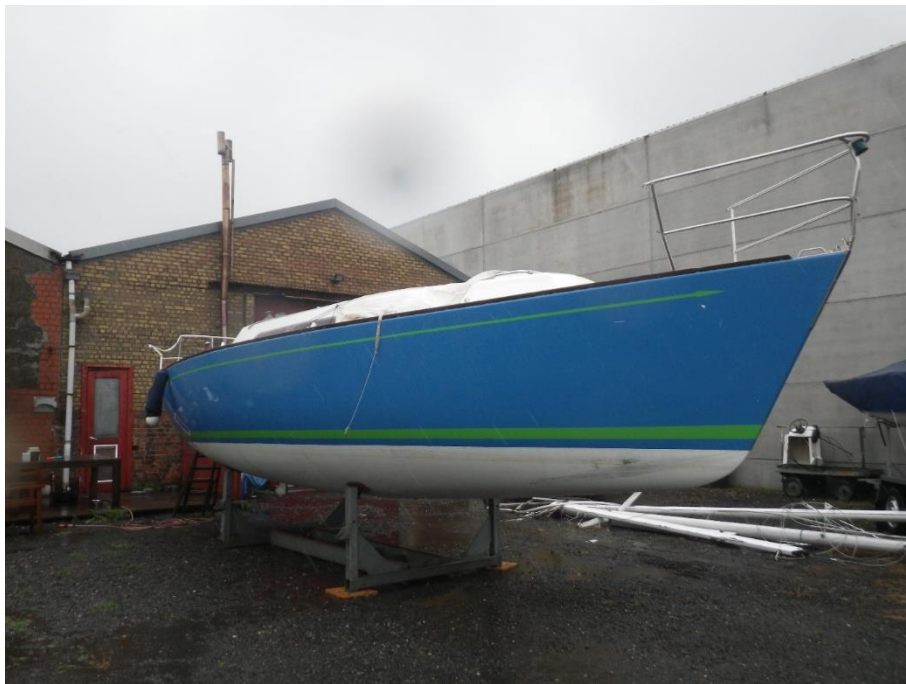
*Figure 14 - sy CAPELLA as it had been stored at Zeebrugge*

Apart from a damaged rig, and damaged roof of the superstructure, the latter most probably by the rigging giving way, the hull of the sy CAPELLA appeared in sound condition.

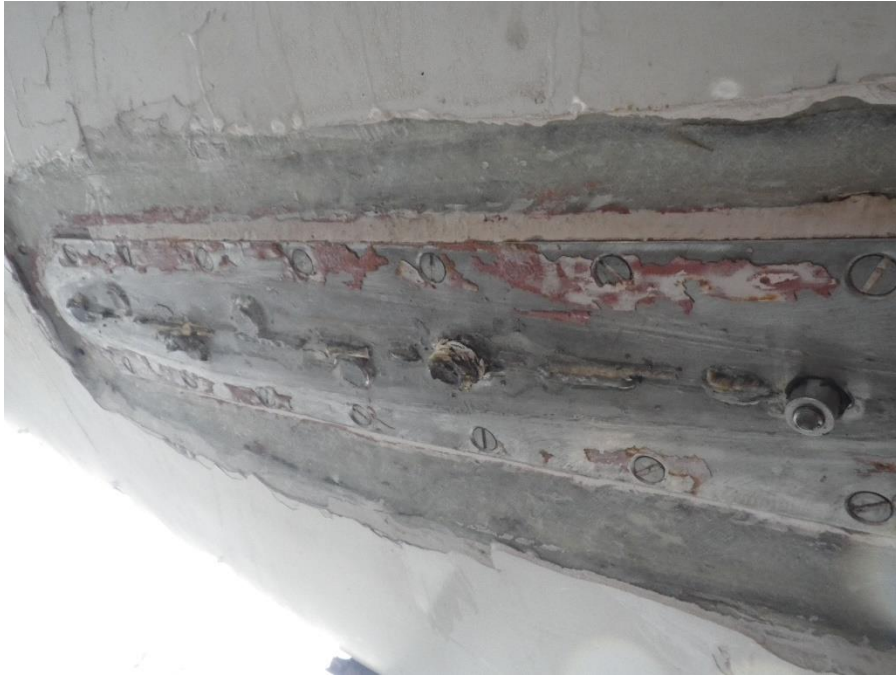
The keel of the sy CAPELLA was found missing. Closer investigation revealed that a part of the keel, the keel plate, was still present and in position against the vessels hull.

*Figure 15 - Keel plate still present on hull  
with larger part of keel missing*

It was noted that the threaded rods or keel bolts, provided to keep the keel in place, were sheared off below the welds, where the threaded rods or keel bolts had been welded to the keel plate. It was also noted that all keel bolts had been positioned near the centre line of the keel.

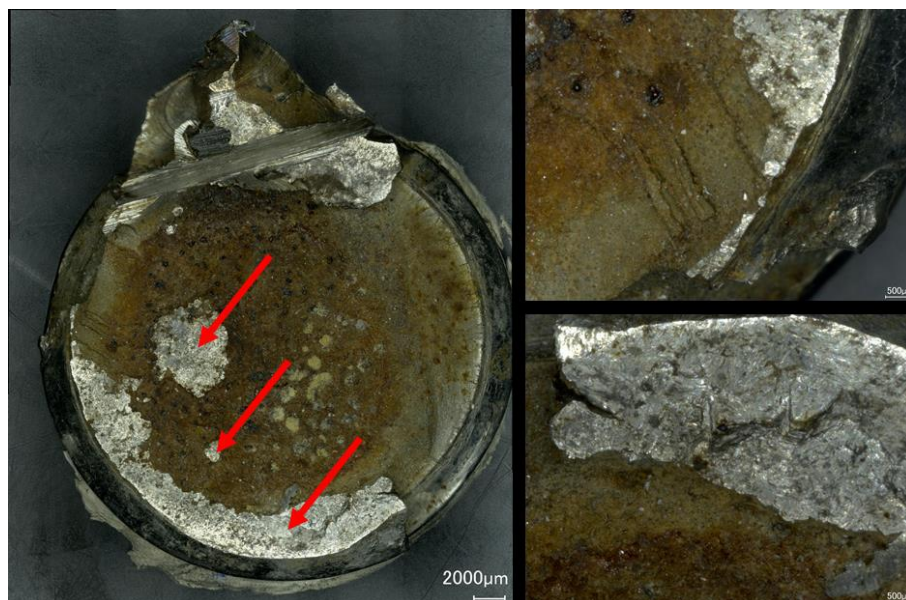
With the use of an optical microscope bolt 2 was investigated as seen in Figure 19. The fracture surface was highly corroded, which indicated that fracture had not occurred recently, but that the fracture surface had been submitted to seawater for a longer period of time.

The corroded nature made it hard to determine the type of failure. Some zones, indicated with red arrows in Figure 19 had a reflective appearance, which indicated that the metal was ground against another metallic part for a certain period of time. Friction between two parts of the broken off keel bolt must have taken place, so that consequentially, corrosion products were ground away or never had the chance to be formed in these particular positions

*Figure 19 - Optical microscopy images of bolt 2*

*Left: fracture surface with indication of reflective surfaces. Right: more detailed image of reflective surfaces and corrosion products*

An EDX analysis was conducted on the corrosion products and on the fracture surface of broken off keel bolt 2 and the following elements were detected: Fe, O, C, Cr, Mo and Ni.

Cr, Mo and Ni were part of the passive protective layer of the stainless steel, however, the presence of iron indicated that corrosion had taken place. The red rust, ferric oxide -  $\text{Fe}_2\text{O}_3$ , was also a clear indication of the aforementioned corrosion.

Besides aforementioned elements, 10 wt% of sodiumchloride -  $\text{NaCl}$ , commonly known as salt, and some small amounts of sulphur, 2 wt%, were detected. The present of sodiumchloride indicated that corrosion had taken place in saline environment, such as sea water.

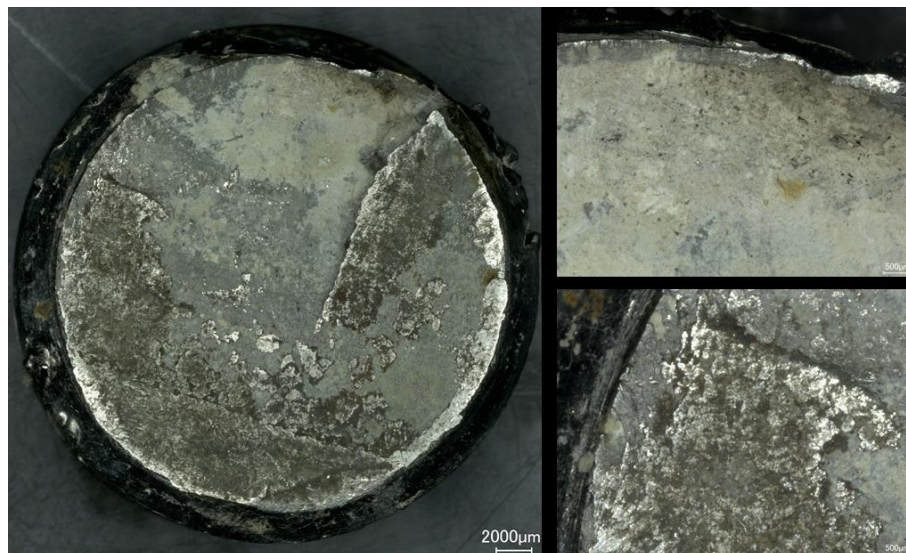
In Figure 20 images of optical microscopy investigation of the fracture surface of broken off keel bolt 4 are shown. In the overview left image, a white deposit was visible. Most of the fracture surface of the broken off keel bolt, when not covered with white deposits, consisted of reflective surface. Similar to the fracture surface of broken off keel bolt 2, this reflectiveness indicated that the metal surface had been ground against another metallic part.

*Figure 20 - Optical microscopy images of bolt 4*

*Left: fracture surface. Right: detailed image of the white deposits (top) and reflective surface (below) of the fracture surface*

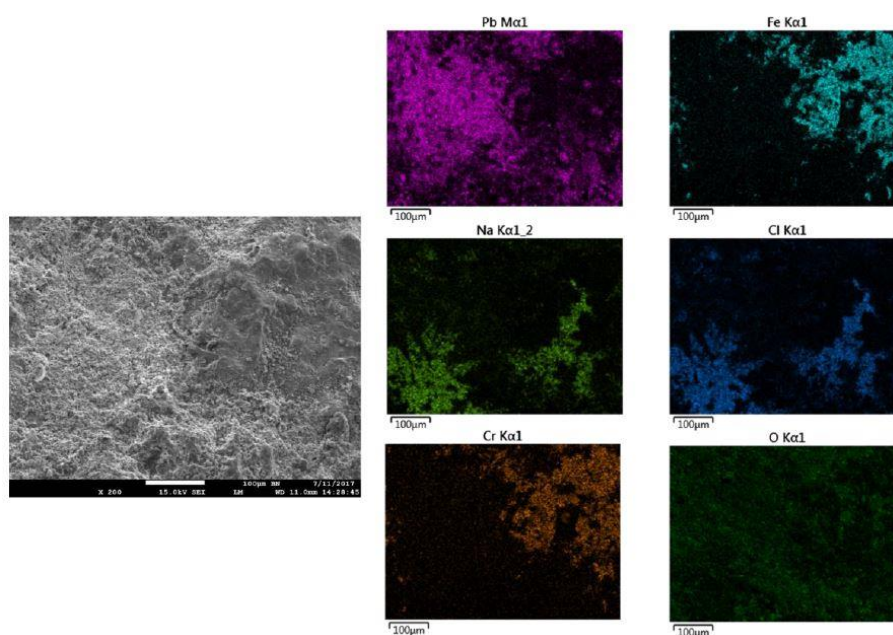
With use of the EDX mapping technique the nature of the white deposits was determined. In figure 10 a secondary electron image of the white deposit on the fracture surface is shown. EDX mappings of Pb, Fe, Na, Cl, Cr and O are displayed. Traces of Si, Ca, C, Mg, Mo, Al and Ni were also found, but since they were present in very small amounts and were distributed more or less evenly over the surface, they were not shown. The mappings visualized the presence of lead oxides, PbO, on the fracture surface of the broken off keel bolt. Some parts of the investigated area were not covered with the PbO, but instead iron with passive Cr<sub>2</sub>O<sub>3</sub>, chromium oxide, on top was present. The presence of salt, NaCl, was also demonstrated.

*Figure 21 - Secondary electron image of white deposits  
and the EDX-map of Pb, Fe, Na, Cl, Cr and O.*

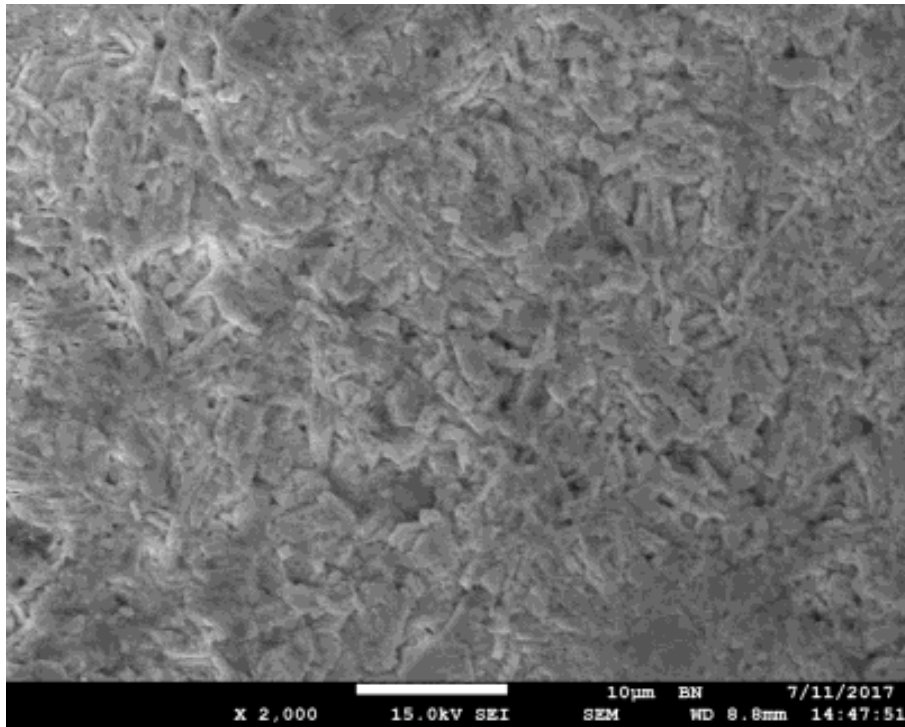
*Figure 22 - Secondary electron image of the lead oxide*

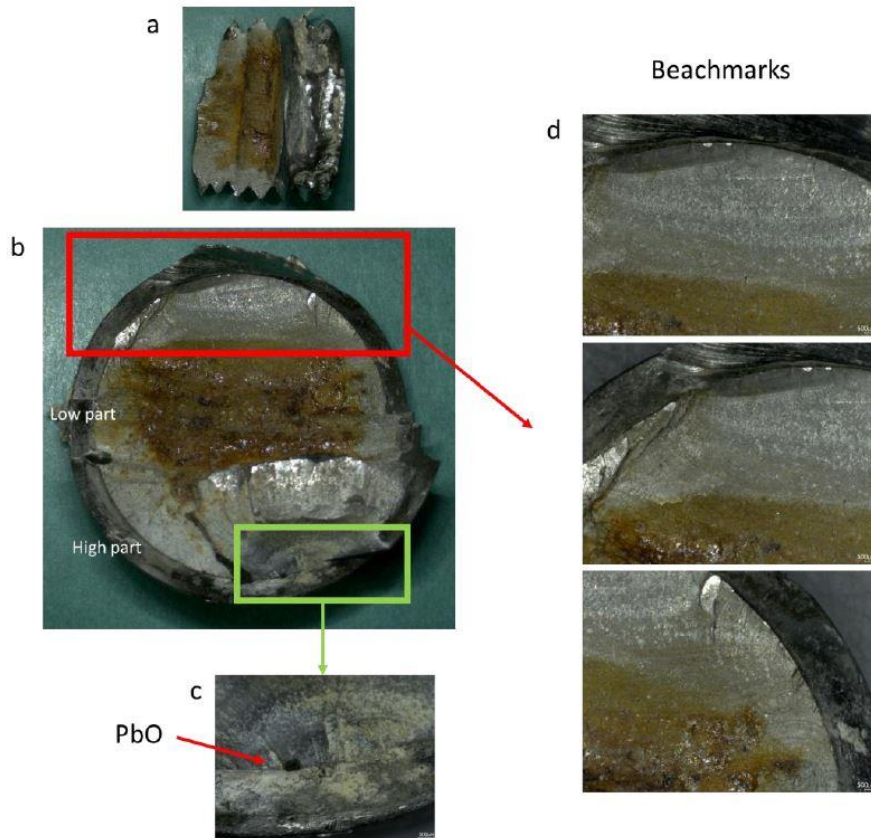
Figure 23 shows the optical imaging of the fracture surface of broken off keel bolt 5. Attention was drawn to the important findings on this surface, delimited by the red and green boxes.

Figure 23 - Optical microscopy images of fracture surface of broken off keel bolt 5

a) Side view b) Overview of fracture surface c) PbO deposits, high part fracture surface d) Beachmarks, low part fracture surface.

On the higher part of the fracture surface of the broken off keel bolt, PbO deposits were found and were verified by EDX, as well as a reflective surface similar to the reflective surfaces found on the fracture surfaces of broken off keel bolts 2 and 4. On the lower parts of the fracture surface of the broken off keel bolt 5, two zones can be determined. One zone consisted of corrosion products similar in composition to the corrosion products found on the fracture surface of broken off keel bolt 2, which indicated that this part of the bolt had been exposed in a saline environment, such as sea water, for some time.

The second zone was not corroded, nor did it exhibit a reflective appearance or PbO deposits on the surface.

This zone exhibited clear signs of a recognizable failure mode, i.e. fatigue. The lines visible on figure 12d and 13 were referred to as beachmarks<sup>10</sup> and were an indication of failure by fatigue. Fatigue is a form of failure that occurs in structures subjected to dynamic and fluctuating stresses, after a lengthy period of repeated stress or strain cycling. Fatigue failure is characterized by three distinct steps. 1) crack initiation, 2) crack propagation, and 3) sudden final failure. Beachmarks are formed during the crack propagation step. They indicated that there were interruptions during the crack propagation stage. A possible explanation for the presence of the not corroded beachmarks, was that this part of the bolt was attached for a longer period of time to the counter part of the bolt compared to the corroded part.

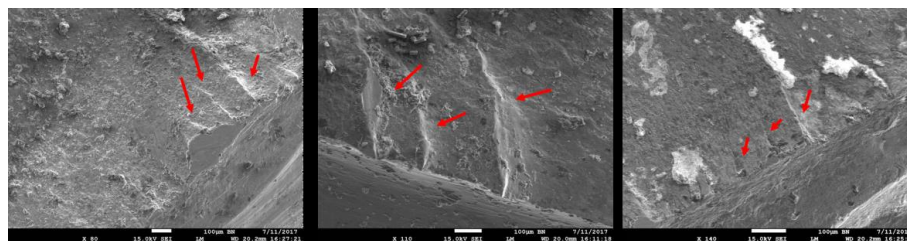
*Figure 24 - Secondary electron images of the edge of the low part of the fracture surface of broken off keel bolt 5 with indication of the beachmarks*

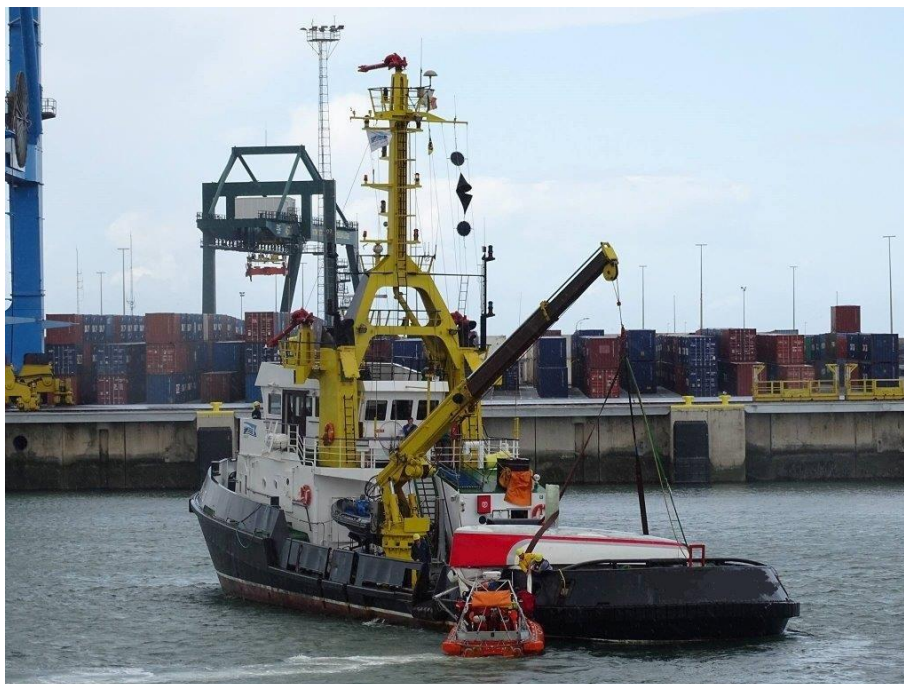
*Figure 25 - Sailing yacht recovered off the Belgian coast after keel was lost*

The yacht that had lost its keel, had reportedly grounded in the months prior to losing its keel. In 2014, a 40 foot sailing vessel lost its keel and capsized in mid Atlantic.

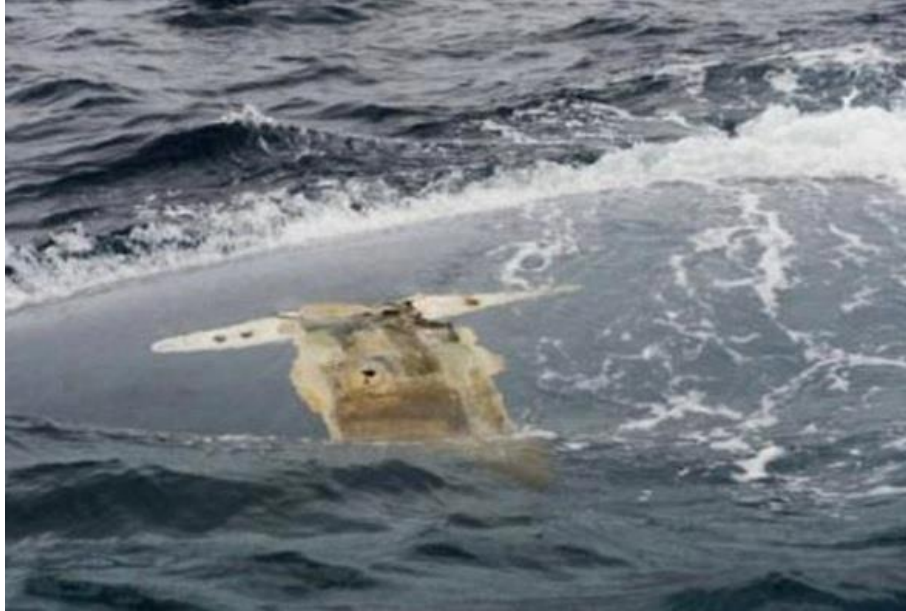
*Figure 26 - Derelict sailing vessel found in the Atlantic ocean  
with keel missing*

There were no survivors. The hull was found adrift in upside down position, with the keel missing. An investigation into the cause of capsizing, by a marine accident investigation body, revealed that the vessel had capsized after having lost its keel and that the vessel had grounded in the past, without having the keel removed for inspection of the keel bolts, after it had grounded.

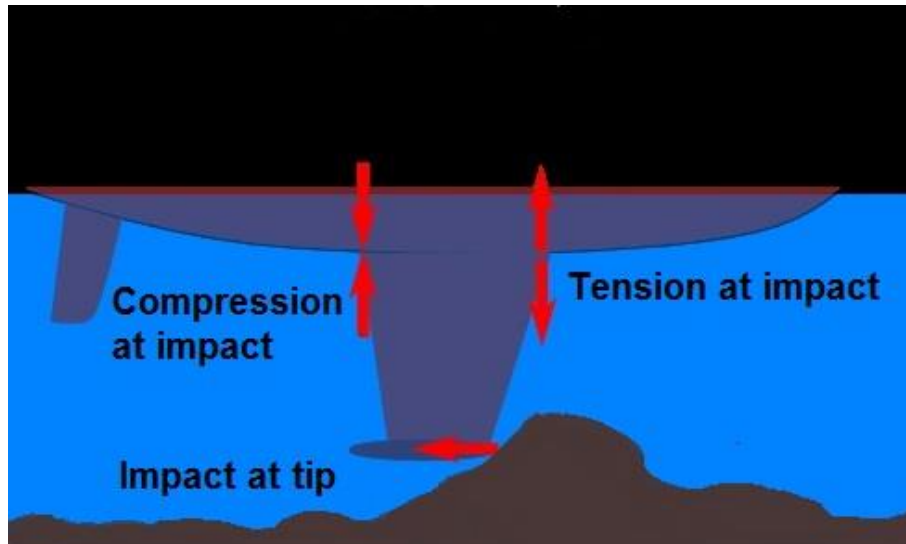
*Figure 27 - Forces on keel bolts of sailing vessels during grounding*

The tension at impact can be that severe that keel bolts break, in which case the broken off ends of the bolts could be observed from inside the sailing vessel when checking the pre-tension on the nuts.

In the case of the sy CAPELLA, with the keel bolts welded to the underside of the keel plate it was also not possible to assess the condition of the keel bolts by checking the pre-tension on the nuts holding the keel bolts in position inside the sy CAPELLA, since the way of fastening concealed the condition of the keel bolts below the welds on the bottom of the keel plate.

- 2) The Belgian Federal Public Service Mobility and Transport, DG Shipping, directorate pleasure craft, are recommended to inform sailing craft owners and sailing craft operators of the possible hidden dangers of failing keel bolts on sailing yachts with bolt-on keels, and to address the importance of a thorough inspection of keel and keel bolts after grounding.
