Report on the investigation of the capsizing of Z.19 -Sonja off the UK coast on 25 August 2018

August 25th 2018, 1530 LT (UK Daylight Saving Time, UTC+1), the Belgian Fishing vessel Z.19-Sonja capsized and sank in a position 25 nm ENE of Great Yarmouth.

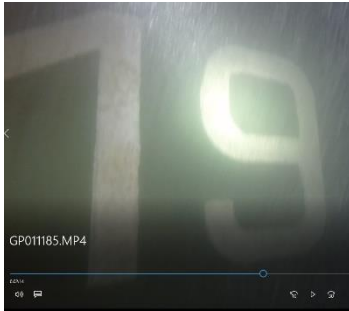
Figure 15 - Vessel's ID number at the stern

1. Wreck was identified by name and number

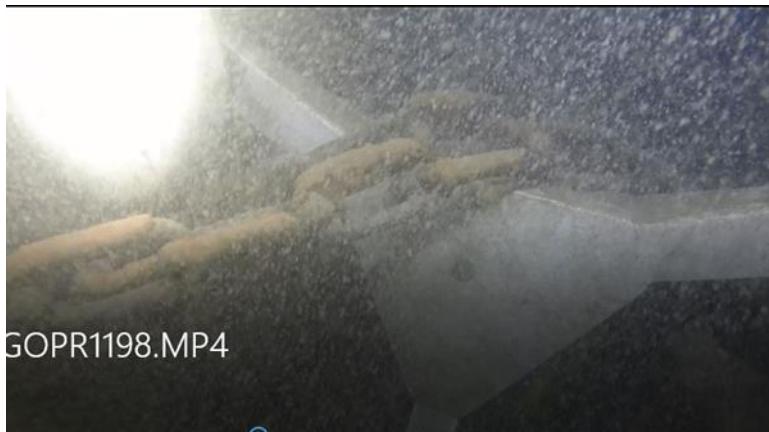
*Figure 17 - Position net
Part of chain net of the trawl gear damaged the GPS compass antenna.*

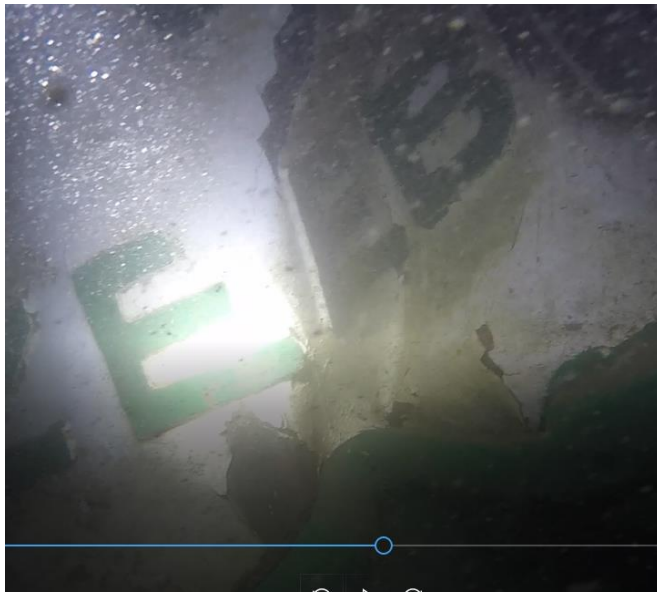
Figure 18- Damage Aft

- Damage was detected at the aft of the vessel. It looked like a small but deep impact. It was not clear how this damage was caused. It might have been caused when the vessel landed on the sea bottom.

The sternlight right above this impact was not damaged and there was no fishing net near the place of the incident. These observations could exclude damage by own fishing gear during capsizing.

There were no other scratches or tears nearby, what could exclude damage by fishing gear of other vessels after the incident.

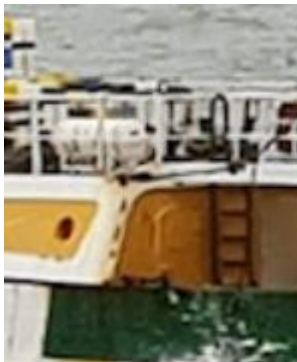
Figure 20- Liferaft

The vessel turned upright down over PS. The automatic release to free a liferaft only reacts when it is under water. This means that the release was only been activated when the vessel was completely turned upside down.

The consequence was that the liferaft was released, when it was stuck under the vessel. By the motion of the wreck in the waves, the liferaft became free after 10 minutes, according to witnesses.

Position of the liferaft on SB side of the vessel.
