Report on the fatal accident on board mv SIMON STEVIN on 28 January 2019

The subsea rock installation vessel mv SIMON STEVIN was moored alongside at the Port of Zeebrugge for overhauling purposes. Most of the crew, except a few watchmen, were working in dayshifts, from 06.00 to 18.00.

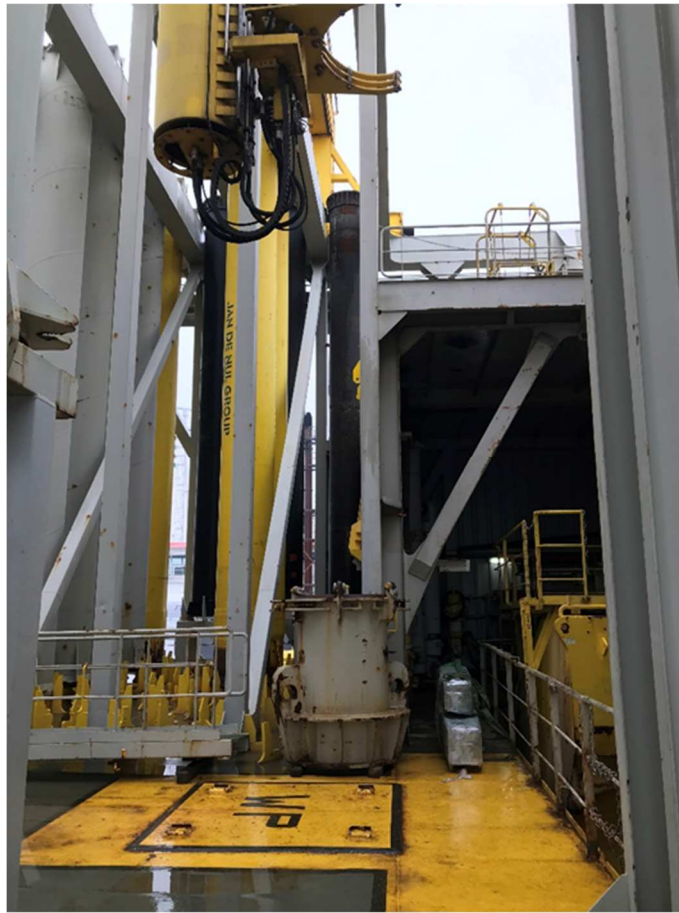
To reset the manipulator back to automatic mode, it was necessary to bring it to the waiting position, in front of the opened gates. From the position of the operator, the waiting position was located behind his back.

Figure 6 - Manipulator at waiting position in caution area

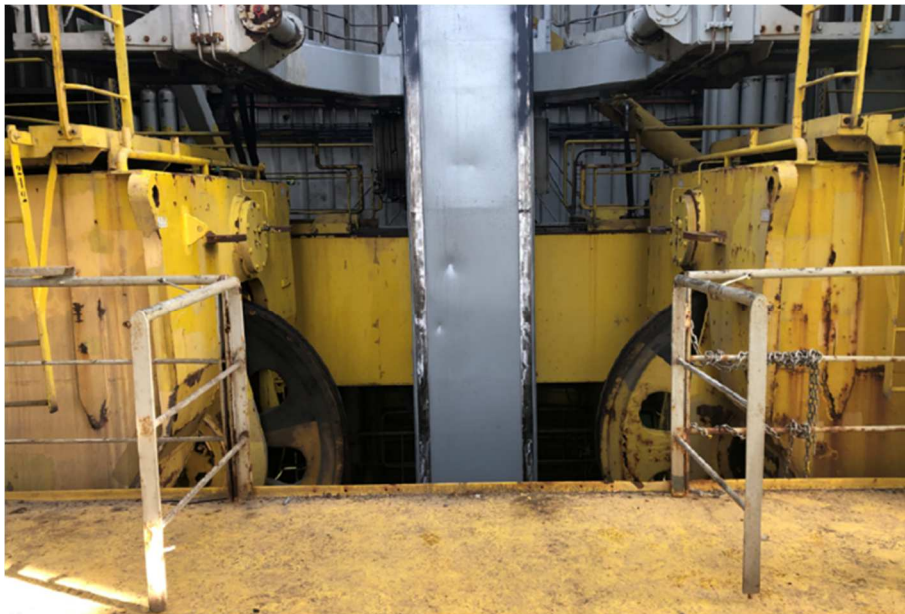
Figure 7 - Open railing, gates turned 90°

During pipe transfers between manipulator and gripper, the two gates in the railing were opened. These two gates and the yellow painted caution area were two barriers to prevent any passage during pipe transfers. When pipe transfers were finished, the gates were closed again.

As the gates in the railing were left open until the complete pipe transfer process had been completed, there was a possibility to fall from heights.
