Report on the grounding of
m/v FAST SAM
on June 20th, 2019

1.2 Accident Details

Time and Date	20 June 2019
Location	River Scheldt, near buoy E12A, (Fairway Everingen)
Deceased	0
Type of accident	Grounding

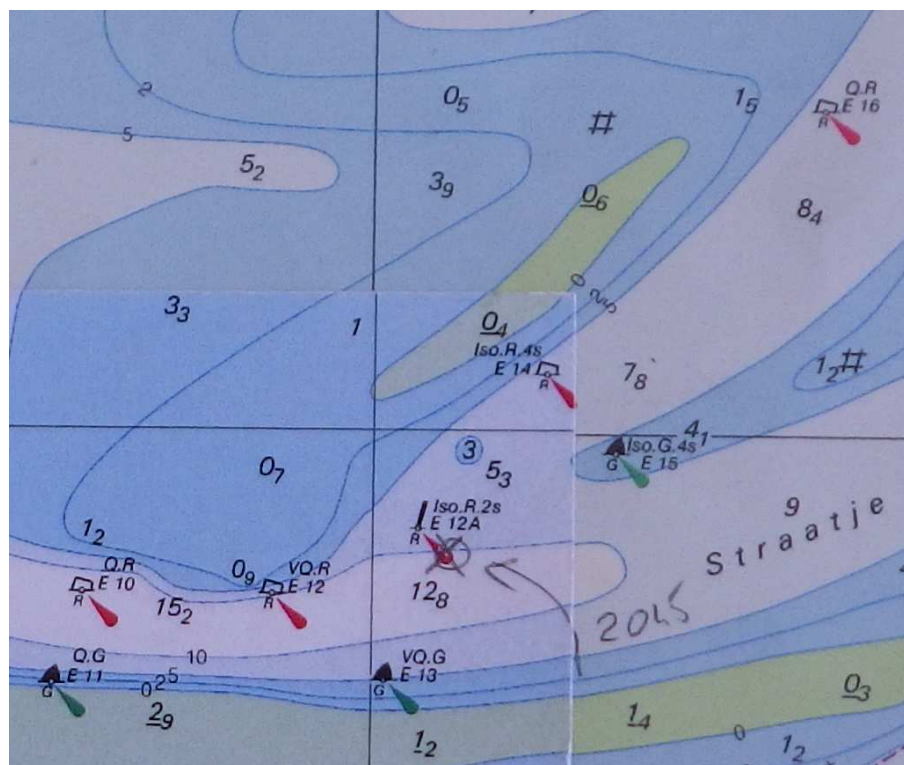
Figure 3 – Position of buoy E12A on Chart 120

Buoy E12A was positioned in between buoys E12 and E14 and marked shallow waters on the northern site of the fairway, see Figure 3.

According the ENC and Chart 120, buoy E12A was lying in an area between depth contours 5 and 10 m (see Figure 3 and Figure 8 **Fout! Verwijzingsbron niet gevonden.**).

On chart 120, Buoy E12A remained charted in position N 051° 21,85' E 003° 52,11'.

Related to the position of buoy E12A on chart 120, the grounding position (N 51° 21,82' E 003° 52,17') was within the boundaries of the fairway.

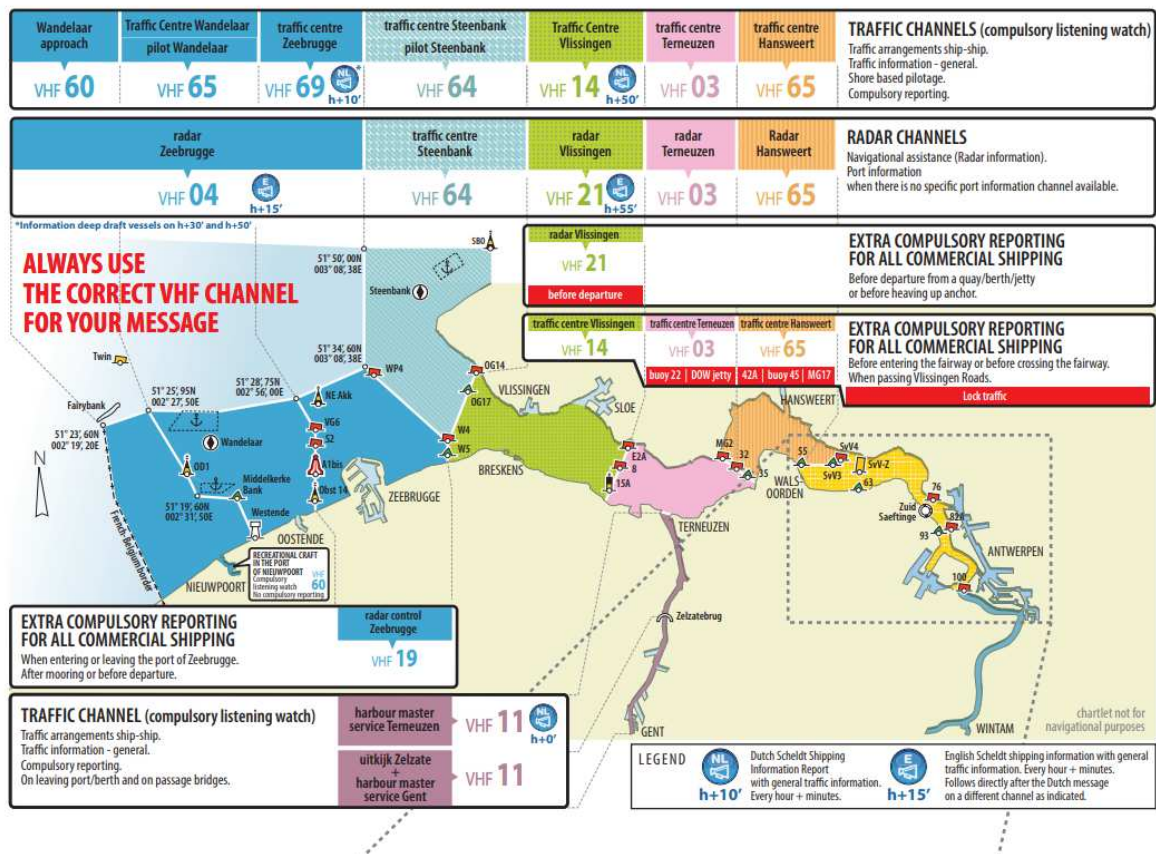
Figure 7 – VHF sectors on river Scheldt

By entering sector Terneuzen, m/v FAST SAM had switched her listening watch from VHF channel 65, sector Hansweert, to VHF channel 03, see Figure 7. Messages broadcast before 2033 on VHF channel 03 were not heard on board m/v FAST SAM.

It can be concluded that m/v FAST SAM had not received any information about buoy E12A being adrift.

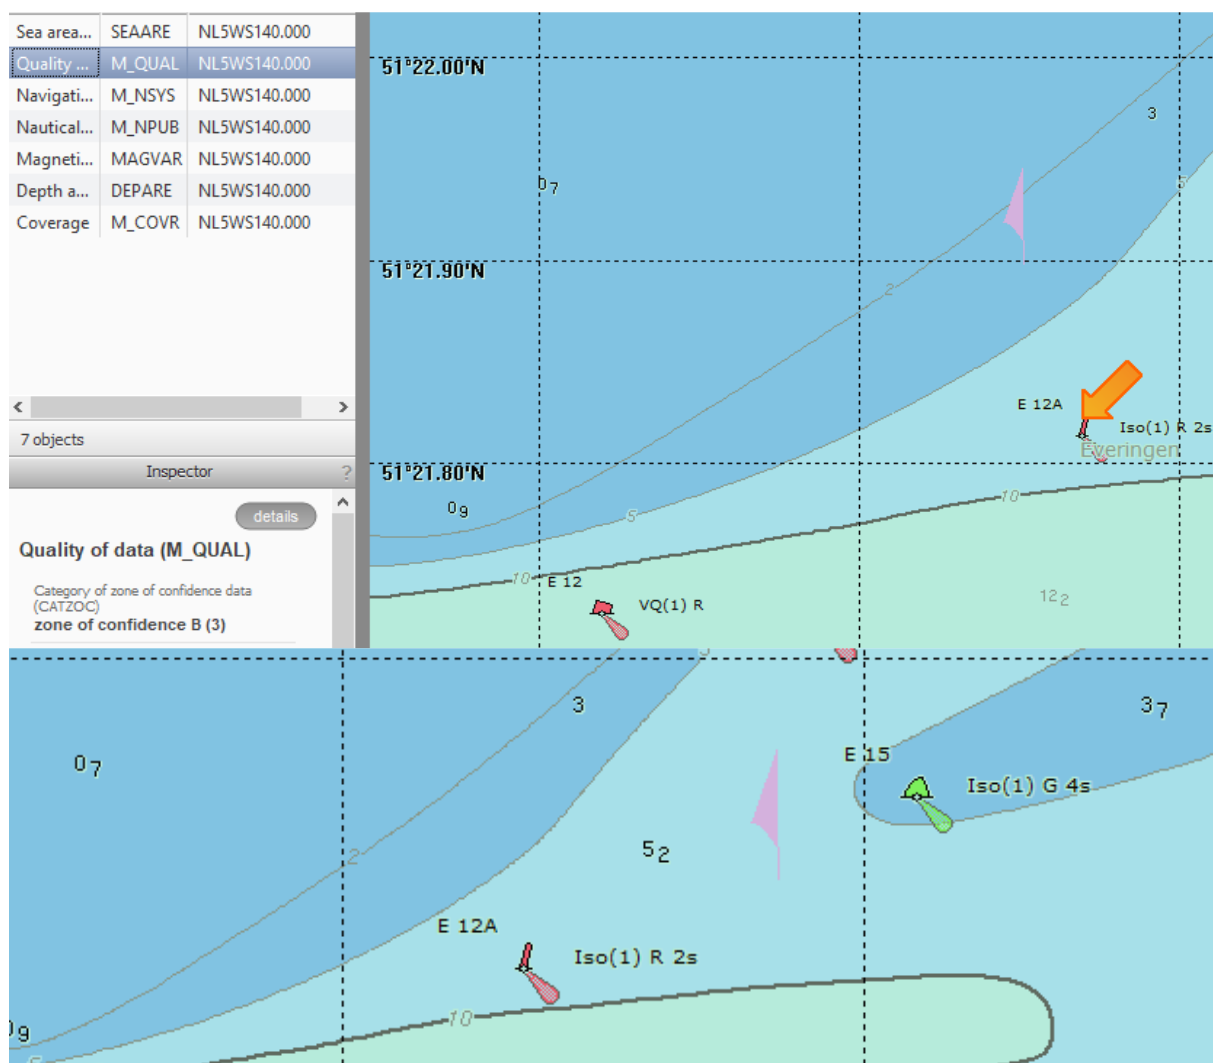
Figure 8 – ENC NL5WS140

The reliability of the charted data was assigned to as CATZOC B.

CATZOC B criteria stated that uncharted features, hazardous to surface navigation are not expected but may exist.

The movement of sand beds is often unpredictable and thus cannot be charted.

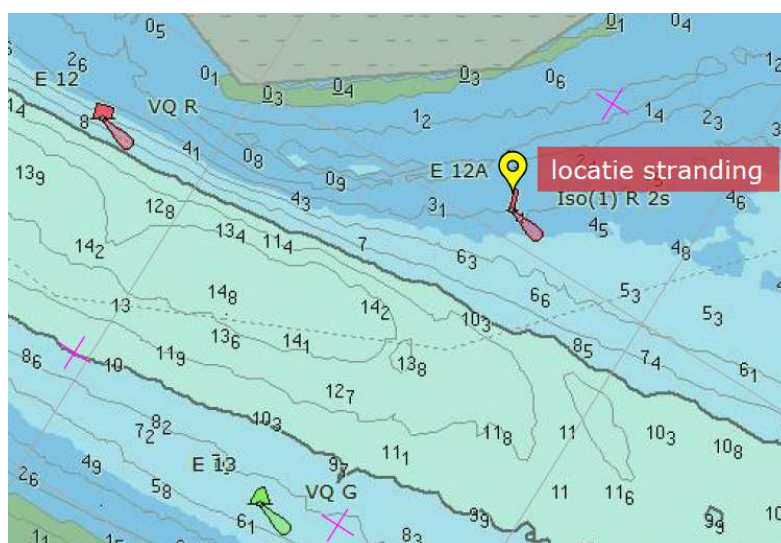
Figure 10 – Survey fairway Everingen

The whole area had been surveyed between July 2016 and June 2019. The measured values north of buoy E12A explained why the vessel ran aground.

The results of the survey lead to a new target depth of the fairway of 35 dm. The Common Nautical Management of the river Scheldt issued a notification on June 24, 2019, see Figure 15. A preliminary NtM was published in week 26 by the Hydrographic Office of The Netherlands, see Figure 16 and in adapted format published by the UKHO in week 30, see Figure 17.

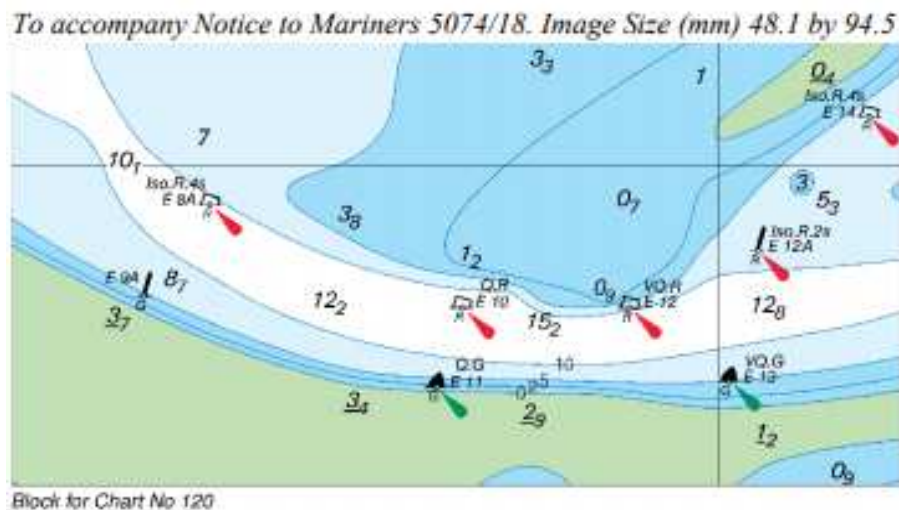
Figure 12 – Block to NtM 5074/2018

The British Admiralty published the notice in week 43 (2018) with reference 5074/2018. The notice was accompanied with a block that needed to be cut out and pasted on the paper chart, see Figure 12.
