Report on the investigation into the  
cause of a serious injury  
on board MT COASTALWATER  
on 27 October 2019

On October 27<sup>th</sup>, 0010 (UTC+2), a crewmember on board the Dutch flagged chemical tanker MT COASTALWATER seriously injured his right hand during mooring operations in the Boudewijn lock at the Port of Antwerp (Belgium). After surgery, four of his fingers needed amputation.

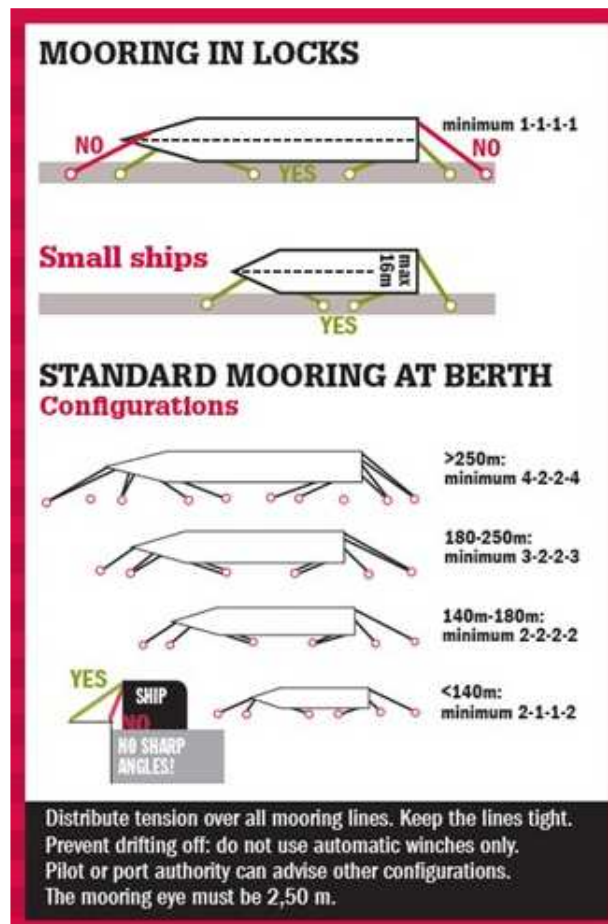
Figure 3 - Information leaflet

No port regulations about a minimum amount of mooring lines was in place. An information leaflet regarding port tug and mooring operations in the port advised to use two fore lines and two aft lines in the locks, see Figure 3.

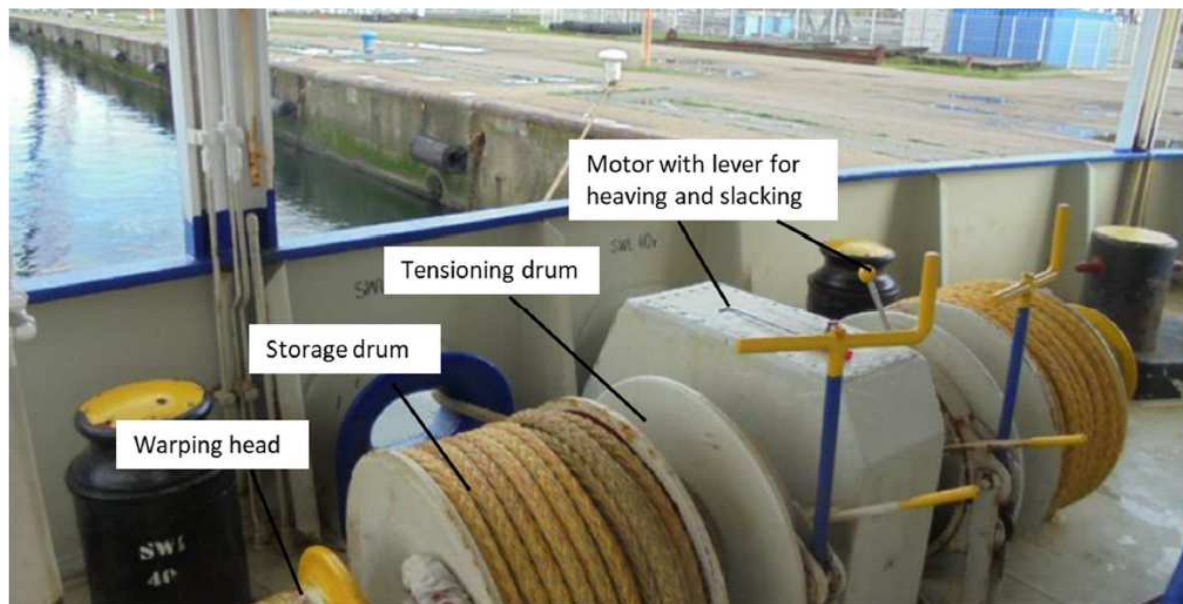
Figure 4 - Aft winces on board MT COASTALWATER

The winches on board MT COASTALWATER consisted out of a central motor with a single axle on each side. On each axle there was a warping head and a drum. The drum consisted out of two parts : a storage drum where the mooring rope was stored without tension and a tension drum where a limited amount of mooring rope (up to two layers) could be put under tension when the vessel was moored. This is indicated in Figure 4.

The winches on board MT COASTALWATER did not have spring loaded control valves. When putting the winch into a turning position, the winch started turning. When releasing the lever, the winch continued turning. To stop the winch, the lever had to be brought back into neutral position.

The winches were turning continuously when they were put in a running position. This configuration made it possible to work without a winch operator who operates the lever continuously. When nobody is standing by at the winch lever and when manual handling of the ropes on the winch is necessary, no immediate action to stop the winch can be taken when someone gets stuck between two layers of rope.

- has issued a circular letter over the entire fleet that it is not allowed to execute mooring operations with one person only.
- investigates whether a spring loaded valve can be installed to avoid that the winch can run continuously when the lever is put in a running position.

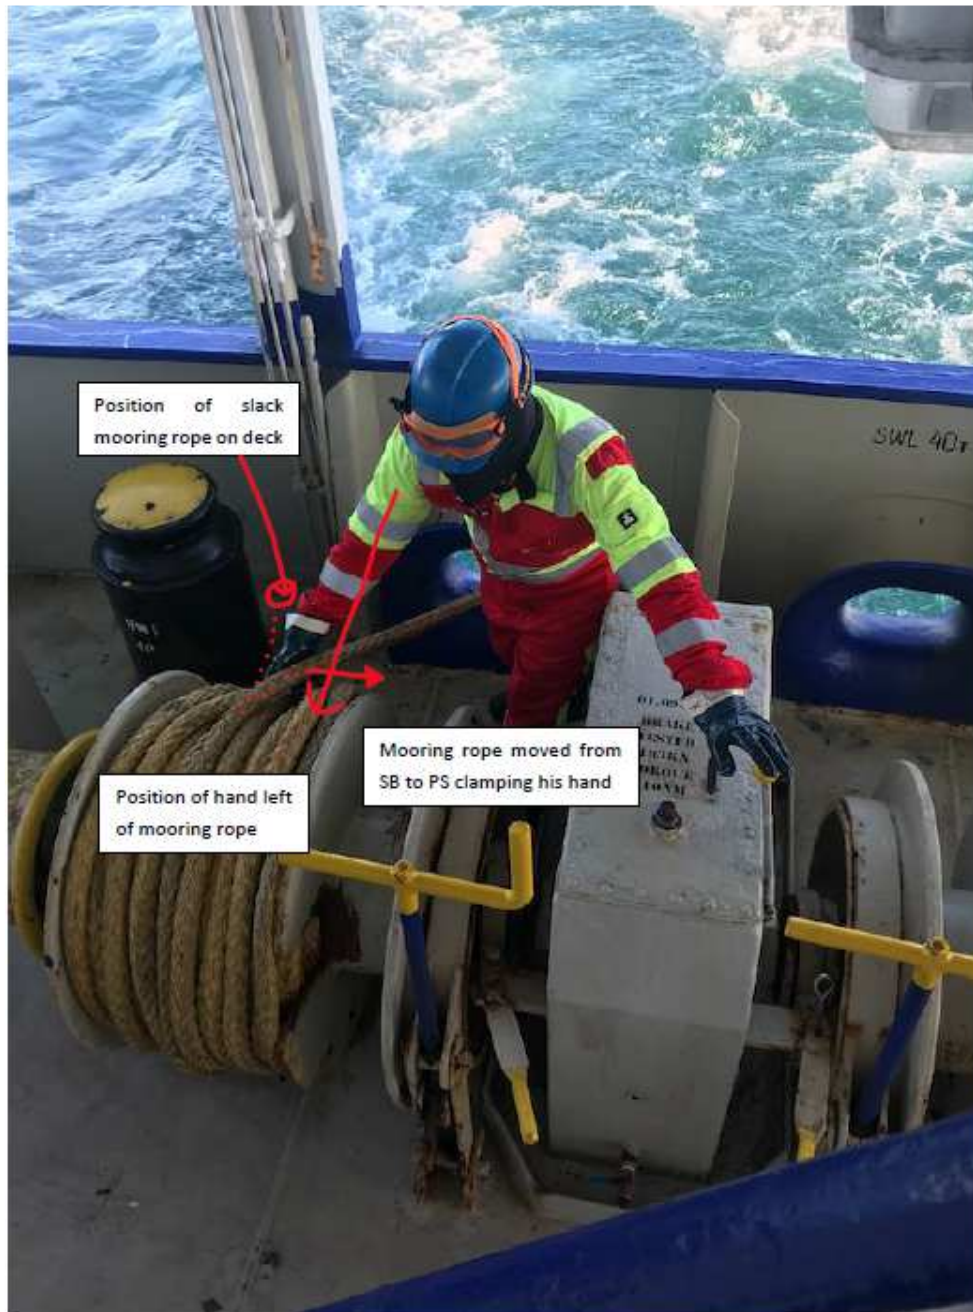
*Figure 5 - Picture of reconstruction of the accident*

There is a notch in the metal plate between the storage drum and the tensioning drum, as can be seen in Figure 5.

Manual handling was required to guide the mooring rope from the storage drum through the notch onto the tensioning drum.

When spooling the mooring rope onto the drums, the winch was continuously running slowly. The person at the aft mooring station was positioned as indicated in Figure 5. He had no overview over the mooring rope and the quay side.

He was guiding the mooring rope onto the storage drum and when guiding the rope onto the tensioning drum, he had not noticed that the aft of the vessel was moving away from the quay.

Due to the vessel's movement, the rope came under tension and his hand got trapped between the rope and the layer of rope underneath.  
He reacted by putting the winch lever in reverse position.

There was insufficient situational awareness at the aft mooring station. There was only one person present and he was standing with his back to the mooring line.
