Report on the investigation into the grounding of
mv LA BELLE DES OCEANS

near the Phi-Phi Islands, Thailand with hull rupture below the
waterline on 25 November 2019.

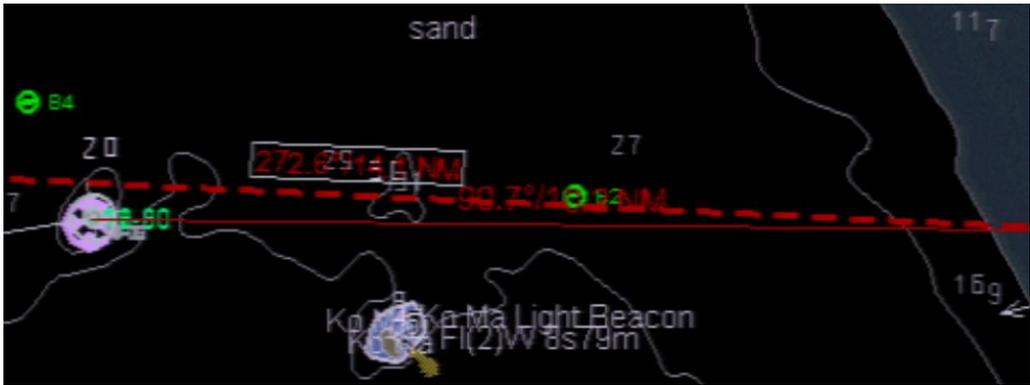
Figure 3 - Sailed course South of planned route

The dotted line indicates the planned route, the thin red line indicates the sailed course. The magenta marked X represents Bita Rock, where the vessel grounded

The vessel was sailing 0.5Nm South of the intended course during more than one hour, due to fishing vessel activity in the area intended to sail through.

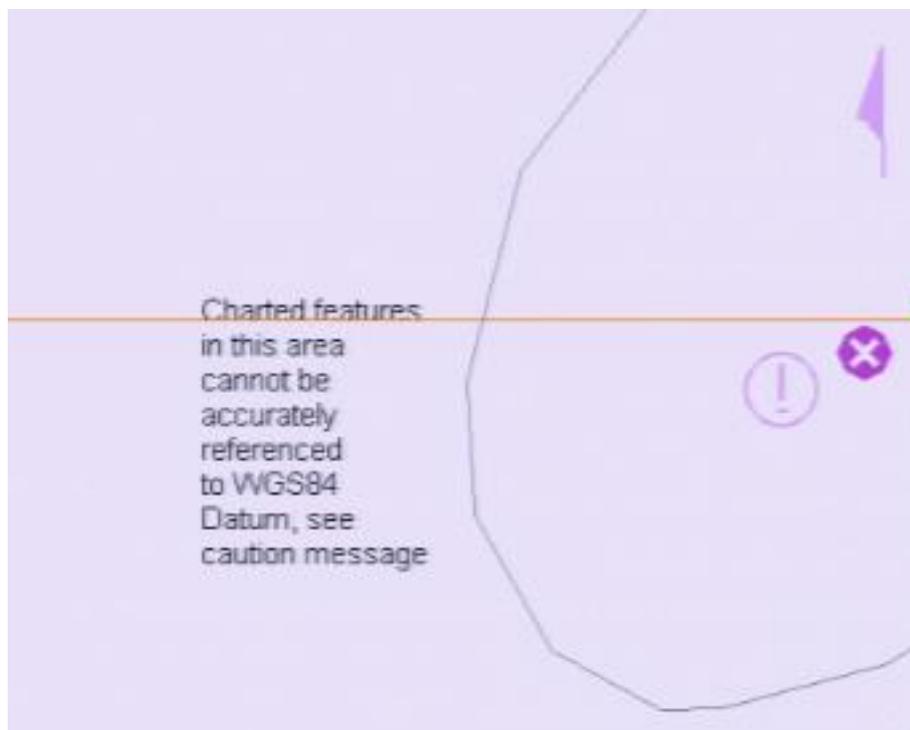
Figure 5 – ECDIS warning

The OOW noticed the rock on the chart, indicated with a magenta “X”, see Figure 5, but he was convinced that he would pass clear of the charted obstruction at a distance of two cables. He did not further follow-up the situation.

The charted rock that the vessel struck upon, was visible in ECDIS, but no attention had been paid to the minimum , by the standing orders required, safe passing distance from this rock.

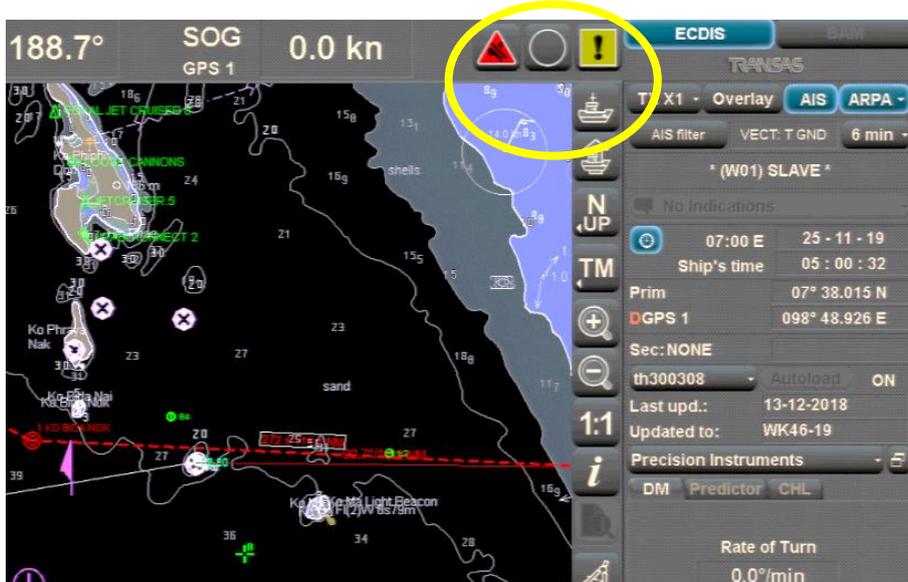
Figure 6 - ECDIS screen, alarms muted

At 2351, the ECDIS gave an alert for a navigational hazard which the OOW did not notice as all ECDIS alerts on board were muted.

Reportedly, many alarms were generated when using ECDIS on board the mv LA BELLE DES OCEANS and thus it was decided to mute the audible ECDIS alarms on board the vessel. All officers used the ECDIS in the same way.

ECDIS was used in muted mode as many alarms were constantly sounding. This was a generally accepted behaviour on board. The safety parameters of ECDIS should contribute to safe navigation and needed to be adapted to the voyage.

Define who is responsible for voyage specific settings according to the voyage plan and implement a usage of ECDIS that contributes to safe navigation. Awareness needs to be created to prevent overconfidence in the system.

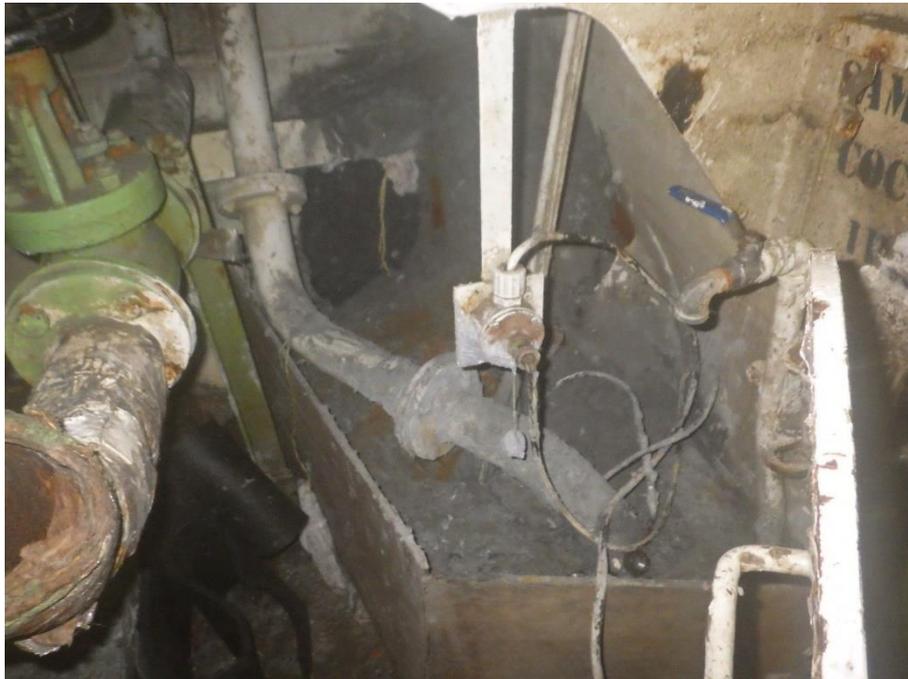
Figure 7 - Water ingress from FW tank into the pump room

When checking the condition of the pump room, water ingress was noticed on portside forward in the pump room from the FW tank, see Figure 7.

The water ingress into the pump room was caused by damage to the bulkhead between pump room and fresh water tank. There was no direct ingress of seawater into the pumproom.

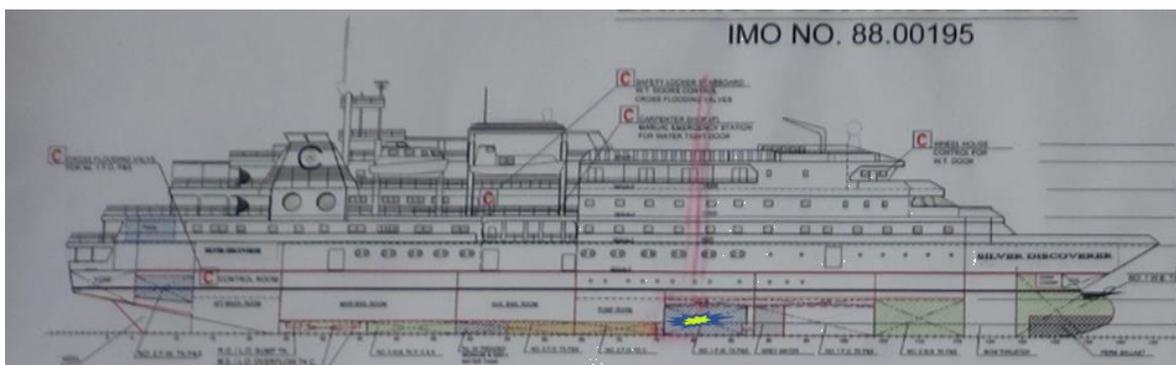
Figure 8 - Position of hull rupture

The position of the hull rupture is, in this picture of the on board control damage plan, indicated with a yellow spot.

At 1125, as diving operations started, it became obvious that a hole of 0.5 by 2 metres in PS FW tank N°1 caused the water ingress into the vessel.

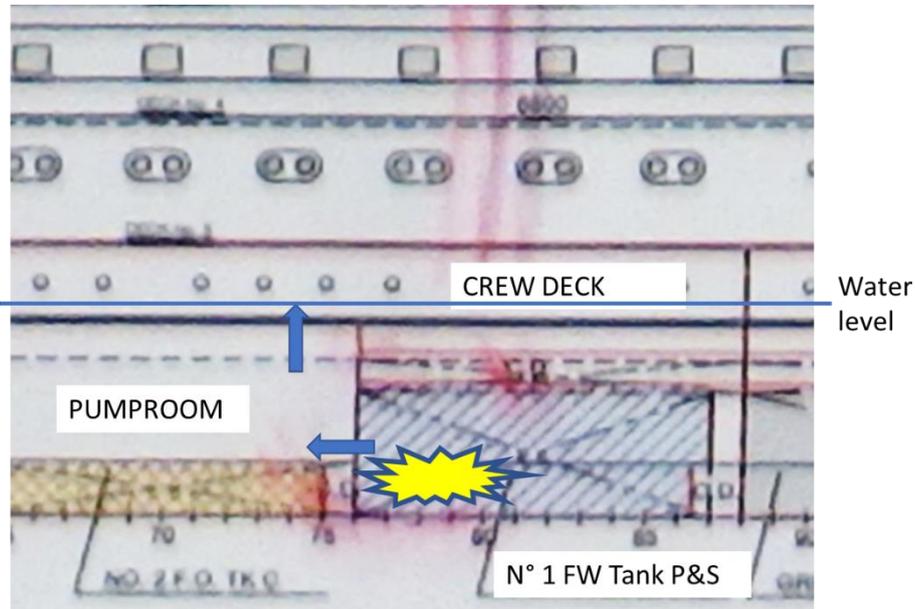
Figure 9 - Flow of seawater from FW tank to Crew Deck

The water was still rising and when the pump room was completely flooded, water entered the above crew deck, between watertight doors two and three until it reached sea level.

Tank soundings indicated that water was also flooding N°1 fresh water tank PS, see Figure 8, Figure 9 and Figure 10.

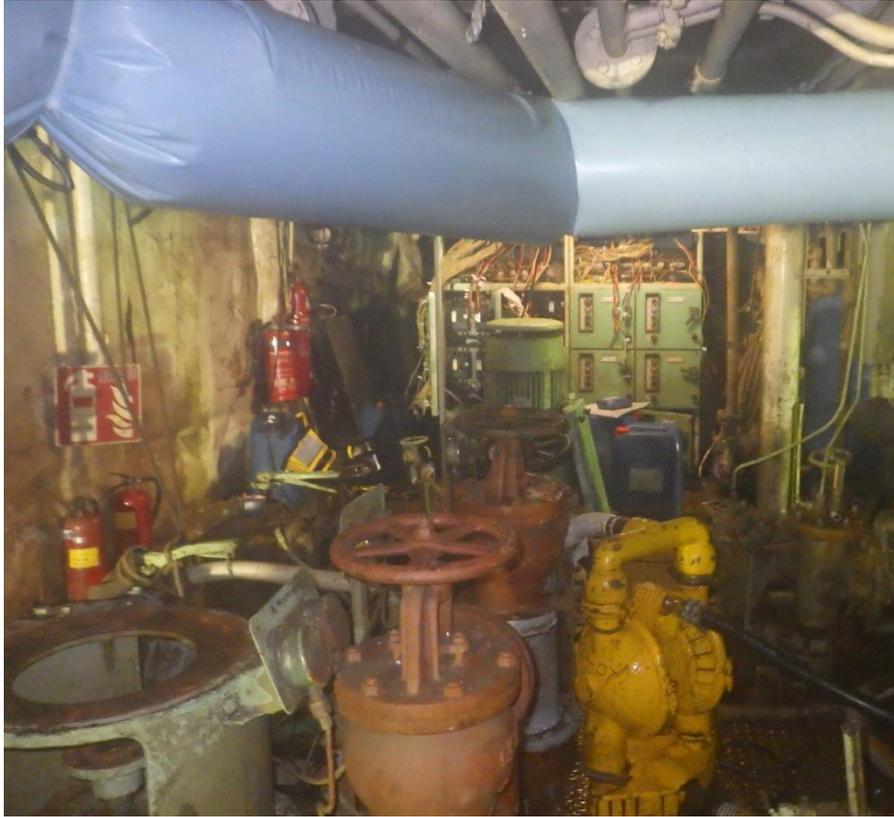
Due to the water ingress in the pump room, all the equipment inside, such as airconditioning units, fresh water pumps and other, was shut down affecting the on board comfort for crew and passengers.

*Figure 11 – General impression of the pump room
The pump room was completely flooded, in this picture, repairs were already going on.*
