EXTRACT FROM THE EUROPEAN DIRECTIVE 2009/18/EC

1 MARINE CASUALTY INFORMATION

Time and Date	9 December 2019
Location	River Scheldt, Deurganckdok, near quay 1702
Deceased	0
Type of accident	Allision with gantry crane with hull damage below the waterline, impairing seaworthiness

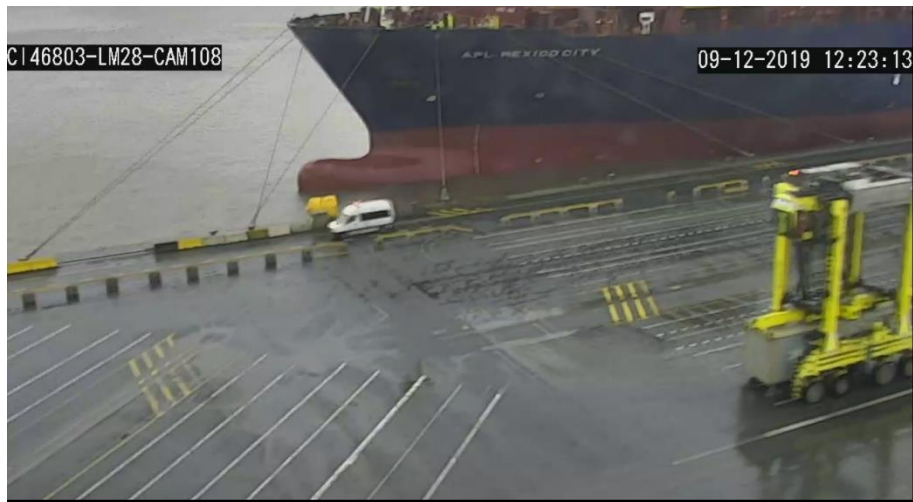
Both the engine and bow thruster were kept on stand by. The vessel was moored using 7 mooring lines fore and aft in an 2+2+1+2 configuration as seen in Figure 1 on page 8, with certified mooring ropes as depicted in on page

Figure 1 - Mooring line configuration forward upon arrival

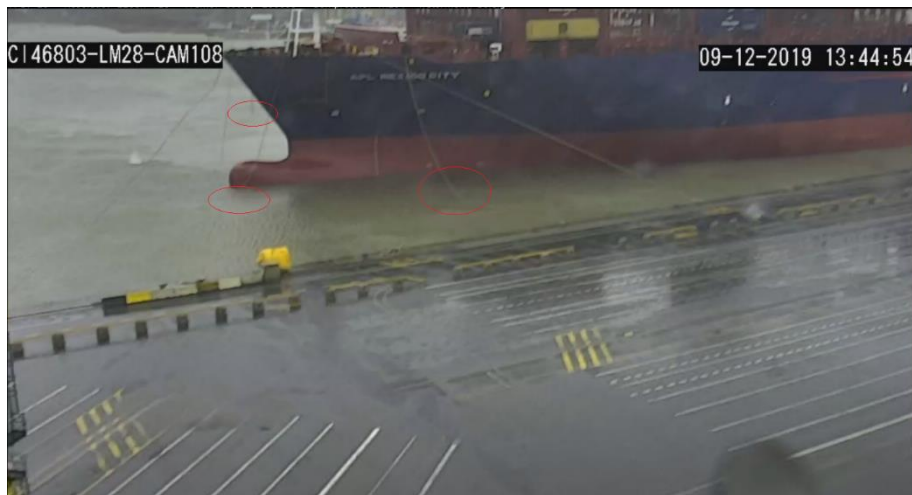
At 13:44 hours an able bodied seaman on duty on deck noted that the vessel was parting from the quay and informed the officer on duty. Within a minute the general call was sounded and subsequently a first spring line gave way followed by all other mooring lines coming under very high tension. Consequentially, the forward mooring lines started snapping one after the other as seen in Figure 2, on page 8.

Figure 2 - Mooring lines breaking (marked up in red)

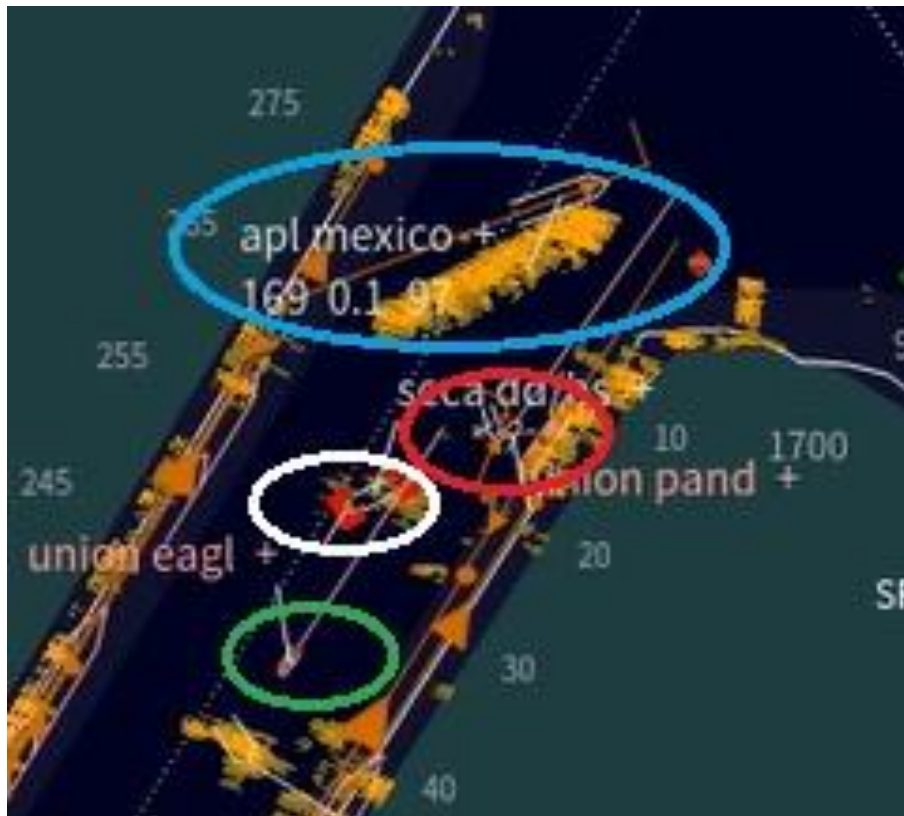
Figure 3 - Situation in the Deurganckdok just after breaking loose

with *mv APL MEXICO CITY*, *mv UNION PANDA*, *mv UNION EAGLE* and *mv SABASTIANO CABOTO*

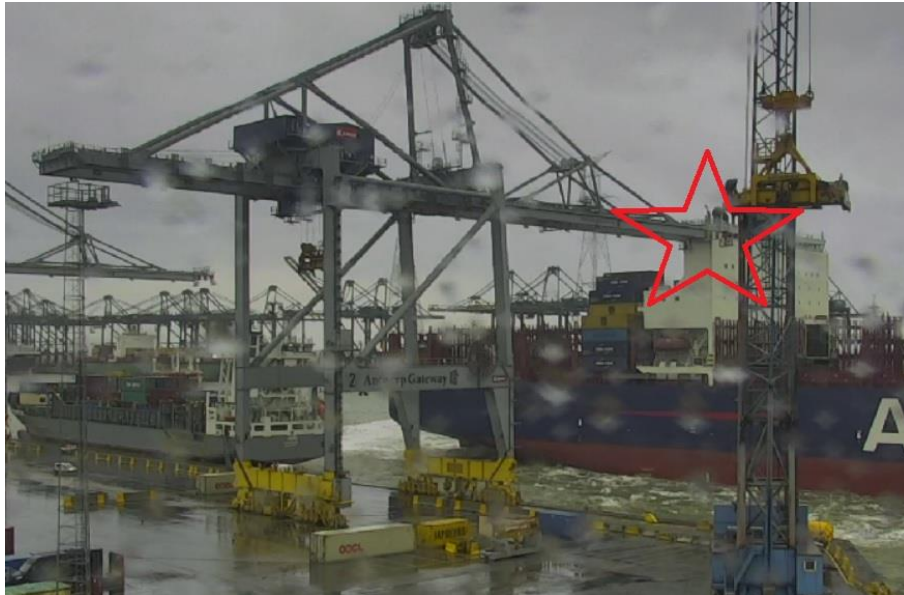
At 13:57, the mv SABASTIANO CABOTO informed Traffic Centre Zandvliet again via VHF Channel 12 that a gantry crane at the DP World terminal was struck by the mv APL MEXICO CITY, and that subsequently the gantry crane had collapsed

Figure 4 – mv APL MEXICO CITY striking gantry crane

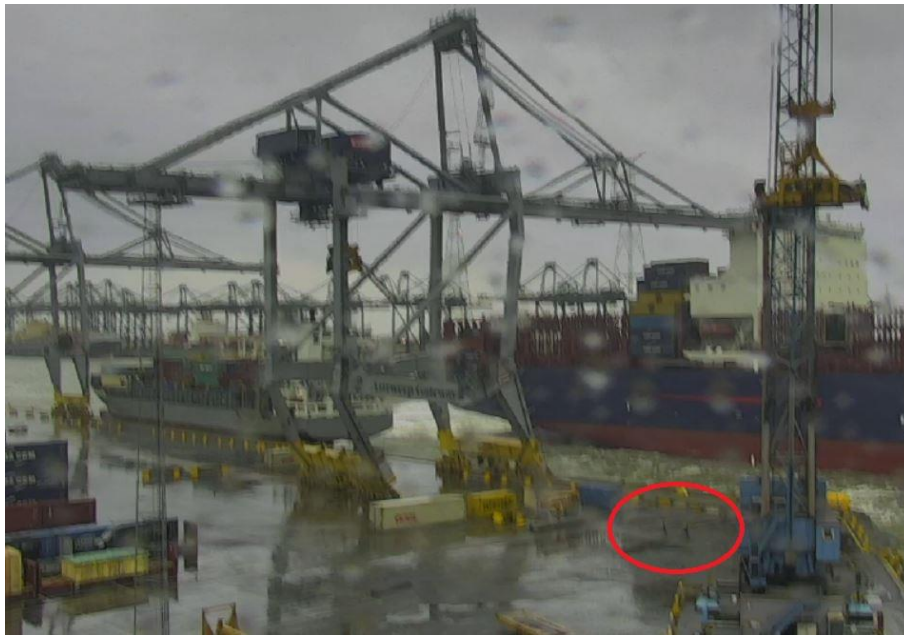
Two service technicians, occupied with maintenance on the gantry crane, barely escaped from being crushed under the collapsing gantry crane, running at their highest velocity as seen in Figure 5 on page 12.

Figure 5 - Gantry crane collapsing and people running for their lives

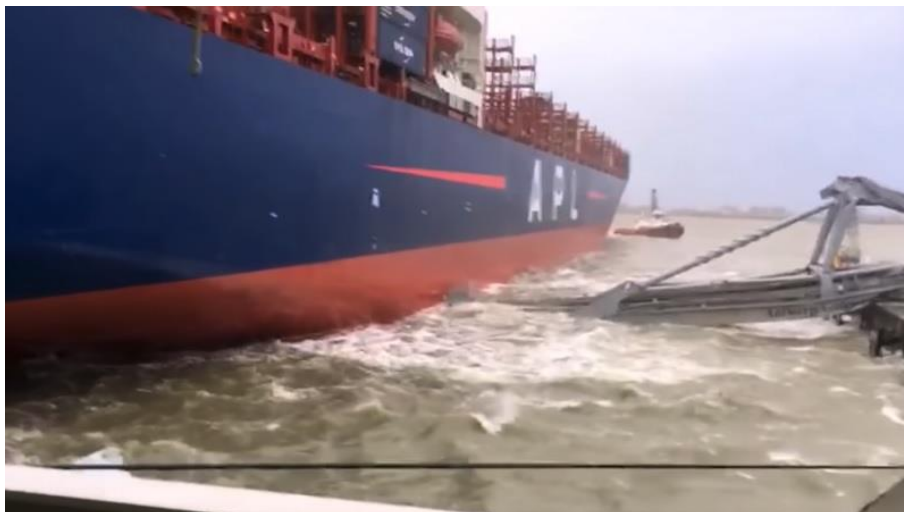
The jib of collapsing gantry crane penetrated the hull of the mv APL MEXICO CITY during the fall into the water, and consequently, a compartment near the engine room of the mv APL MEXICO CITY was flooded impairing the vessel's seaworthiness.

Figure 6 - Jib of gantry crane penetrating hull of mv APL MEXICO CITY during fall

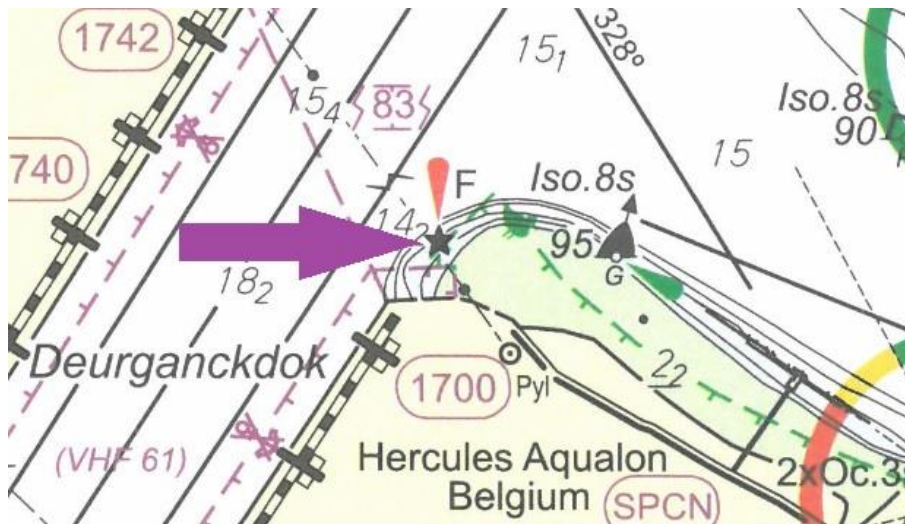
The mv APL MEXICO CITY further proceeded onto the River Scheldt thereby alliding with a dolphin near the Phenol Jetty.

Figure 7 - Position of the dolphin the mv APL MEXICO CITY allided with when adrift

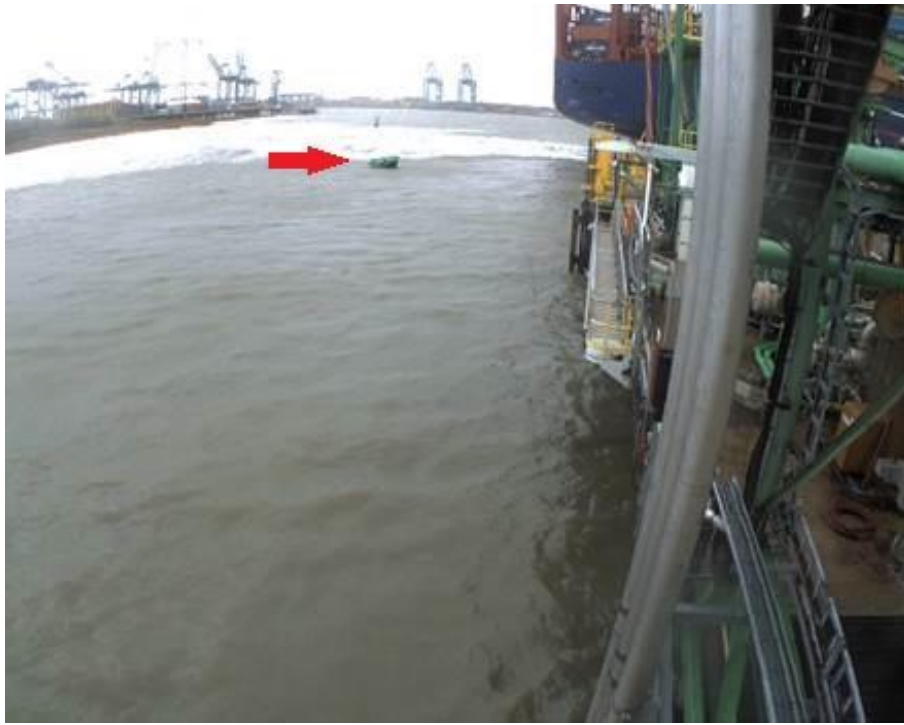
At 14:09 hours the mv APL MEXICO CITY further proceeded towards the River Scheldt and by doing so, she sailed over Buoy 95 near the Phenol Jetty.

Figure 8 – Buoy 95 sailed over by the mv APL MEXICO CITY

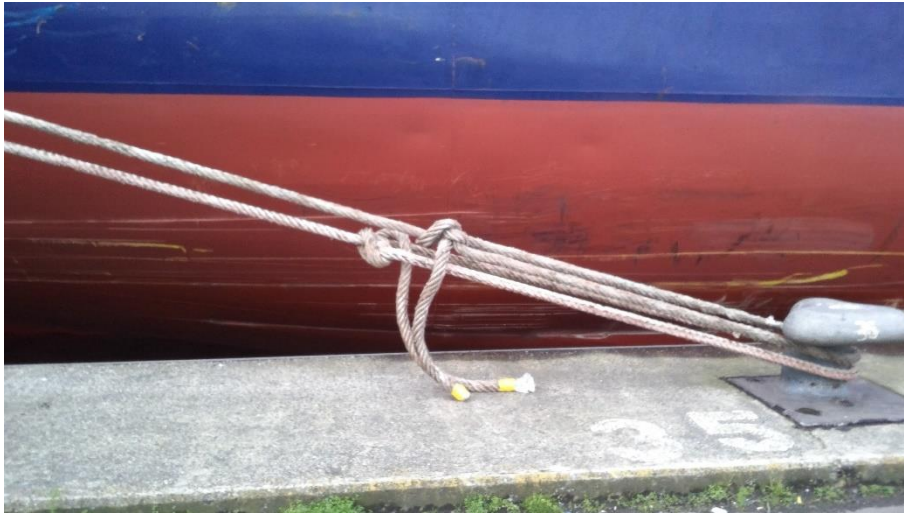
All fourteen mooring hawsers of The mv APL MEXICO CITY were damaged at the beginning of the sequence of ill-fated events. After the mv APL MEXICO CITY was adrift the crew temporarily repaired the hawsers by means of a bowline.

Figure 11 - Repaired mooring hawsers

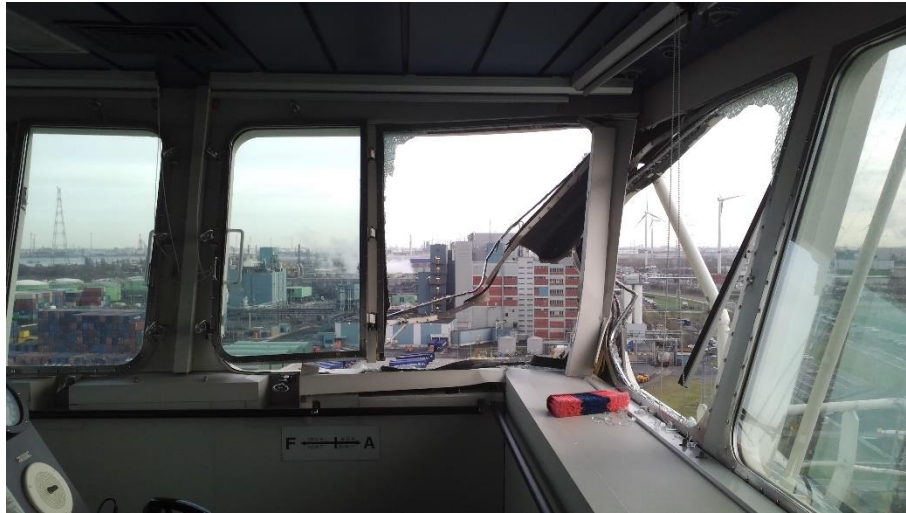
The mv APL MEXICO CITY allided with a gantry crane at the DP World terminal at the Port of Antwerp. Consequentially the area of impact on board the vessel, the starboard side of the wheel house got damaged. Several windowpanes were shattered and the metal structure got bent.

*Figure 12 - Damage to the wheelhouse of the mv APL MEXICO CITY
seen from inside*

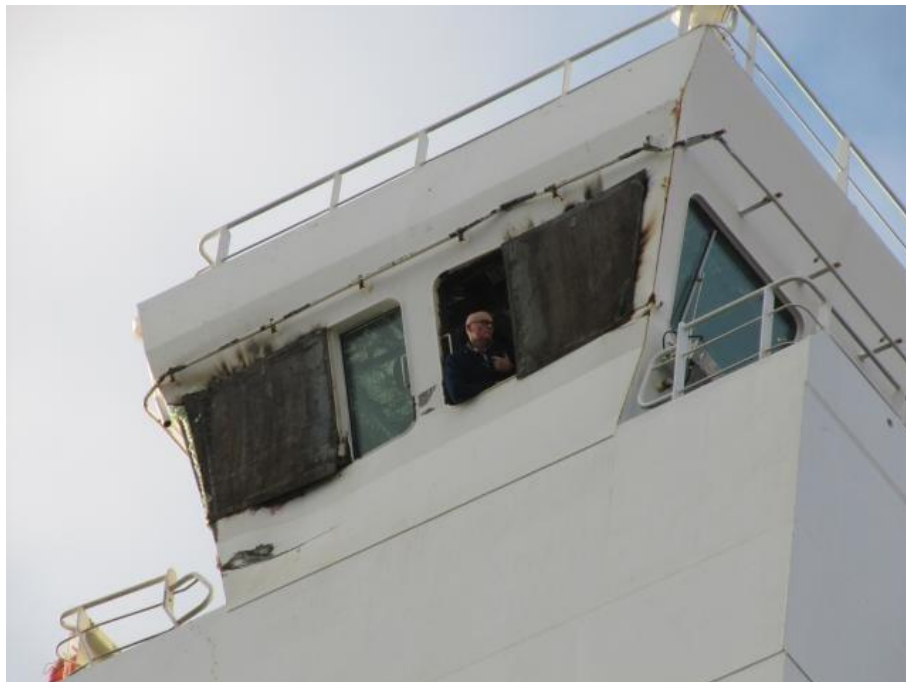
*Figure 13 - Damage to wheelhouse of the mv APL MEXICO CITY
temporarily repaired*

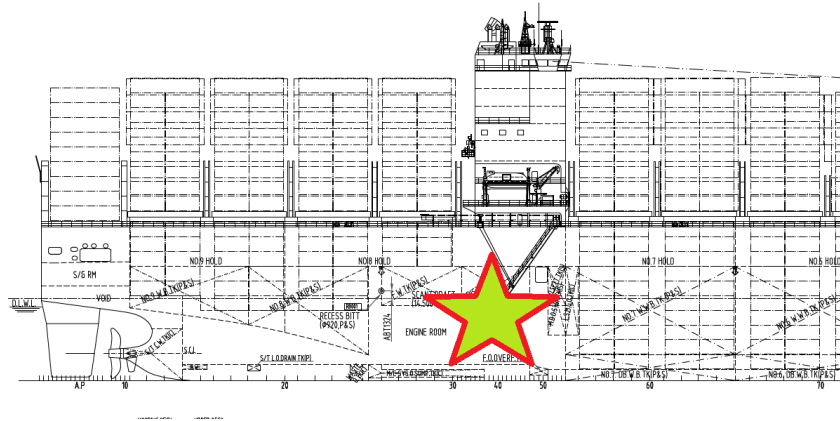
After the mv APL MEXICO CITY had allided with the gantry crane at the terminal of DP World at the Port of Antwerp, the jib of the collapsed crane had penetrated the hull of the mv APL MEXICO CITY below the waterline, rendering the vessel no longer seaworthy as seen in Figure 5 on page 12. The hull was found torn between frames 45 and 46 just above the engine room's third deck. The length of the fracture was 600 mm.

Figure 14 - Approximate position of hull damage

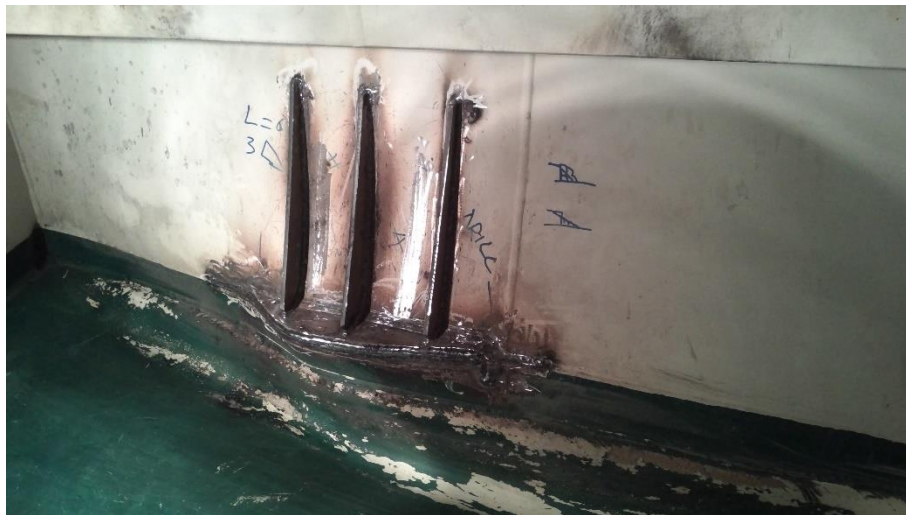
Figure 15 - Temporarily repaired hull of the mv APL MEXICO CITY
seen from inside the engine room

The day after the incident, temporary repairs were carried out, allowing the vessel to sail to a repair yard for more in depth repairs.

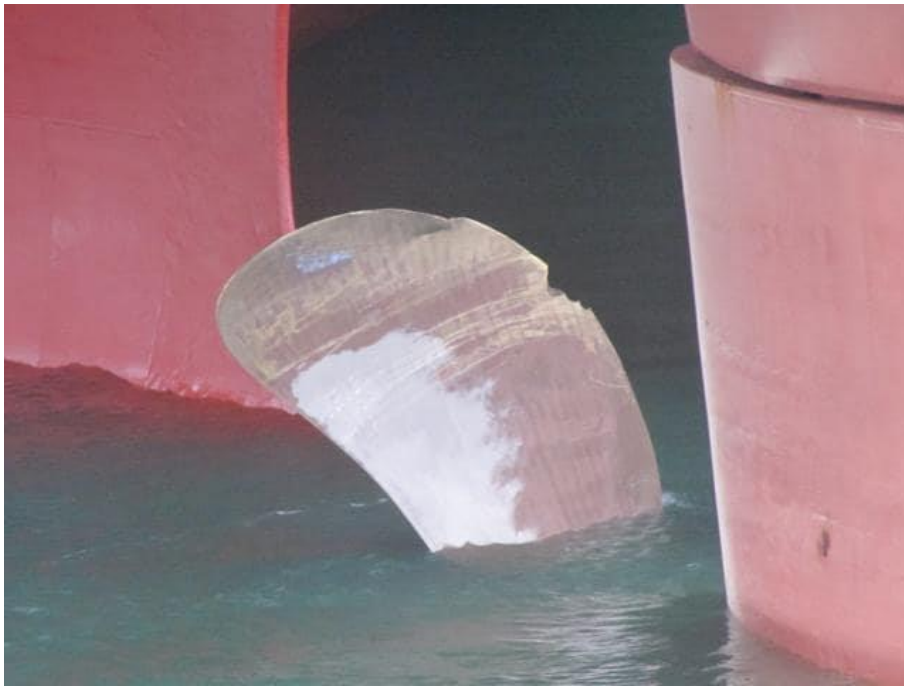
By sailing over the debris of the collapsed gantry crane at the terminal, and over the dolphin at the entrance of the Deurganckdok and subsequently the fairway buoy on the River Scheldt the propeller of the mv APL MEXICO CITY got damaged as seen in Figure 16.

Figure 16 - Damaged propeller of the mv APL MEXICO CITY

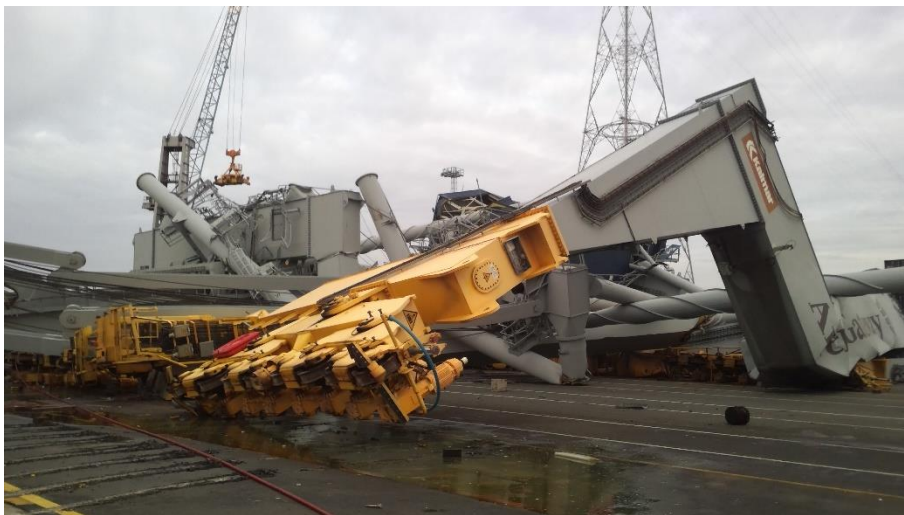
The gantry crane at the DP WORLD terminal in the Deurganckdok collapsed as a consequence of the impact om the mv APL MEXICO CITY onto the gantry's jib. The gantry was to be considered as a constructive total loss after the incident.

Figure 17 – Collapsed gantry crane

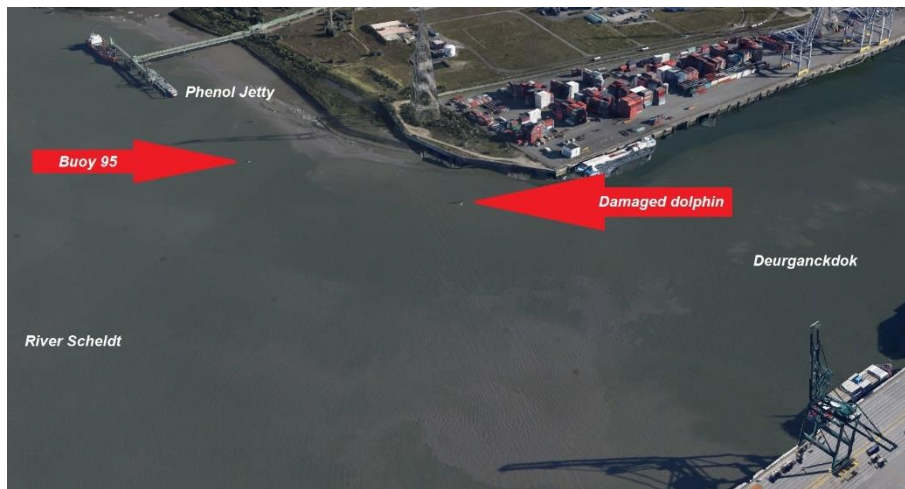
The mv APL MEXICO CITY allided with a dolphin near the entrance of the Deurganckdok on the River Scheldt and subsequently with a buoy marking the starboard side of the fairway when sailing upstream. Both the buoy and the dolphin were severely damaged.

Figure 18 - Dolphin and buoy that were damaged during incident

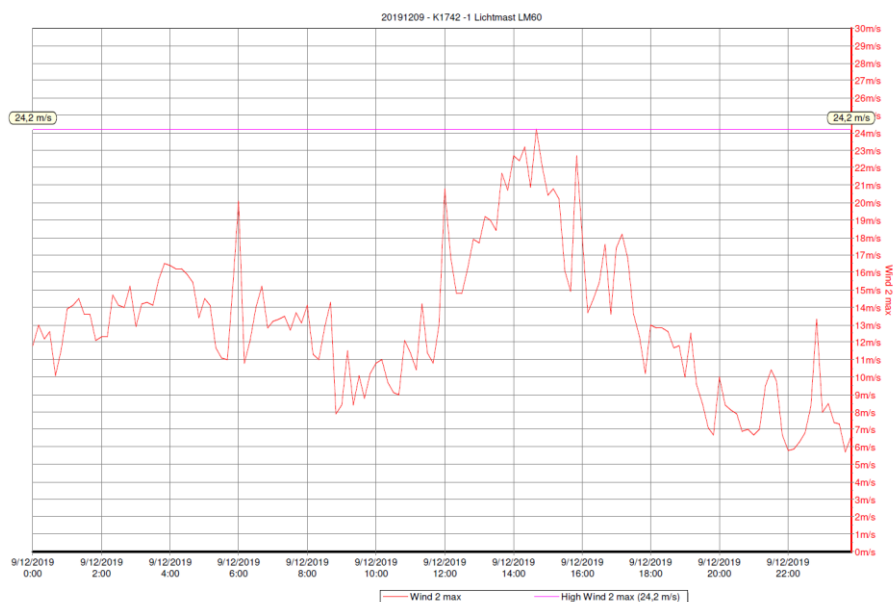
Wind speed measurements, in different locations, at the terminal of MSC PSA EUROPEAN TERMINAL, as seen in Annex 5 on 36, indicated wind speeds up to 24,2 metres per second in location LM60, as seen in Table 1 – Measured wind speeds at terminal.

Table 1 – Measured wind speeds at terminal

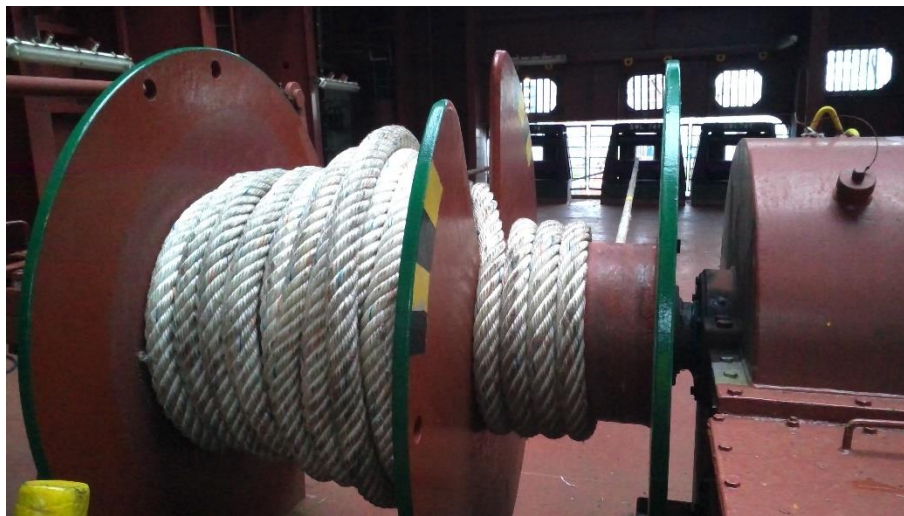
The fourteen hawsers used to moor the mv APL MEXICO CITY, on 9 December 2019 at quay 1704 in the Port of Antwerp, were all in relative new condition as seen in Figure 19 on page 24 and were fully certified as seen in Annex 7. Each individual hawser was certified for a minimum breaking load of 103 metric tons.

Figure 19 - Condition of mooring ropes
