Report on the investigation  
into a serious injury  
on board fv Z.18 - SOETKIN

At the Bay of Biscay, France, on June 11<sup>th</sup> 2020.

On June 11<sup>th</sup> 2020, beam trawler fv Z.18-SOETKIN was fishing in the Bay of Biscay, France. After a tickler chain was broken, the fishing gear was hoisted to secure it for repairs. One fisherman on deck involved in the operation got hit by the fishing gear when it made an unpredicted movement due to the heavy swell. He was evacuated from the vessel with a serious flesh wound to his left forearm.

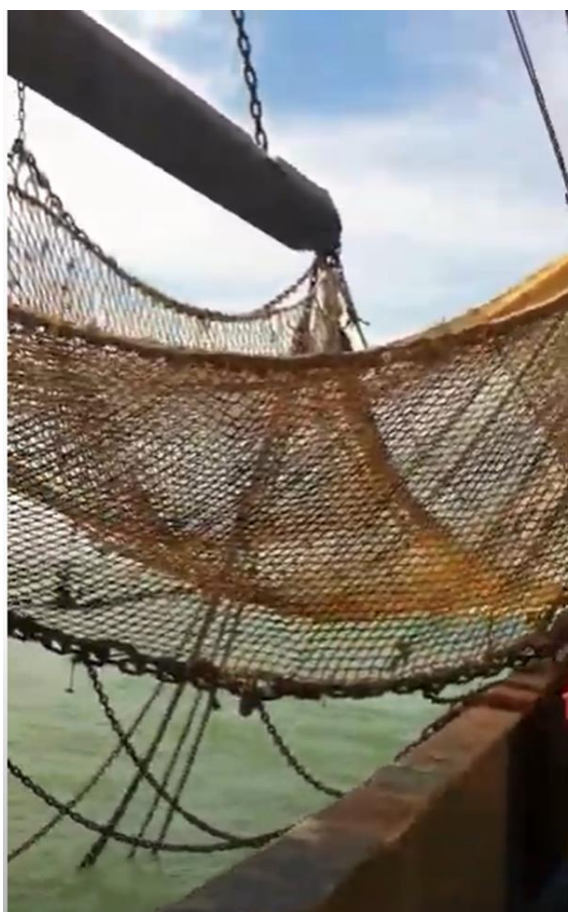
*Figure 1 – Sumwing with tickler chains of Z.18-SOETKIN*

On June 11<sup>th</sup> 2020 , beam trawler fv Z.18-SOETKIN was fishing in the Bay of Biscay, France. The vessel was equipped with a Sumwing<sup>1</sup> with tickler chains. The approximate mass of the sumwing was 2 tons.

Around 10:15 hours the nets were hauled and it was noticed that one of the tickler chains was broken.

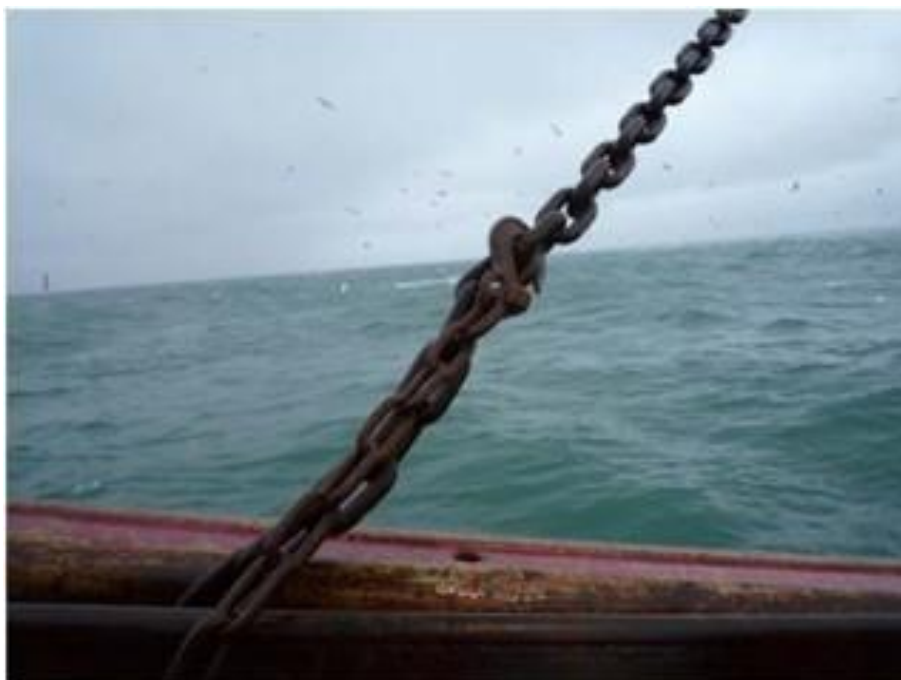
*Figure 2 - Example of hooks to secure Sumwing*

To repair the tickler chain, the sumwing needed to be pulled above deck and secured with the therefore foreseen hooks on deck, an example is given in Figure 2.

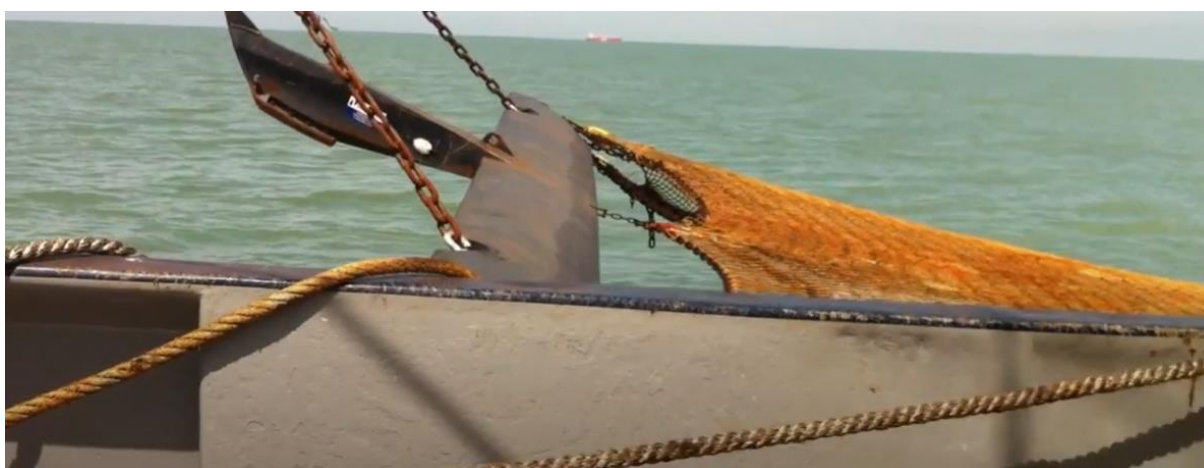
*Figure 11 – Sumwing on board Z.18 - SOETKIN*

The victim was wearing the required PPE and was positioned on the working deck, where the Sumwing is placed on board to be hooked up with the provided hooks. It was not possible to avoid the unpredicted swing of the Sumwing as a result of the heavy swell.

An unpredicted movement of the vessel caused by the heavy swell made the hoisted Sumwing swing.

At that moment, the crew was standing on deck near the hoisted Sumwing, ready to attach the securing hooks.

To avoid unpredictable movements of hoisted objects in rough seas, a safe distance should be maintained until hoisted objects are in rest on deck or against the ship's structure. Once in rest, further manipulation can take place.
