Report on the collision between
fv Z.575 – HEIN SENIOR and mv ACEROMAR
on August 3rd 2020

in the traffic separation scheme Terschelling - German Bight
near Schiermonnikoog
with material and structural damage to the vessels.

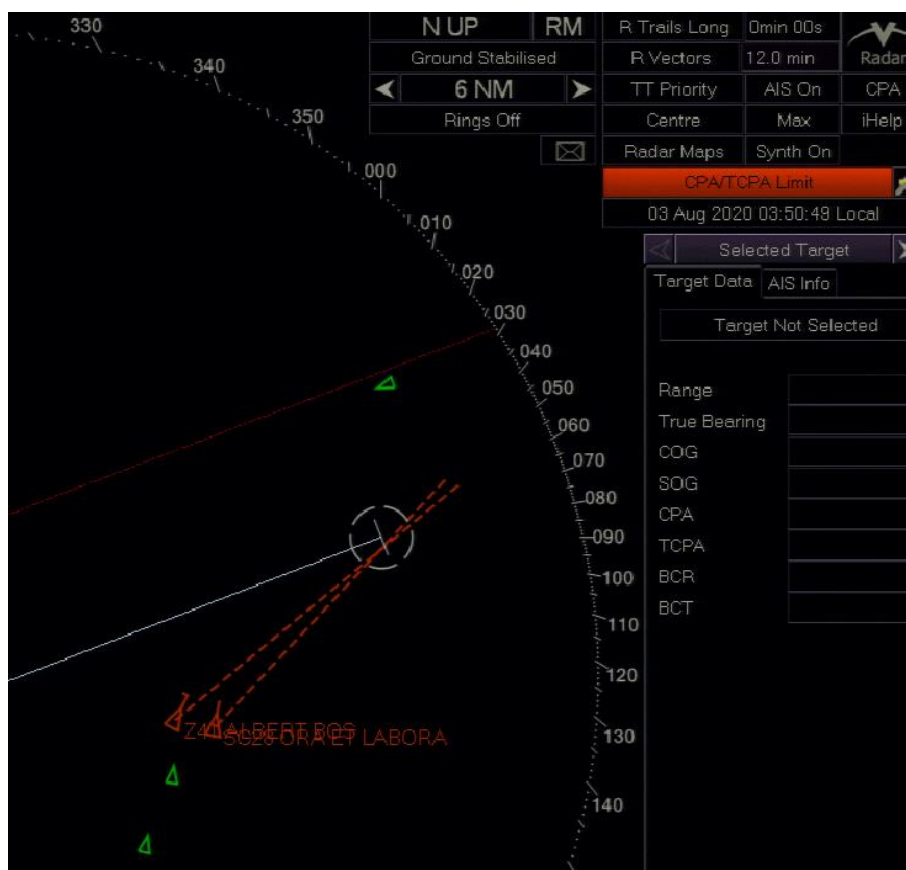
Figure 6 - CPA/TCPA limit alarm on radar on board mv ACEROMAR

At 03:50 hours, the officer of watch on board mv ACEROMAR had set the radar to a 6nm range and the radar indicated two *CPA/TCPA limit* alarms³, one from fv Z.41-ALBERT BOS and one from fv SC.28-ORA ET LABORA, as indicated in Figure 6.

At 03:51 hours, a third alarm, from fv Z.575-HEIN SENIOR also appeared on the screen.

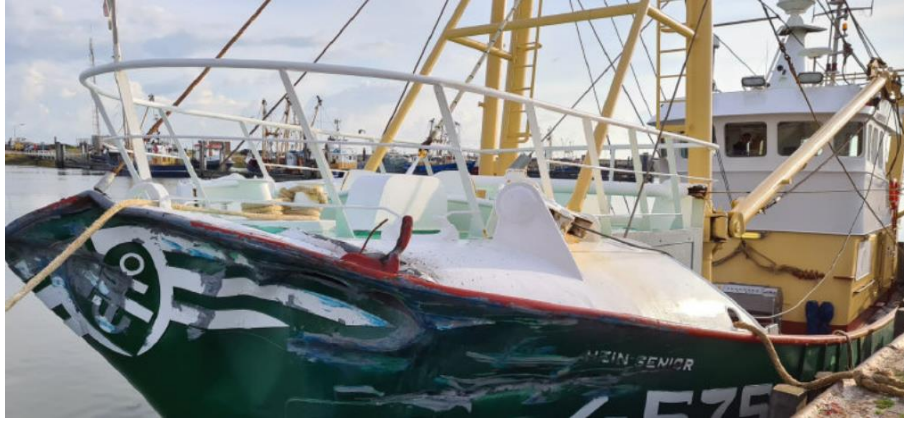
Figure 7 - Fv Z.575-HEIN SENIOR damaged after collision

Fv Z.575 HEIN SENIOR ran with her PS bow into mv ACEROMAR and hit her on PS, from midships up to the aft.

The derrick of fv Z.575 HEIN SENIOR hit the railing and hatch cover gantry of the mv ACEROMAR where after the derrick turned over against the wheelhouse of fv Z.575-HEIN SENIOR.

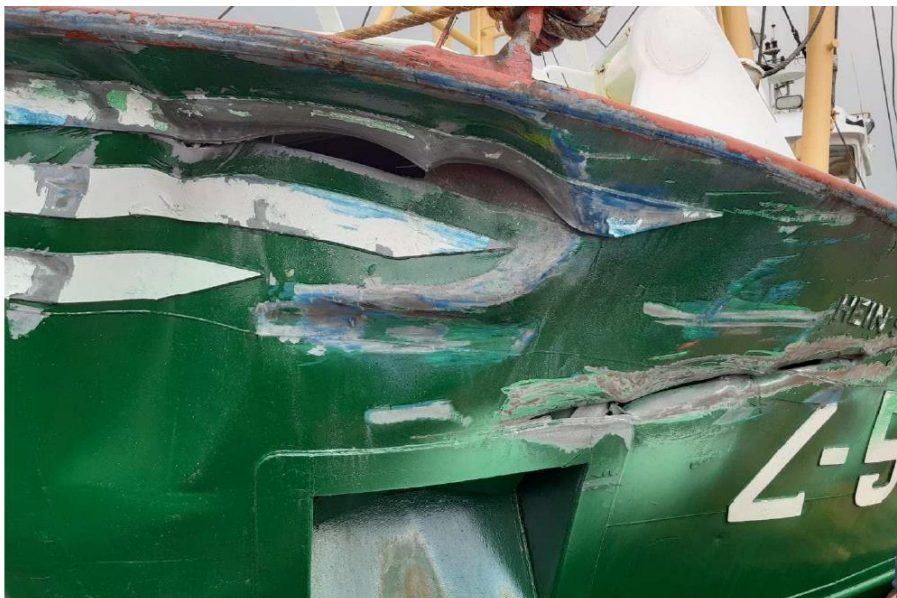
Figure 11 - Ruptured hull of Z.575-HEIN SENIOR

Fv Z.575-HEIN SENIOR was heavily damaged on her PS bow, in front of the collision bulkhead. The ship's hull was ripped open in two positions above the PS anchor lock, as indicated in Figure 11.

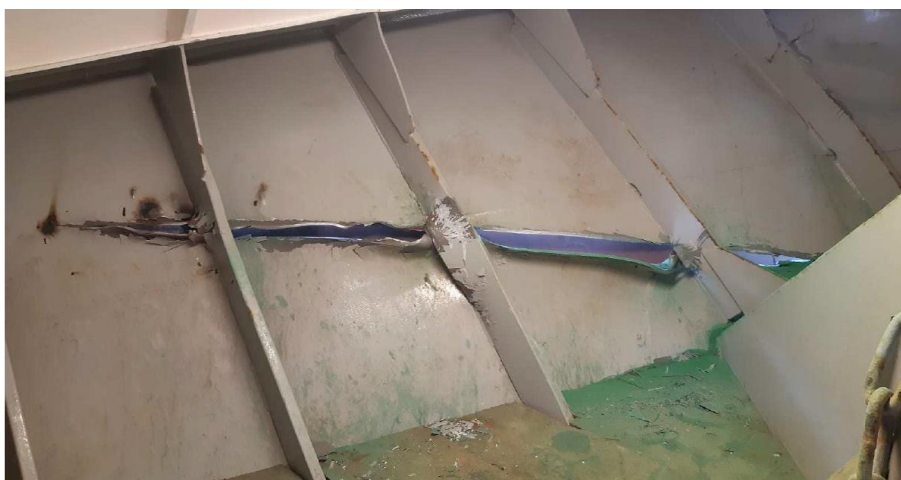
Figure 12 – Lower rupture in the hull of fv Z.575-HEIN SENIOR

Figure 12 shows the lower rupture from inside the vessel. Three stiffeners were partially teared through.

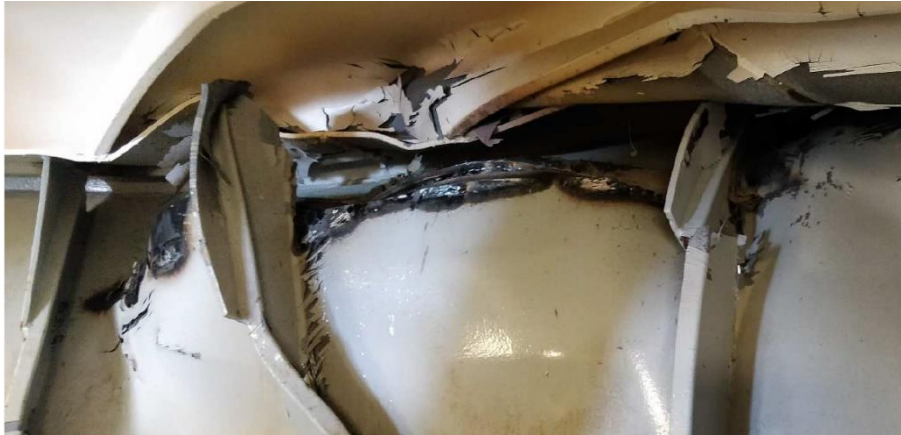
Figure 13 - Upper rupture of the hull of fv Z.575-HEIN SENIOR

Figure 13 shows the upper rupture from inside the vessel. Two stiffeners were completely torn through.

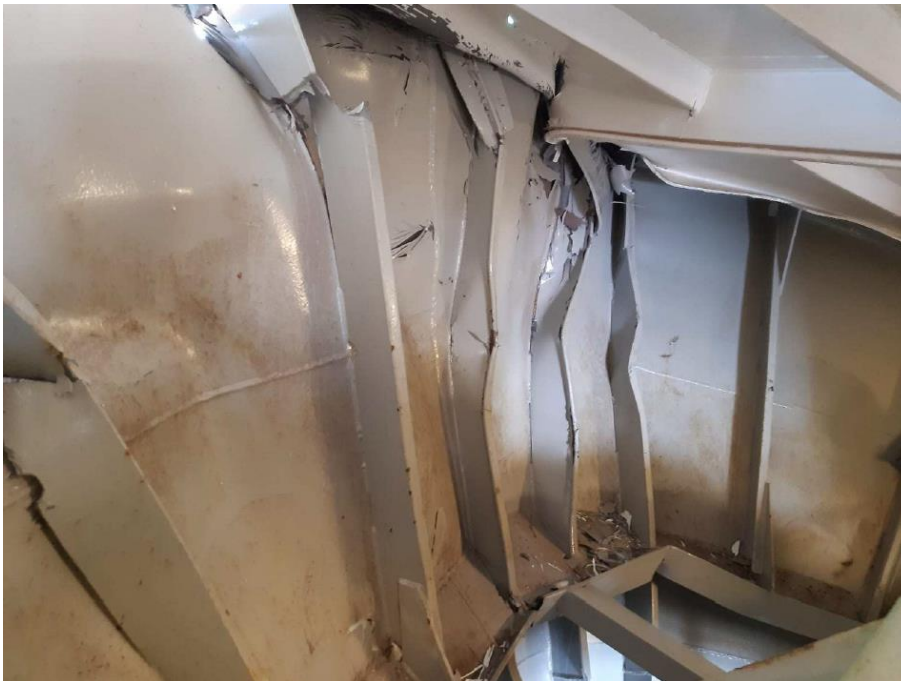
Figure 14 - Damaged stiffened plate structure at the stem of fv Z.575-HEIN SENIOR

Figure 14 shows the damage at the stem of fv Z.575-HEIN SENIOR. The central deck beam and the stiffeners below were bent. The knee joint of the second stiffener on PS was completely torn through.

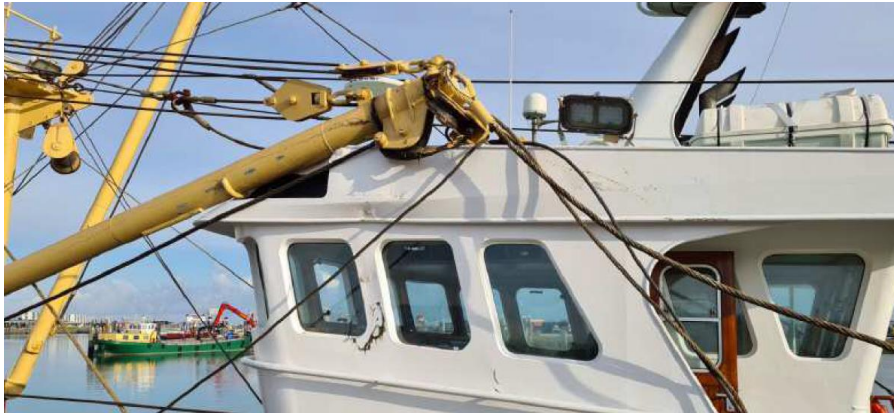
Figure 15 - PS derrick hit the wheelhouse of fv Z.575-HEIN SENIOR

The derricks of fv Z.575-HEIN SENIOR were put at 45° during the sea passage. The PS derrick hit mv ACEROMAR and damaged the hatch cover gantry crane of the mv ACEROMAR. After hitting mv ACEROMAR, the derrick was swung against the wheelhouse of fv Z.575-HEIN SENIOR, as indicated in Figure 15.

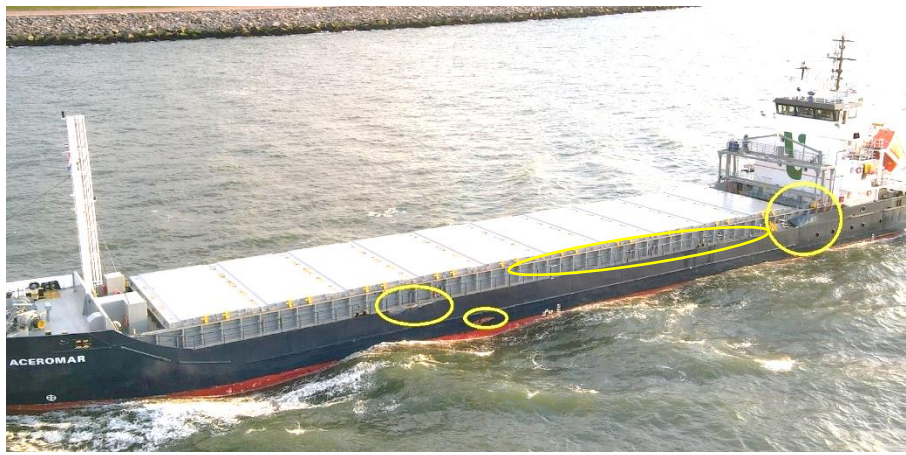
Figure 16 – Impact of the collision on PS of mv ACEROMAR

Mv ACEROMAR had some material damages on PS, as indicated in Figure 16.

The PS side shell plate was also damaged between frames 79-83.

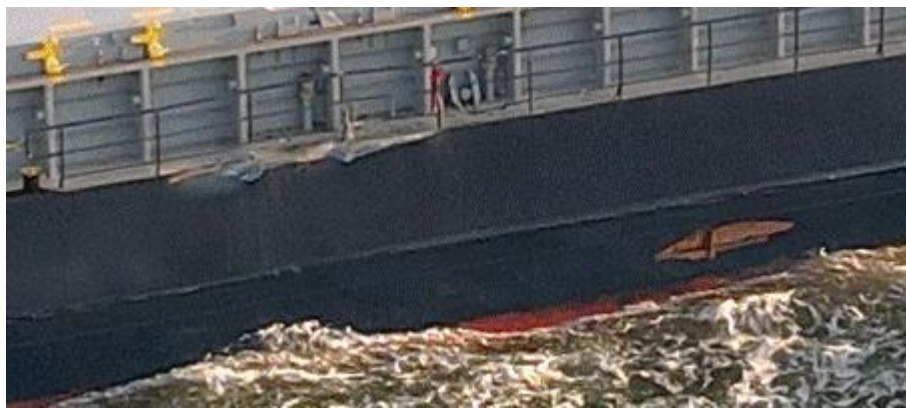
Figure 17 - Detail of damage on PS side plate of mv ACEROMAR

Figure 17 shows a more detailed view of the PS side shell damages.

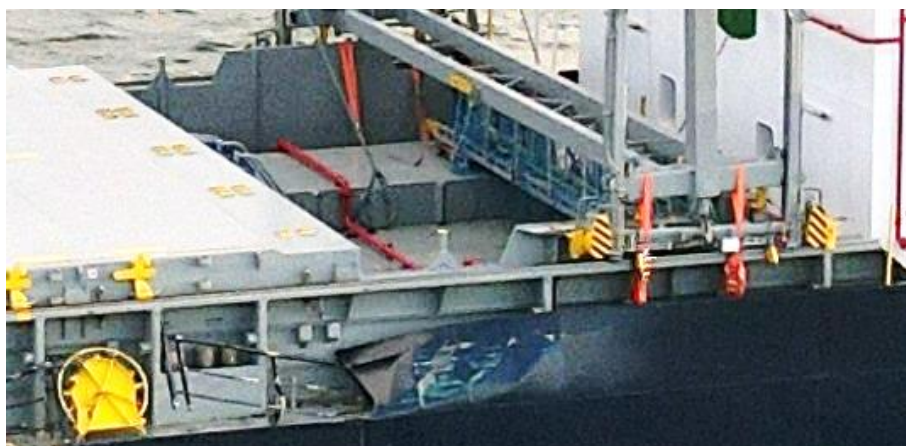
Figure 18 - Damaged railing, bulwark and gantry crane on board mv ACEROMAR

PS bulwark and PS railings were found contact damaged from the midship section up to the aft, between frames 19 and 95. The PS aft fairlead was found with the rollers blocked.

The hatch cover gantry crane was hit by the PS derrick of fv Z.575-HEIN SENIOR and was found contact damaged. It needed to be dismantled for repairs.

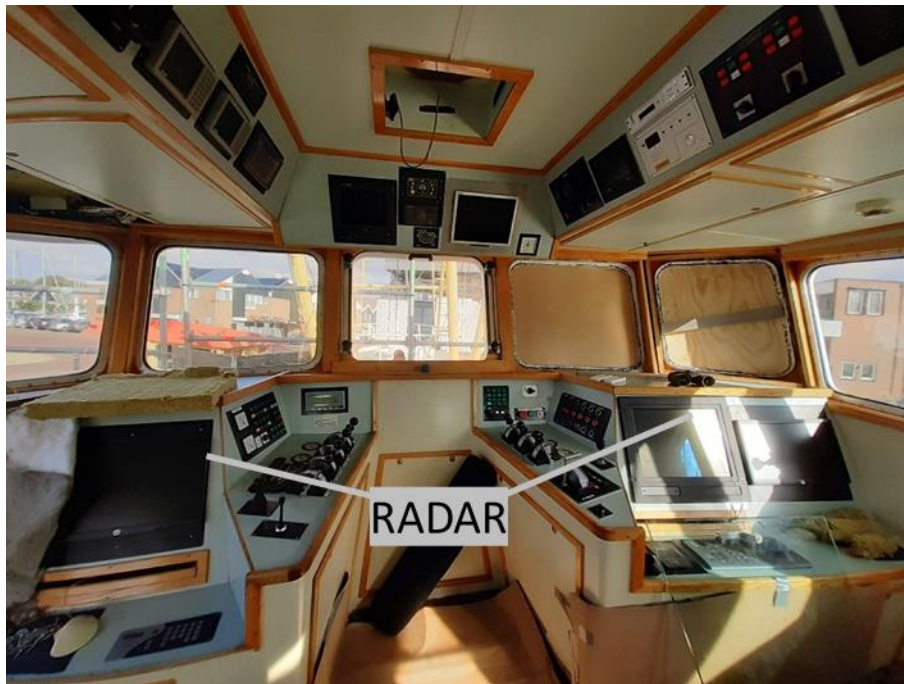
Figure 20 - Front view from helm'sman chair

Figure 20 and Figure 21 give an indication of the outside view when sitting in the helmsman chair.
