Report on the grounding of
fv Z.575 – HEIN SENIOR
on October 12th, 2020

off the isle of Vlieland,
with damage to the propeller.

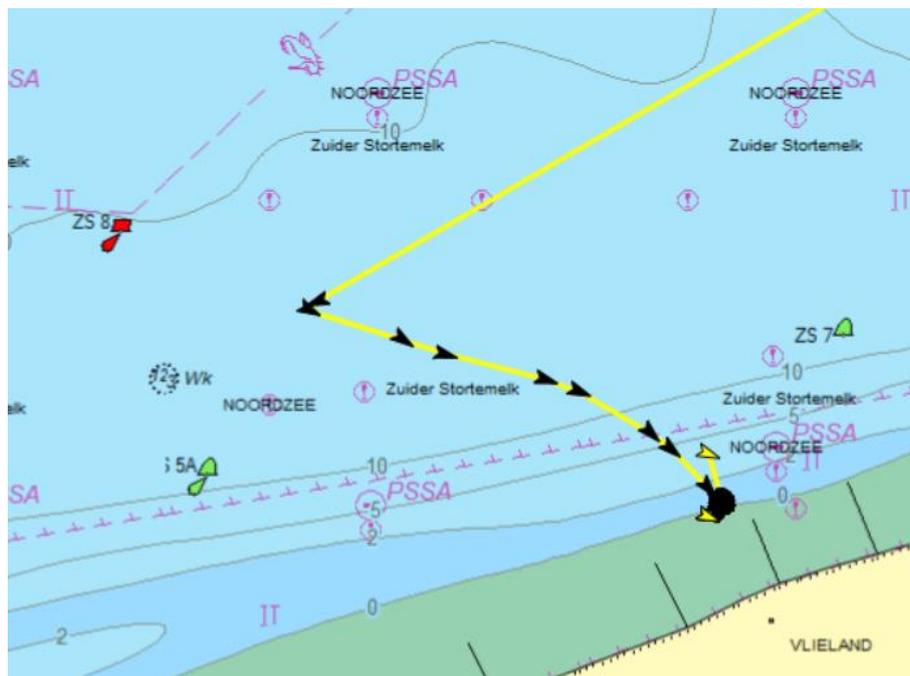
Figure 1 - Track of fv Z.575-HEIN SENIOR adrift

By the influence of the wind and the current, the vessel drifted ESE with a speed of approximately 1.2 knots, see Figure 1.

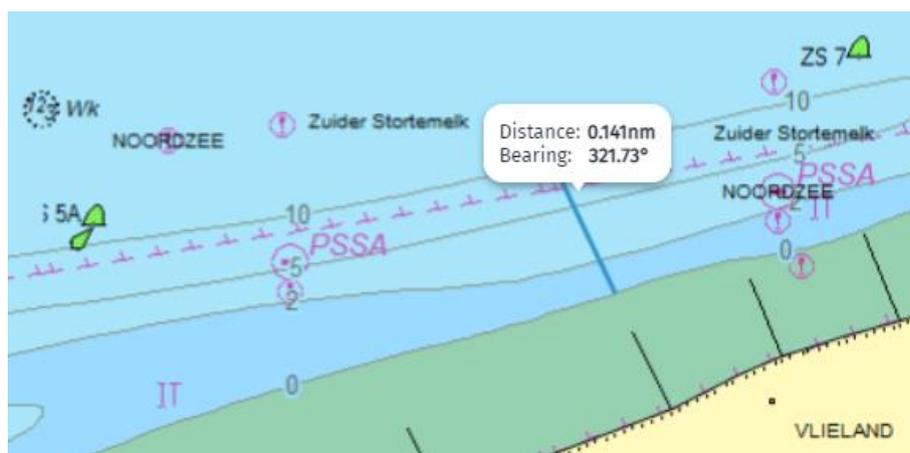
Figure 2 – Shallow water between the fairway and the isle of Vlieland

Meanwhile, the vessel was drifting out of the fairway, where the depth decreased from 10m to 0m over a distance of less than 0.15 nm, as indicated in Figure 2.

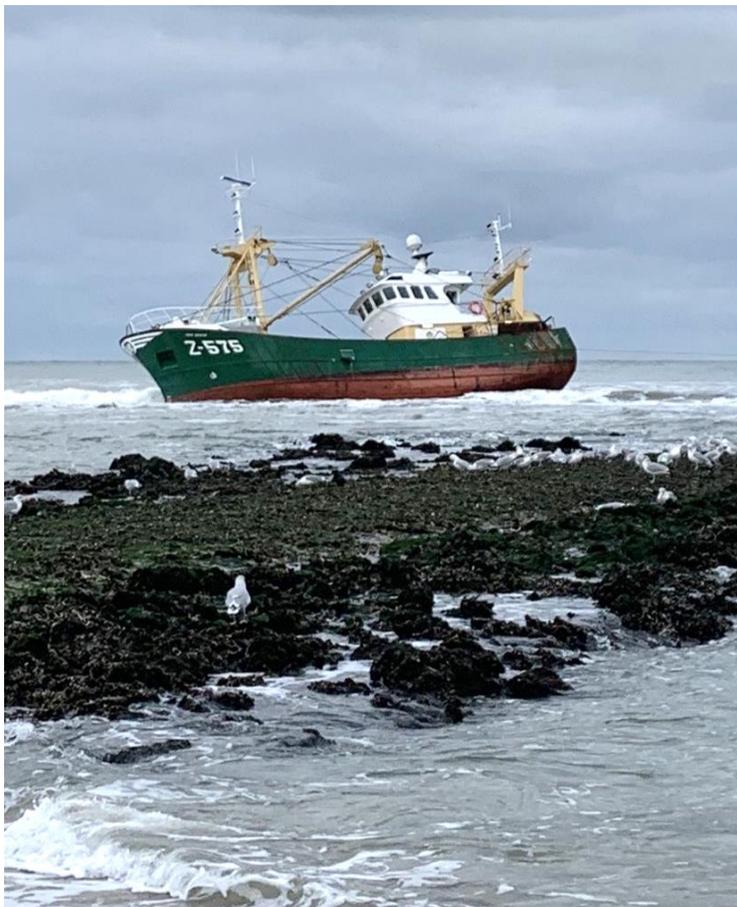
Figure 4 - Fv Z.575-HEIN SENIOR grounded

At 04:09 hours, fv Z.575-HEIN SENIOR reported that they ran aground.

The charted depth in that area was between 0 and 2m.

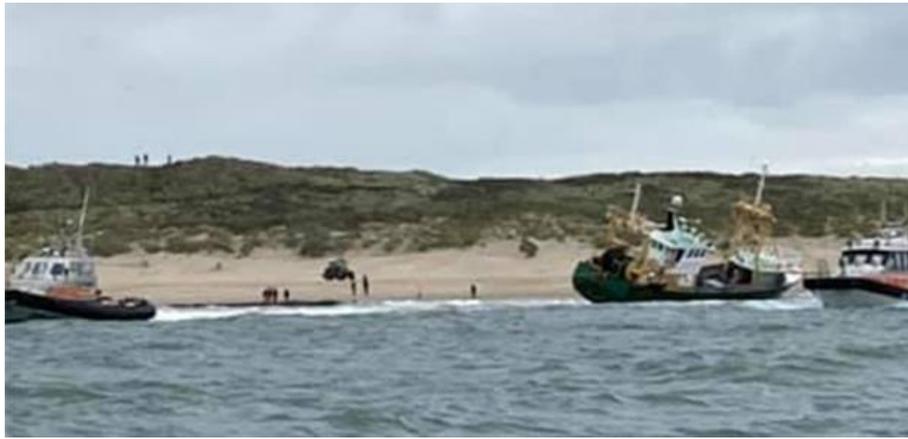
Figure 6 – Grounded fv Z.575-HEIN SENIOR with RIBs SKUA and HURRICANE

At 05:24 hours both RIBs started pulling at the stern, but they could not get the fishing vessel afloat. Around 06:20 hours further attempts were halted until next high tide.

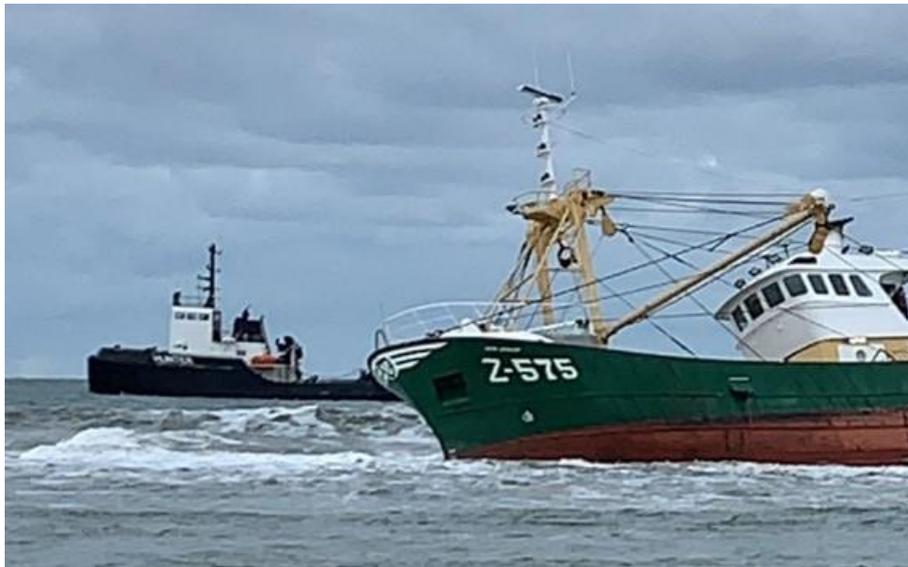
Figure 7 - Fv Z.575-HEIN SENIOR with tug HUNTER

Low tide was at 10:45 hours on October 12th 2020. When the tide was rising again and with the assistance of tug HURRICANE, fv Z.575-HEIN SENIOR was pulled afloat around 15:00 hours.

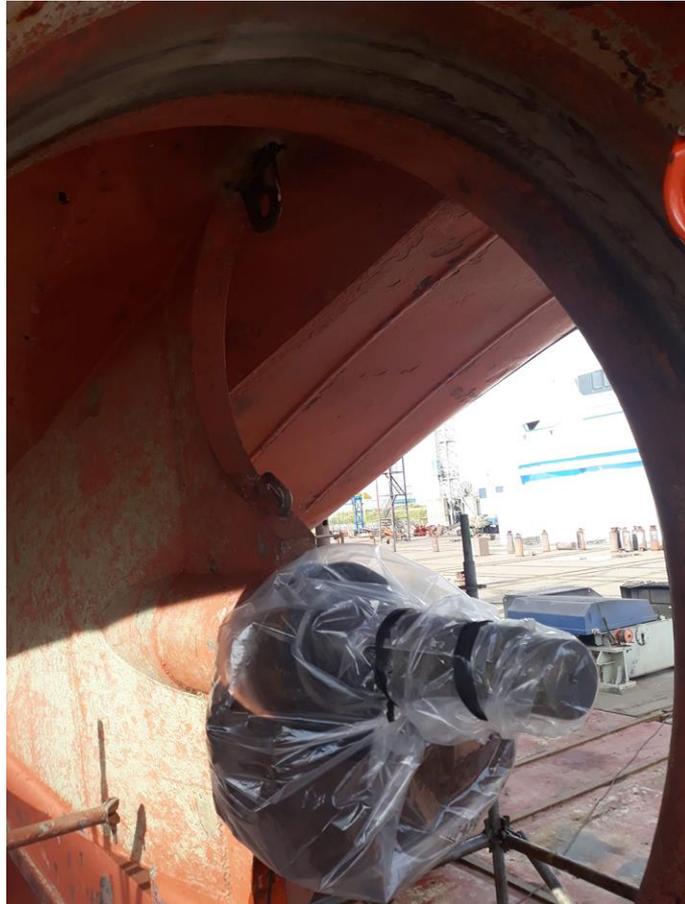
Figure 9 - Propeller of fv Z.575-HEIN SENIOR being replaced

The propeller blades were damaged and a new propeller was installed. The propeller shaft and rudder stock were not affected by the grounding.

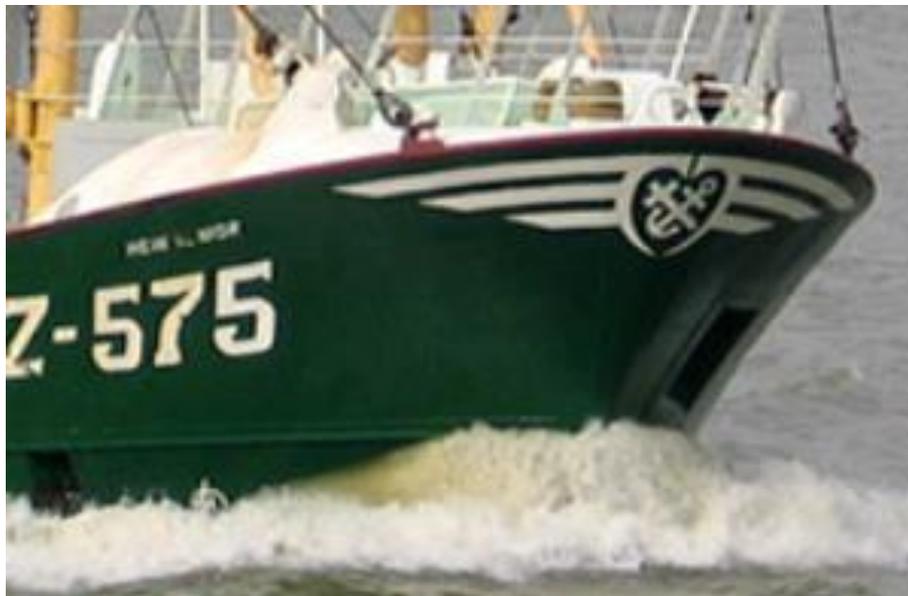
Figure 10 - Bow of fv Z.575-HEIN SENIOR

The anchor, located on PS bow, seen in Figure 10, was not used.

During an inspection of the Belgian Maritime Authority the day after the grounding, the anchor turned out to be stuck inside the hawse pipe and consequentially could not be lowered.

An inspection the day after the incident learned that the anchor was stuck in the hawse pipe.

2020/006586 -1 :The owner of the vessel, BVBA Rederij De Toekomst, is recommended to install a ship specific emergency response plan on board that includes the use of the safety equipment on board.

To ensure that all critical safety equipment is functional, a maintenance program for such equipment should be developed.
