Report on the investigation into  
a serious injury  
on board LNG tanker **SUMMIT LNG**

in the Bay of Bengal  
with a deep cut on the left leg  
on November 24<sup>th</sup>, 2020.

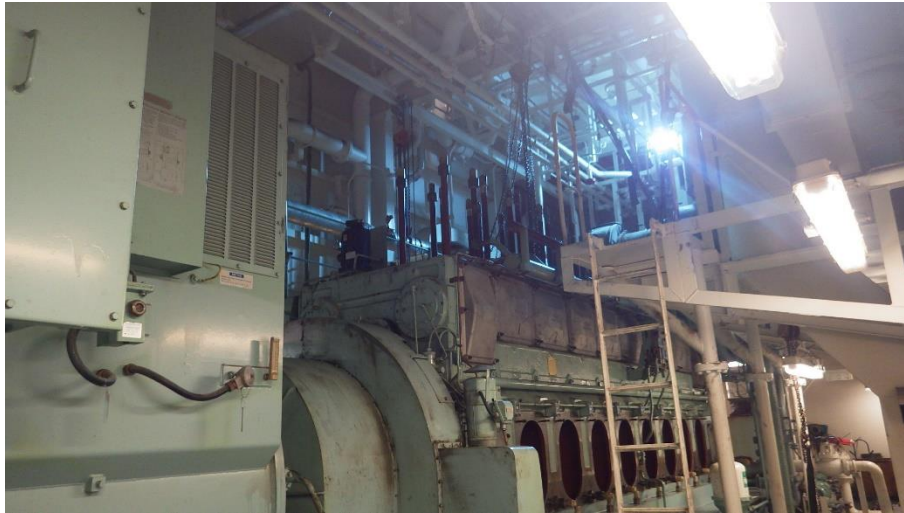
On November 23<sup>rd</sup>, at 18:00 hours, a daily work meeting was conducted and documented. Approximately 80 % of the dismantling job as shown in Figure 2 had been done.

*Figure 2 - Dismantling of auxiliary generator in progress*

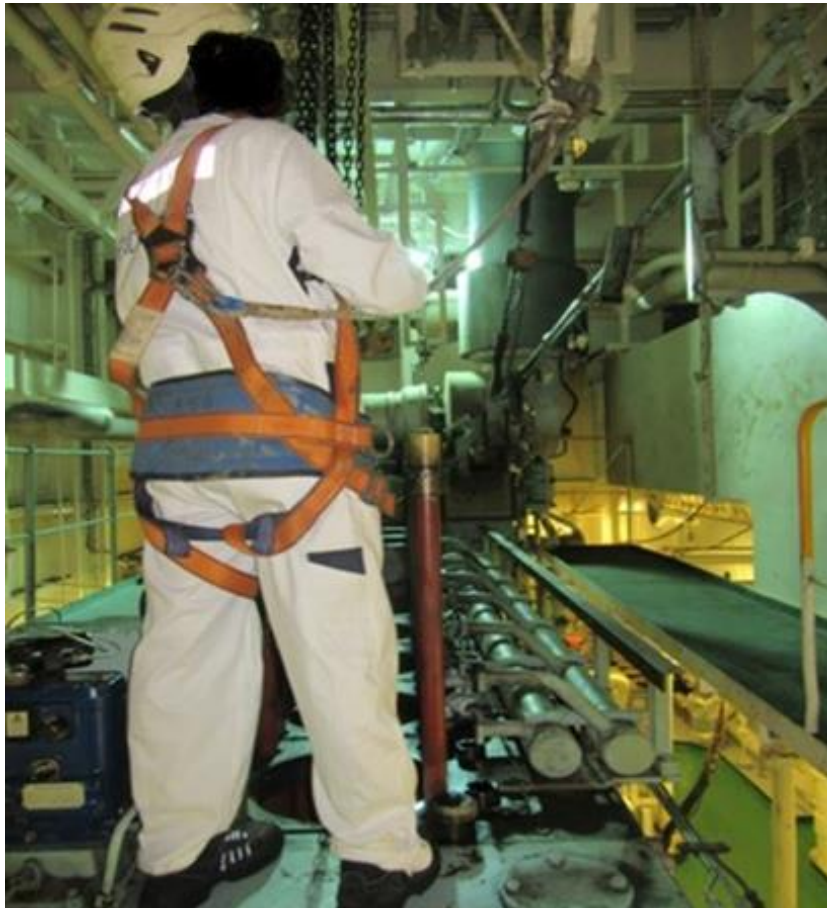
At 11:20 hours, one of the engineers involved in the works was standing on top of the generator, as seen in Figure 3. He was wearing the PPE as shown in the picture. His coverall was a so called tropical coverall, made of a light cloth and designed for working in hot areas.

*Figure 3 - Engineer standing on top of the auxiliary generator  
Reconstruction photograph*

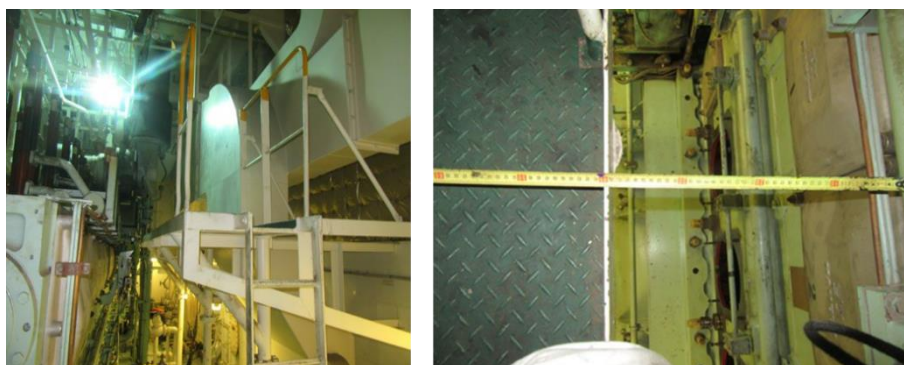
Adjacent to the generator top at the same height, there was a walking platform. Between the generator and the platform was a gap of approximately 40 cm, as shown in Figure 4.

*Figure 4 - Front view and top view of generator and platform*

*The platform was accessible from below by a vertical ladder. Please note the handrails on the left side and the right side of the ladder, as shown in the left picture.*

The engineer had to step over a 40 cm gap.

The generator top and the walking platform were at the same height, but there was a small vertical edge to the walking platform.

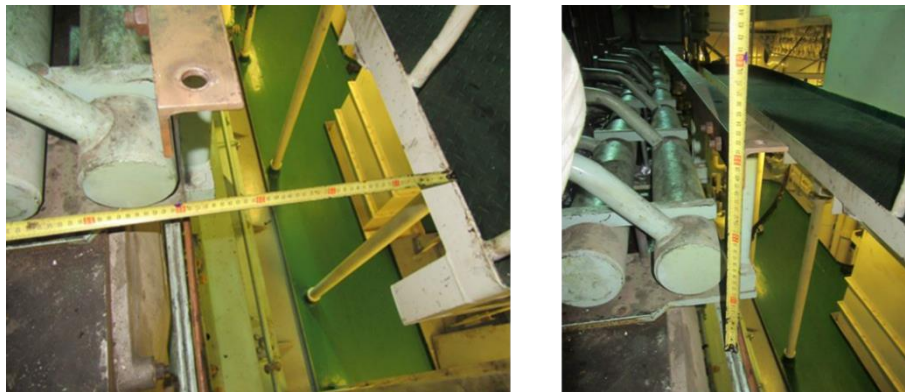
The angle bar was positioned 30 cm higher than the generator top and the platform, as seen in Figure 5.

*Figure 5 - Angle bar that supported the exhaust*

The angle bar consisted out of steel and the edge was an unprotected right angle.

The unprotected edge of the angle bar and the type of tissue where the coverall was made of did aggravate the consequences of the fall and so contributed to the accident.

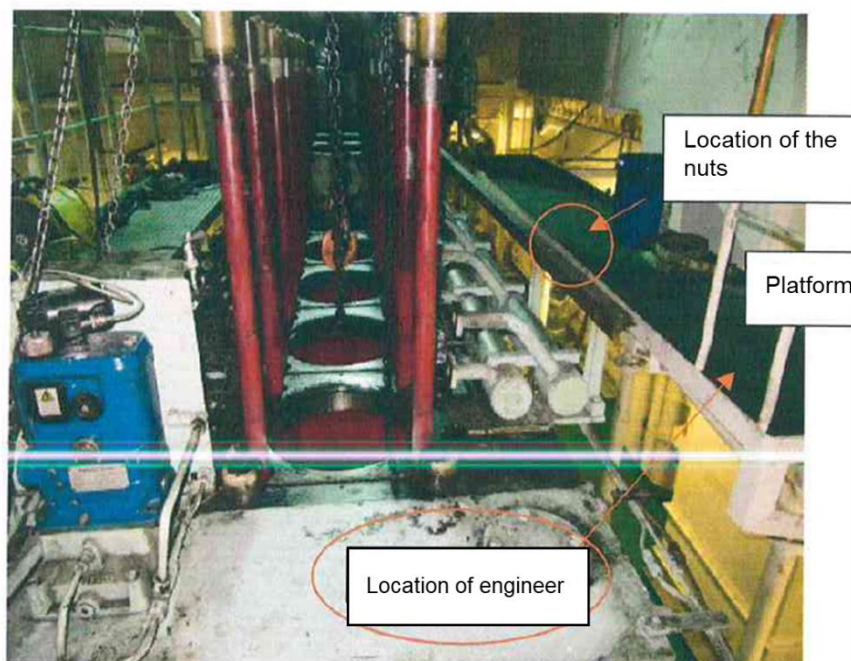
The engineer needed nuts that were lying on the platform, but they were out of his reach. He had to step onto the platform. Figure 6 shows the location and the position of the nuts.

*Figure 6 - Overview of work location*

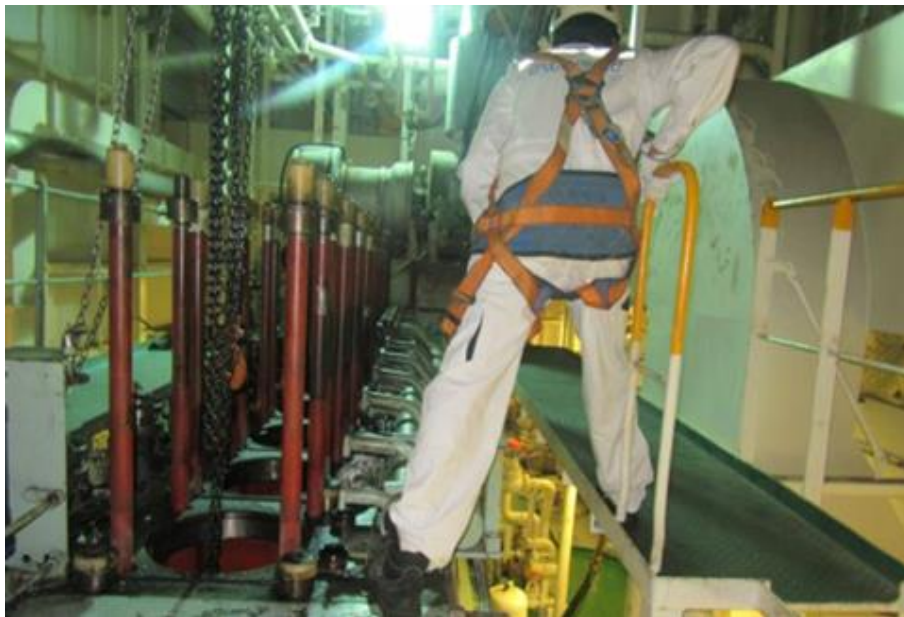
The engineer held the vertical stud bar with his right hand and stepped with his right foot on the platform. His left foot was still standing on top of the generator. His left leg came close to the edge of the angle bar. Figure 7 shows a reconstruction of this movement.

*Figure 7 - Reconstruction of the movement of the engineer*

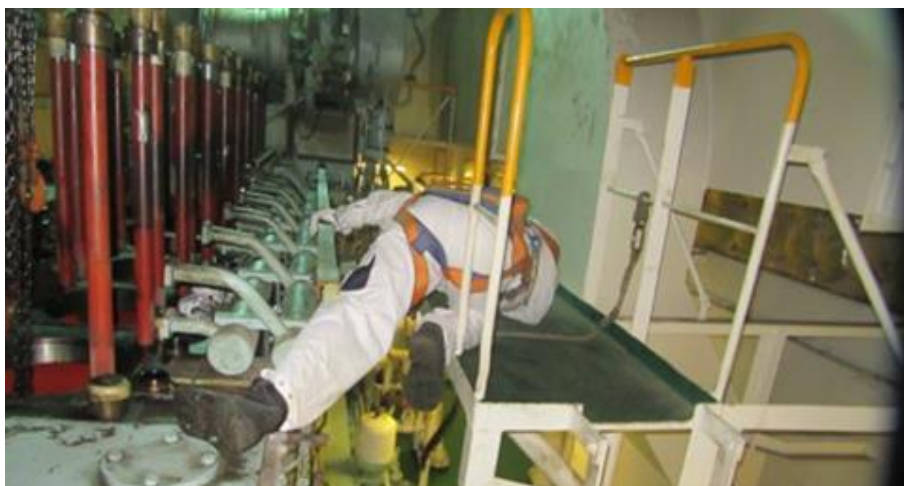
When the engineer wanted to step onto the platform with his other foot, he slipped and fell forward on the platform, as shown in Figure 8. His left leg braced against the edge of the angle bar.

*Figure 8 – Reconstruction of fallen engineer*

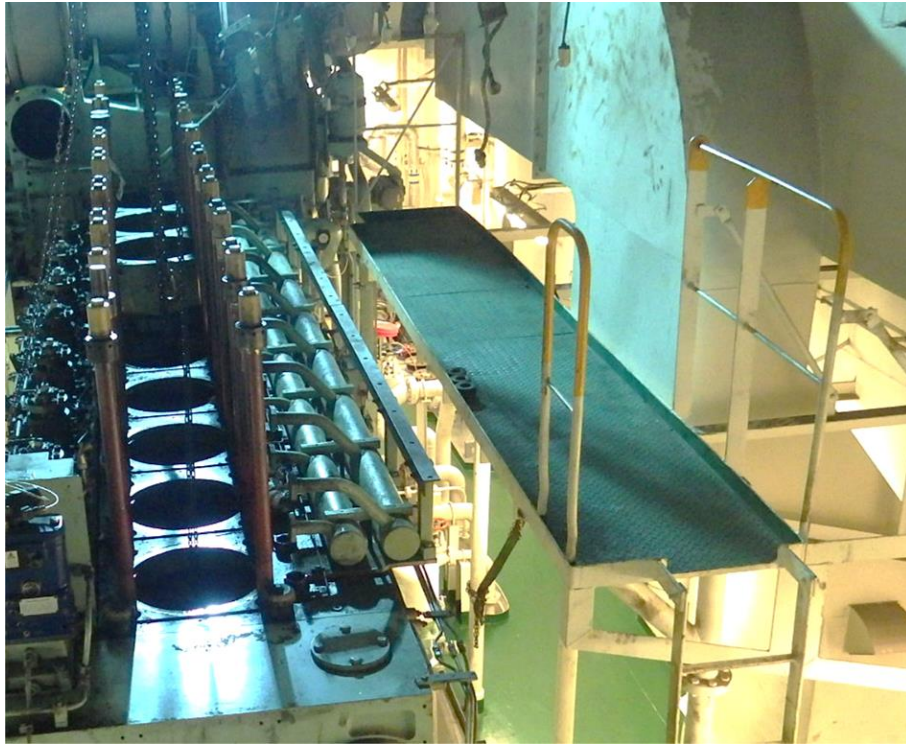
The working area was lit by extra portable lights. The light in the working area was not equally spread. The light distribution was hindered by parts of the generator and hoisting gear, as indicated in Figure 10. The lighting could have influenced the engineer's judgement regarding the distance from his leg to the angle bar.

*Figure 10 - Light distribution in the working area*
