Report on the investigation
into a collision between
fv Z.18 – SOETKIN and mv CALYPSO.GR
on February 12th 2021

in the English Channel
with serious damage to the fishing vessel.

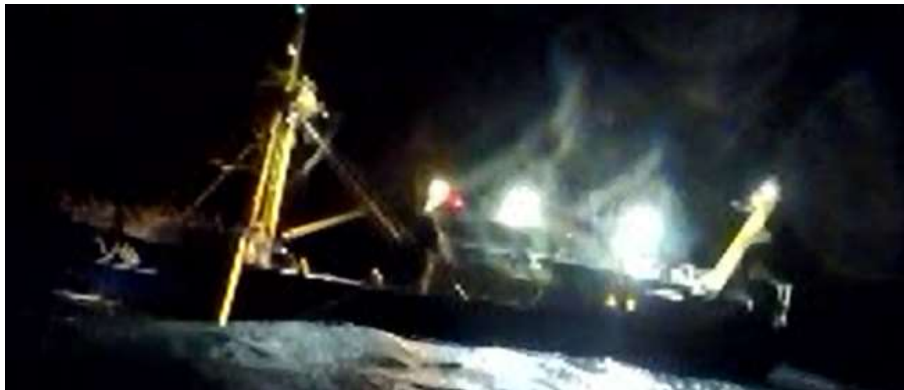
Figure 5 - PS derrick of fv Z.18 - SOETKIN hanging in the water

During the collision, the PS derrick got separated from the lanyards and was hanging in the water, remaining attached to the mast by the swivel, as shown in Figure 5.

When the fv Z.18 – SOETKIN came loose of the mv CALYPSO.GR, the PS derrick was hanging in the water, only attached to the mast by means of the swivel, as shown in Figure 5 and Figure 6. Both PS and SB trawls were lying on the seabed and could not be recovered.

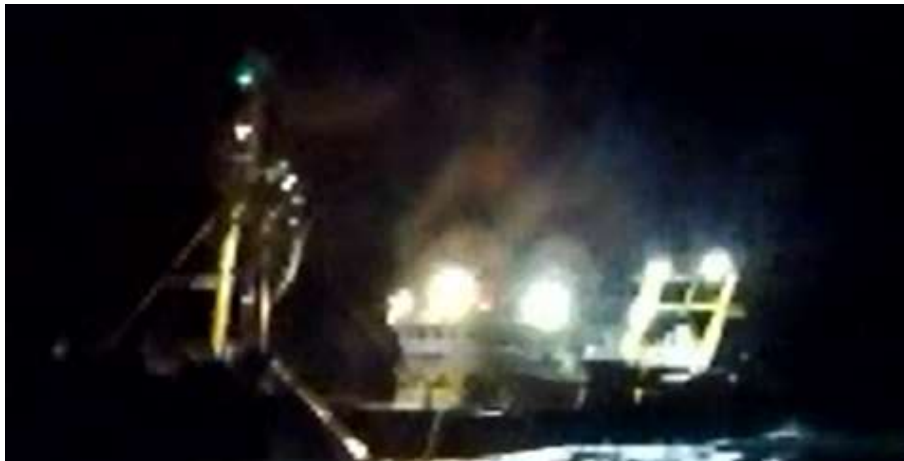
Figure 6 - Fv Z.18 - SOETKIN after collision

At 06:04 hours, the lifeboat arrived at the fv Z.18 – SOETKIN. The recordings made by the RNLI upon arrival showed that the deck lights, fishing lights and navigational lights of the fv Z.18- SOETKIN were working at that moment, as shown in Figure 6.

The RNLI lifeboat reported that the PS bow of the fv Z.18 – SOETKIN was holed approximately 3 m above the waterline.

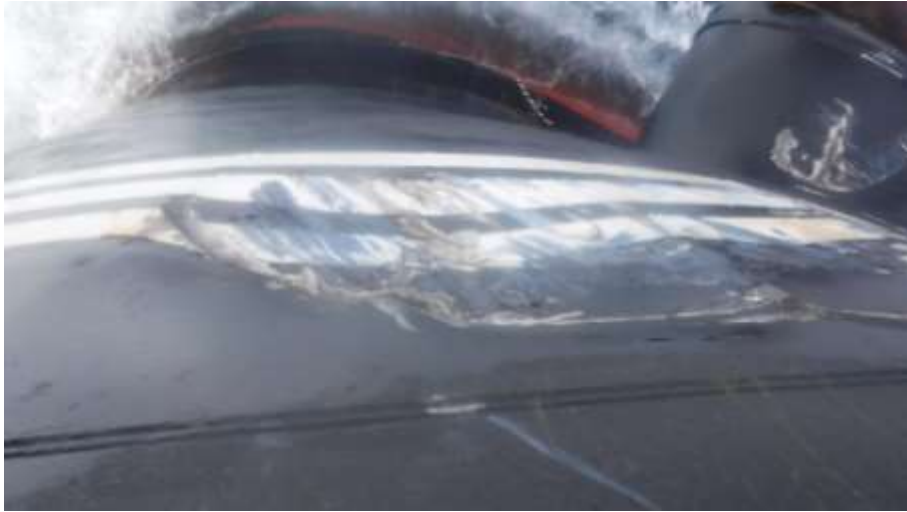
Figure 11 - Indent on SB bow of mv CALYPSO.GR

On board the mv CALYPSO.GR, this first contact resulted in an indent of approximately 4,5m x 1m on SB bow, about 3m above the waterline and near the anchor lock, as seen in Figure 11.

The blue paint of the bow of the fv Z.18 – SOETKIN was well visible on the bow of the mv CALYPSO.GR

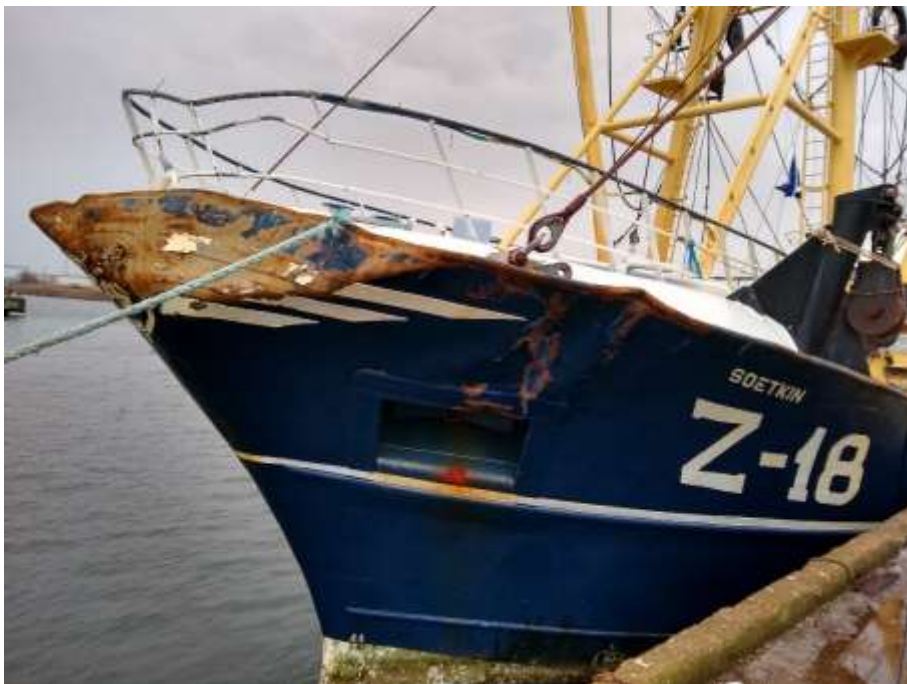
Figure 12 - Damaged bow of the fv Z.18 - SOETKIN

The impact of this first contact damaged the PS bow of the fv Z.18 – SOETKIN and also resulted in a hole approximately 3 m above the waterline, near the anchor lock, as seen in Figure 12. Most probably, the hole originated from the impact of the anchor of the mv CALYPSO.GR on the bow of the fv Z.18 – SOETKIN.

The damage to both vessels corresponded with the headings as reported.

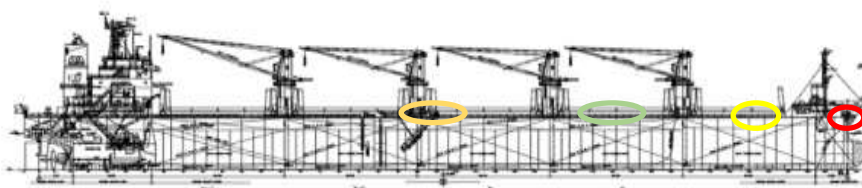
Figure 14 - Damages on board mv CALYPSO.GR

From this moment onward, the PS derrick, together with the attached fishing gear, was blocked by the railing and deck equipment on board the mv CALYPSO.GR, causing damages to air vents, hatch covers and the accommodation ladder, as shown in Figure 14, Figure 15, Figure 16 and Figure 17.

*The red circle shows the location of the impact on the bow
The yellow circle shows where the air vents were hit
The green circle is where cargo hold N°2 was located
The orange circle shows the position of the accommodation ladder*

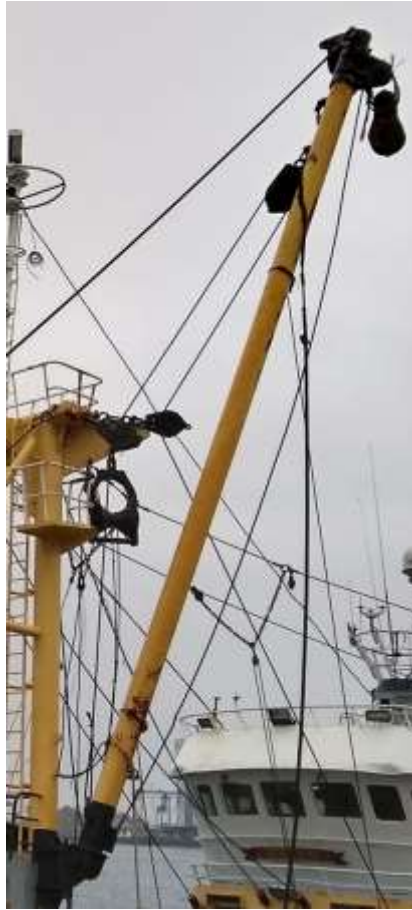
Figure 18 - PS derrick with fish block of the fv Z.18 - SOETKIN

Figure 18 shows the PS derrick of the fv Z.18 – SOETKIN after arrival in Zeebrugge. In the picture, the derrick was secured, but not yet repaired.
