**Federal Bureau for the Investigation  
of Maritime Accidents**

2022/017548

Report on the investigation into the  
death of a crewmember on board  
the mts MAGNIFICA during  
manoeuvring in the ZANDVLIET  
lock at the  
Port of Antwerp on  
26th of July 2022

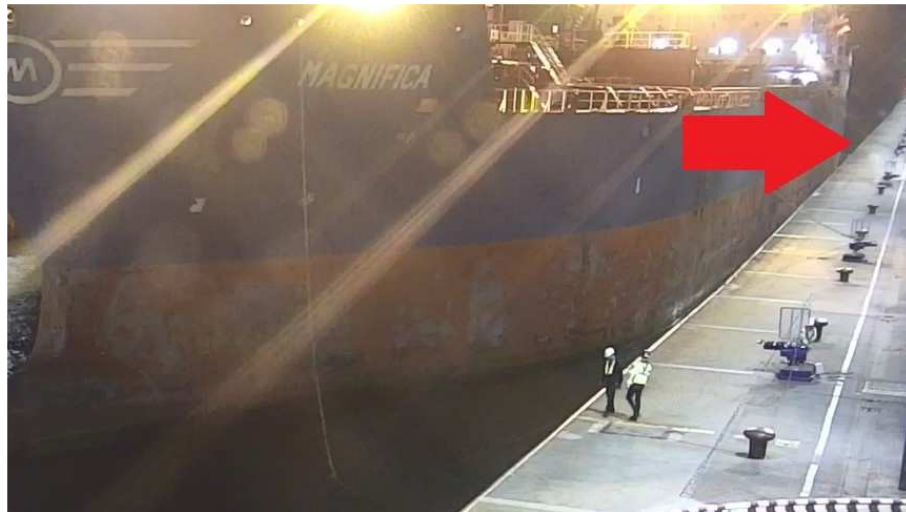
*Figure 3 –Arrow indicates the snapping rear spring (extract from cctv images)*

The vessel's engine was subsequently put in dead slow ahead for a short time. Thereupon the pilot instructed the tug mv 20 to start pulling astern and to stop pulling very soon thereafter, at the same time the Master had instructed the vessel's crew to hold the position of the vessel, whereupon the crewmember entrusted with manipulating the rear spring, tightened the rear spring. Immediately thereafter the rear spring, with a minimum breaking load of 61,7 mtons as seen in Annex 2 on page 29, snapped.

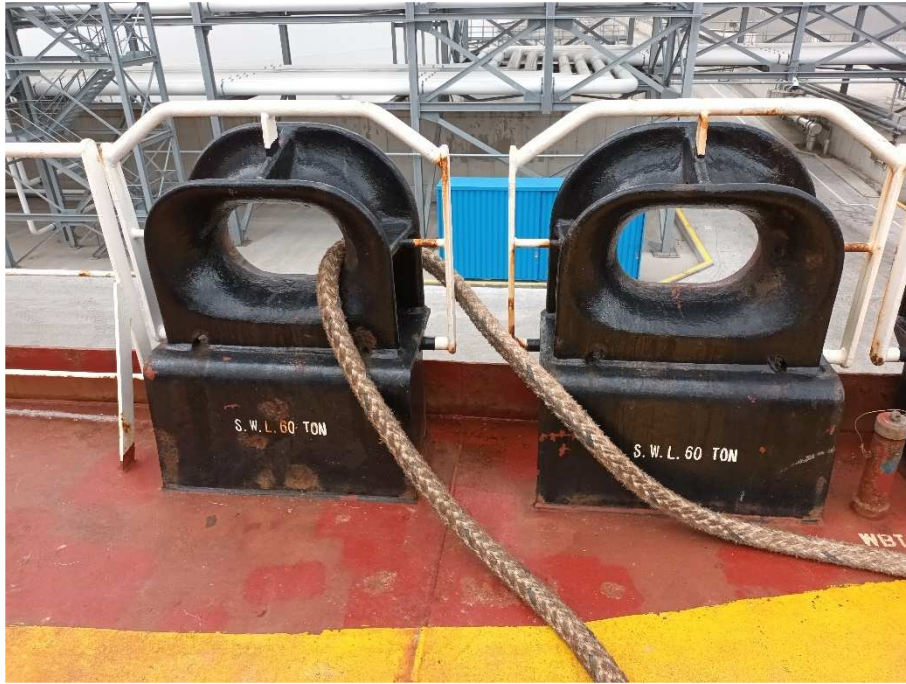
*Figure 4 - Broken spring line through Panama lead*

The broken spring line swung back and hit the crewmember, positioned near the Panama lead wherethrough the rear spring was put ashore as seen in Figure 4 on page 12, frontally.

1. The spring traversed from the winching installation to the Panama lead via the shortest route, however, Panama leads offer no chafing protection to the lines passed through. Chafing may over time have affected the breaking load of the spring line to such extent that breaking force decreased considerably.
2. Changing the direction of mooring lines by means of leads not only reduces the breaking force by bend losses but also causes the introduction of complex snap-back areas. The snap back areas in way of the Panama leads were not indicated as seen in Figure 4 on page 12.
3. The Port of Antwerp regulations for the use of VHF radio communications in the port area impose the use of the English or Dutch language, however, without imposing one or the other.

1. The Port of Antwerp Bruges is recommended to let go of the choice between two languages, Dutch and English, for nautical communication between vessels, harbour tugs, lockmasters and VTS and to always have all aforementioned communication in English.
2. CVBA BRABO are recommended to impose their docking pilots to exclusively use English for all nautical communication, whether on board vessels or via VHF.
3. The operators of the vessel, Millenia Maritime INC – IMO 5230682, are recommended to have precarious zones near Panama Leads on board vessels operated by them marked as such, and to also inform the crew of the vessels operated by them that Panama Leads are not meant to have lines moving through them, by means of winching, but they are a towing fitting installed on the shipside to lead the mooring or towing rope from the ship's inboard to outboard when fixed to a bollard on deck.

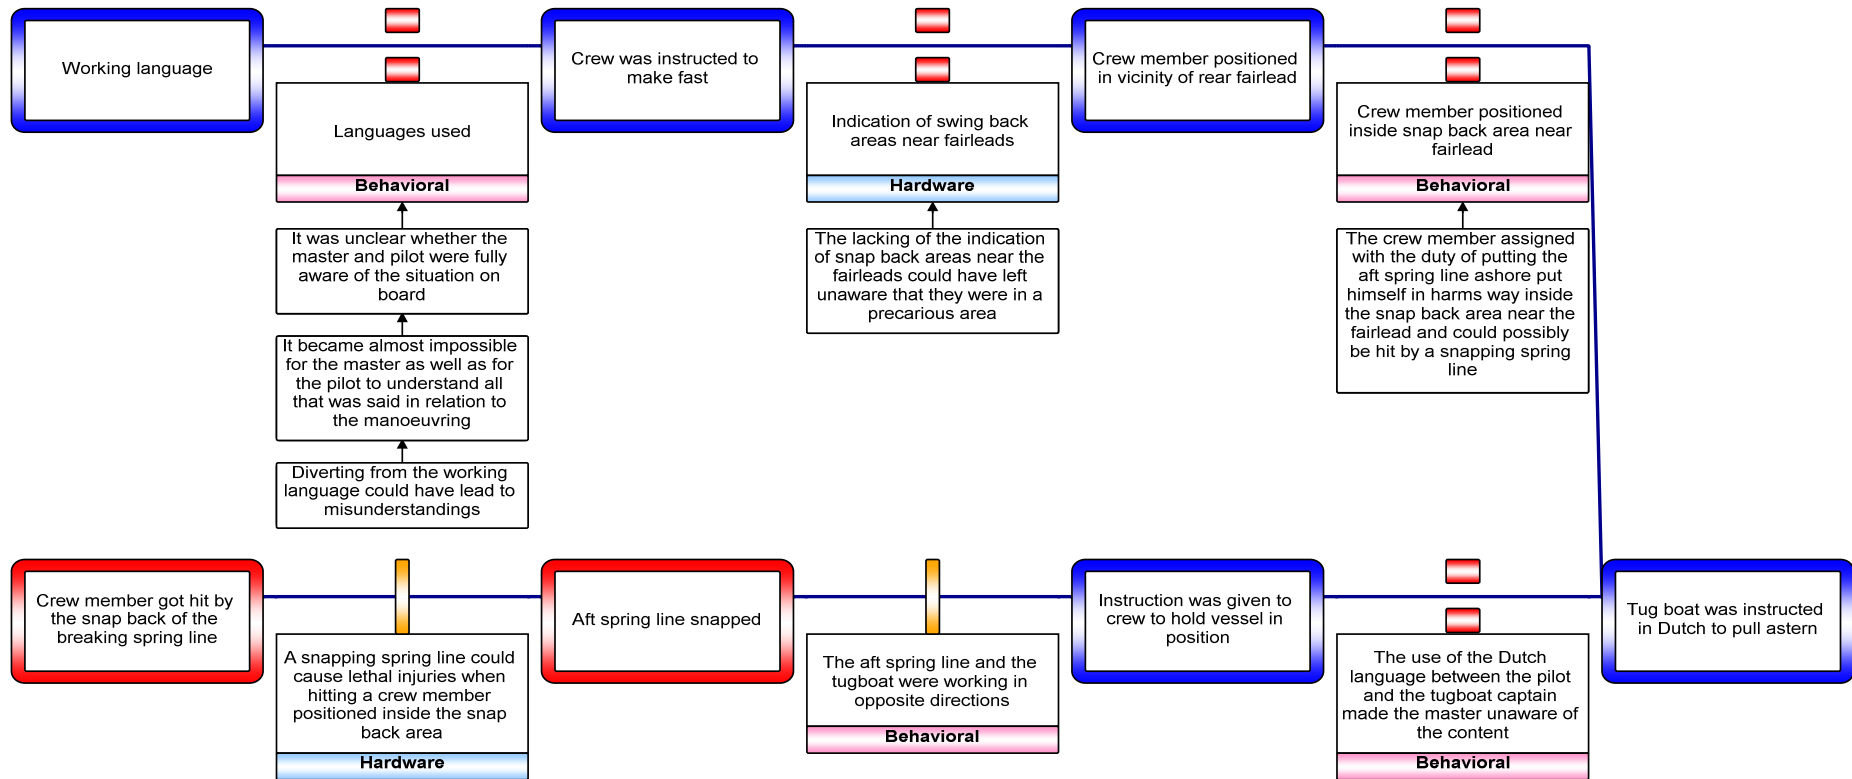
Figure 7 - barrier fail diagram

The working language on board the mts MAGNIFICA was English. The Master communicated in English via handheld radio with the deck crew during manoeuvring. The pilot and Master communicated in English, whereas the pilot communicated with the lock Master and tug boat via handheld radio in Dutch. The use of a mix of languages on board the mts MAGNIFICA during the manoeuvring in the ZANDVLIET lock made it so that not all actors were fully aware of the situation and the instructions given.

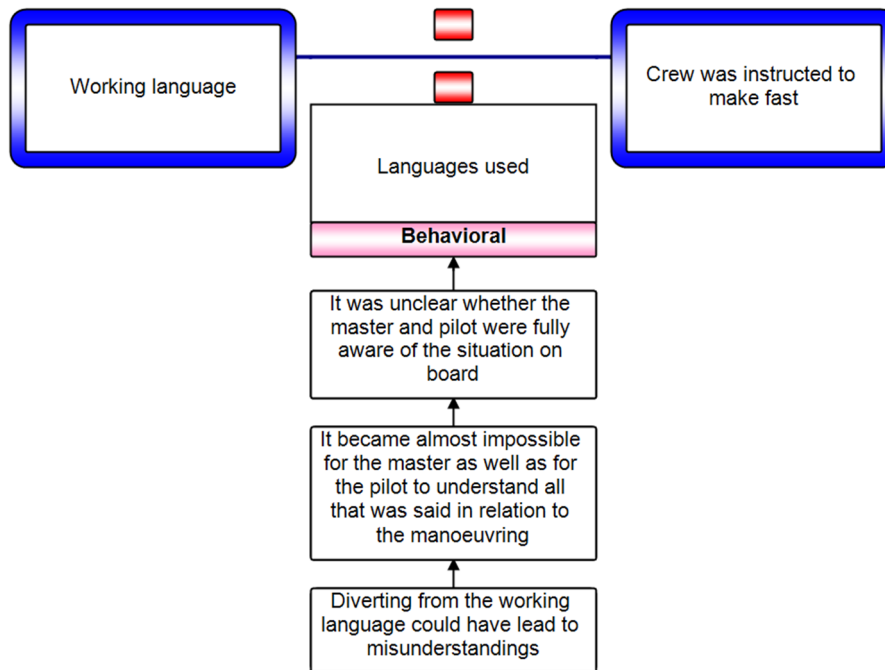
Incident Barrier	Performance / RC Categories	Barrier Challenge / Causes	Comments about performance
<b>Crew was instructed to make fast</b>			
Languages used	Failed		
	BFA Primary Causes		It was unclear whether the Master and pilot were fully aware of the situation on board
	BFA Secondary Causes		It became almost impossible for the Master as well as for the pilot to understand all that was said in relation to the manoeuvring
	BFA Tertiary Causes		Diverting from the working language could have led to misunderstandings

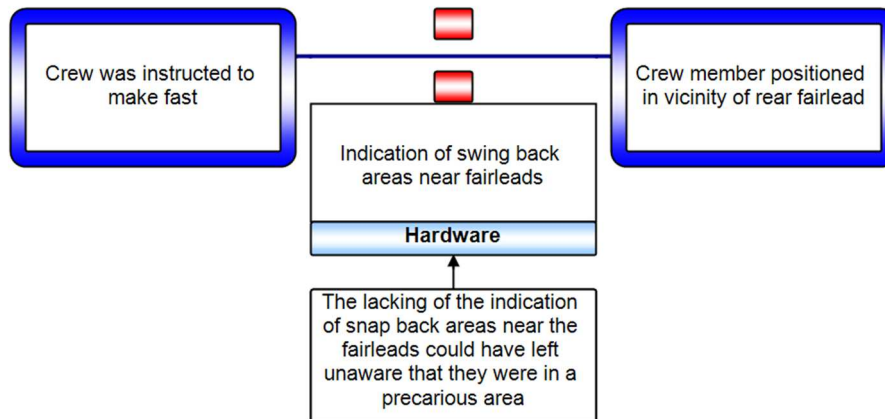
Incident Barrier	Performance / RC Categories	Barrier Challenge / Causes	Comments about performance
<b>Crew member positioned in vicinity of rear fairlead</b>			
Indication of swing back areas near fairleads	Failed		
	BFA Primary Causes		The lacking of the indication of snap back areas near the fairleads could have left the crew unaware that they were in a precarious area

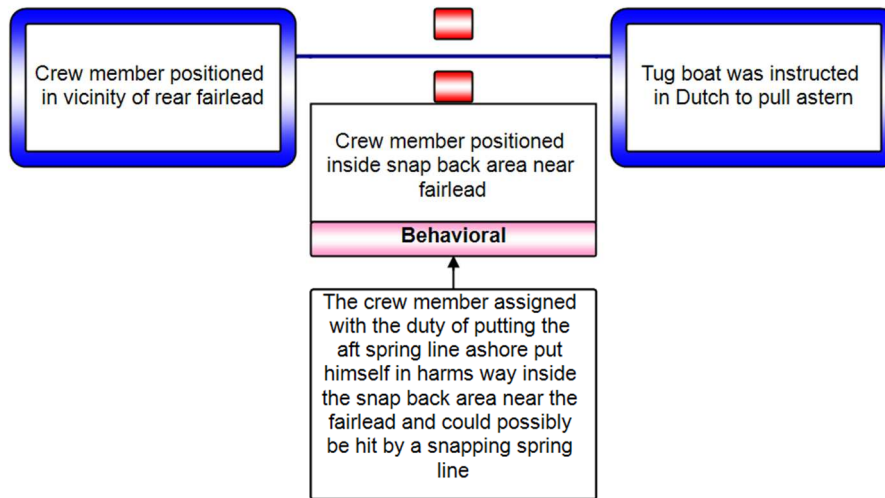
Incident Barrier	Performance / RC Categories	Barrier Challenge / Causes	Comments about performance
<b>Tug boat was instructed in Dutch to pull astern</b>			
Crew member positioned inside snap back area near fairlead	Failed		
	BFA Primary Causes		The crew member assigned with the duty of putting the aft spring line ashore put himself in harm's way inside the snap back area near the fairlead and could possibly be hit by a snapping spring line

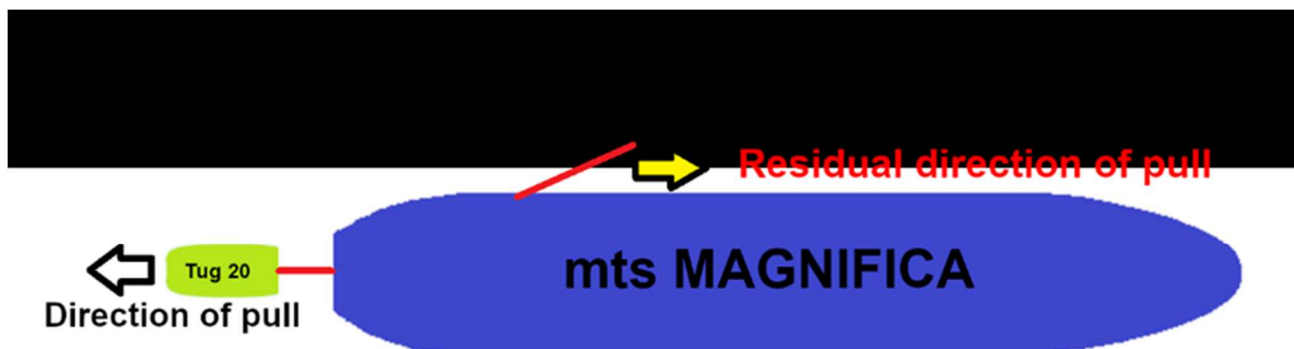
Figure 8 - Residual forces on spring line

The snapping of the spring line and consequential lethal injuries to a crewmember of the mts MAGNIFICA were caused because the execution of the instructions given to the deck crew of the mts MAGNIFICA in English and the instructions given to tug mv 20 in Dutch counteracted and said spring line and the tugboat mv 20 were working in opposite directions as seen in Figure 8 on page 23 thereby exceeding the Line Design Break Force<sup>6</sup> of the spring line.
