Summary
Safety Investigation Report
Derailment of a freight train
Melsele - 12 April 2012

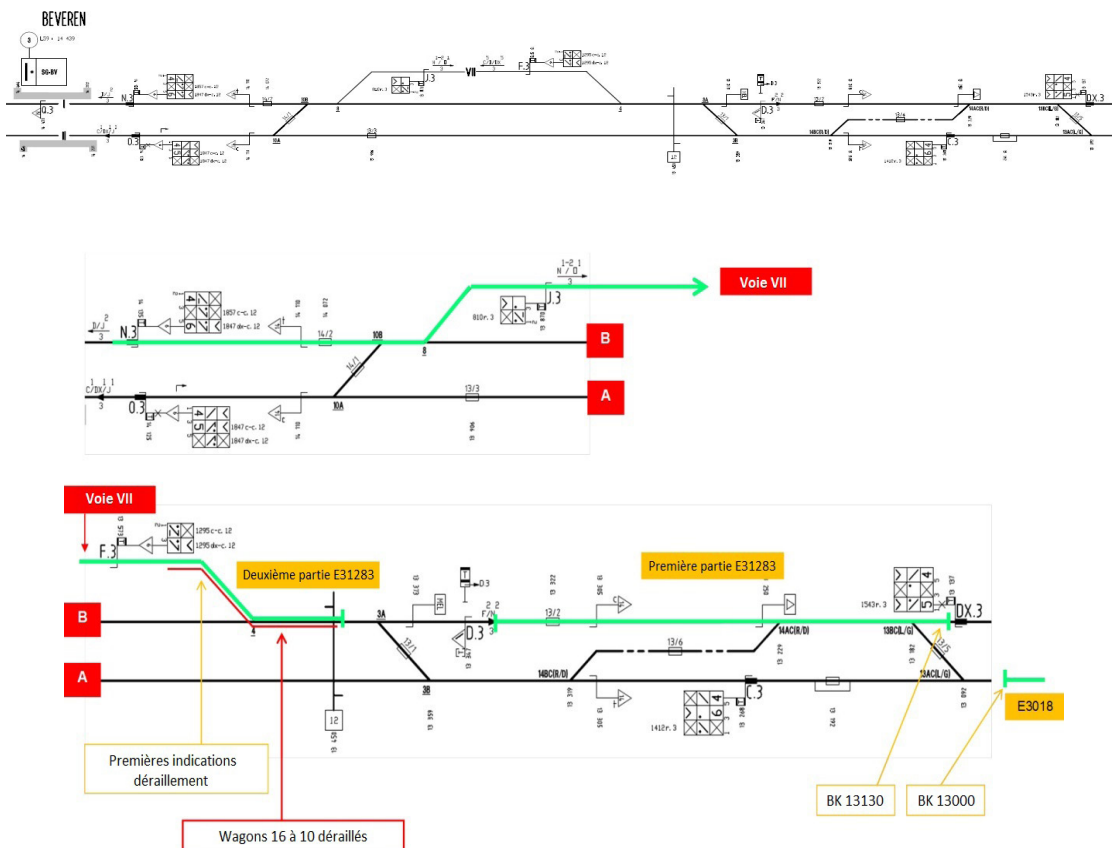
Figure 1: Schematic layout of the signalling with indication of the derailed freight train 31283 and the passenger train E3018
