# Safety Investigation Report

Ref. AAIU-2013-8

Occurrence class	Accident
Occurrence category	Loss of control - ground (LOC-G)
Date and time <sup>1</sup>	Tuesday 23 April 2013 14:00 UTC
Location	Industrial site in Geel 51° 7' 46.50 "N - 004° 57' 1.53"E
Aircraft	Robinson R44
Aircraft category	Rotorcraft - Small helicopter
Location of departure	Industrial site in Geel
Planned destination	Heliport of Diest/Webbekom (EBDW)
Type of operation	Non-commercial - Cross-country
Phase of flight	Takeoff
Injuries	None
Aircraft damage	Substantial

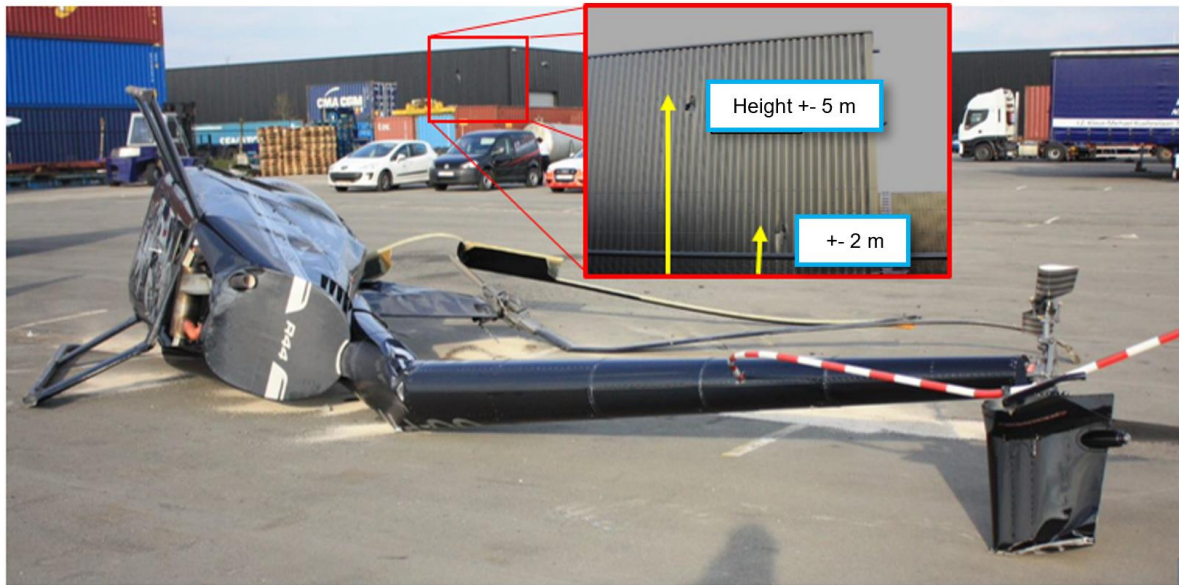
The aircraft sustained substantial damage, considered as being beyond economical repair. Both the fuselage and the tail boom were deformed by the impact. The main rotor mast assembly was displaced slightly forward

The root of the main rotor blades remained attached to the rotor hub and mast assembly but the pitch links of both blades failed due to overload. Both of the main rotor blades were extensively damaged due to bending by impact on the ground. They broke up in several pieces which were ejected away. The tip parts of one blade impacted the wall of an hangar about 90 metres away. The impact of the blades also caused some damage on the asphalt underground.

Figure 1 : helicopter after accident and blade impact damage in hangar

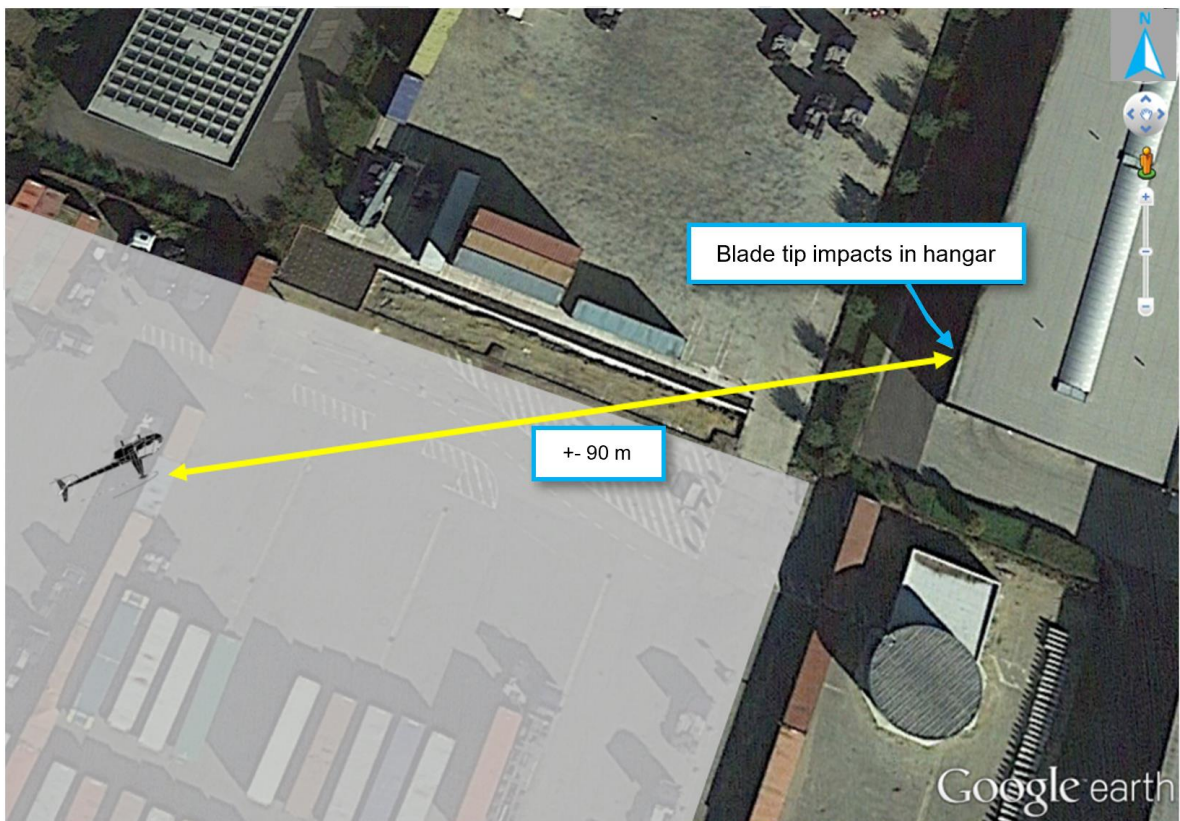
Figure 2 : distance of the blade tip impact and the main wreckage  
(the set-up of the shipping containers is not representative for the situation that day)
