# Safety Investigation Report

Ref. AAIU-2022-04-18-01  
Issue date: 5 September 2023  
Status: Final

## SYNOPSIS

Occurrence class	Accident
Occurrence category	Loss of control - inflight (LOC-I) Low altitude operations (LALT)
Date and time <sup>1</sup>	18 April 2022 08:55 UTC
Location	Ecaussinnes, Belgium 50°33'50.23" N - 004° 9'12.90" E
Aircraft	ELA 09 Junior
Aircraft category	Rotorcraft - Gyroplane
Location of departure	Aerodrome of Buzet (Confluence) EBBZ
Planned destination	Idem
Type of operation	Non-commercial - Cross-country
Phase of flight	Maneuvering
Injuries	None
Aircraft damage	Substantial

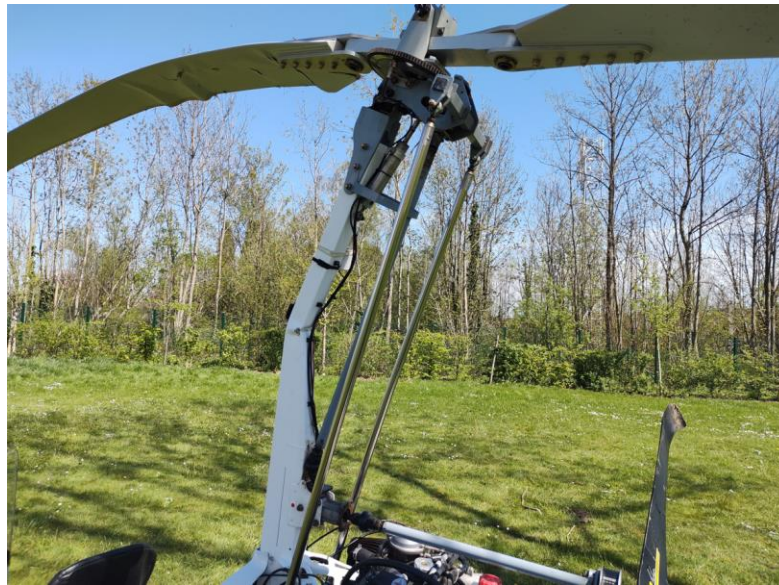
The rotor blades, the mast and propeller blades were damaged by the contact with the tree branches and the subsequent ground impact during the rollover.

Figure 1 : damage to the mast, rotor and propeller blades

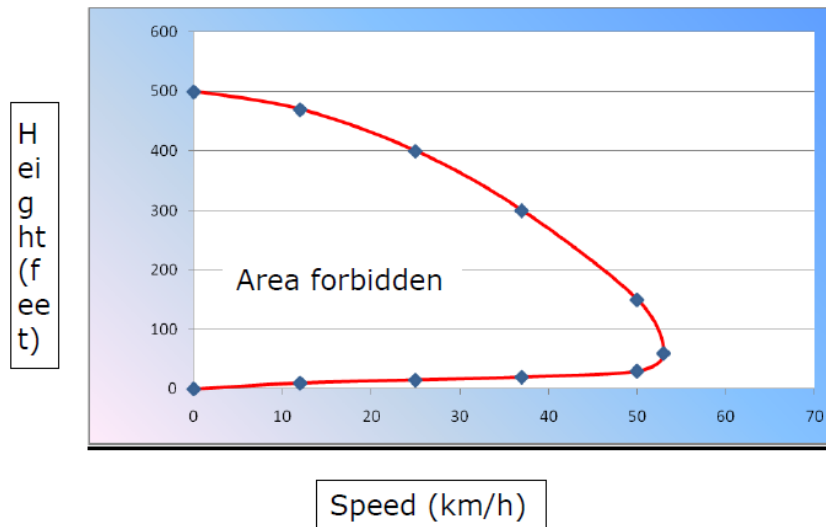
Figure 3 : Height/speed envelope from the flight manual

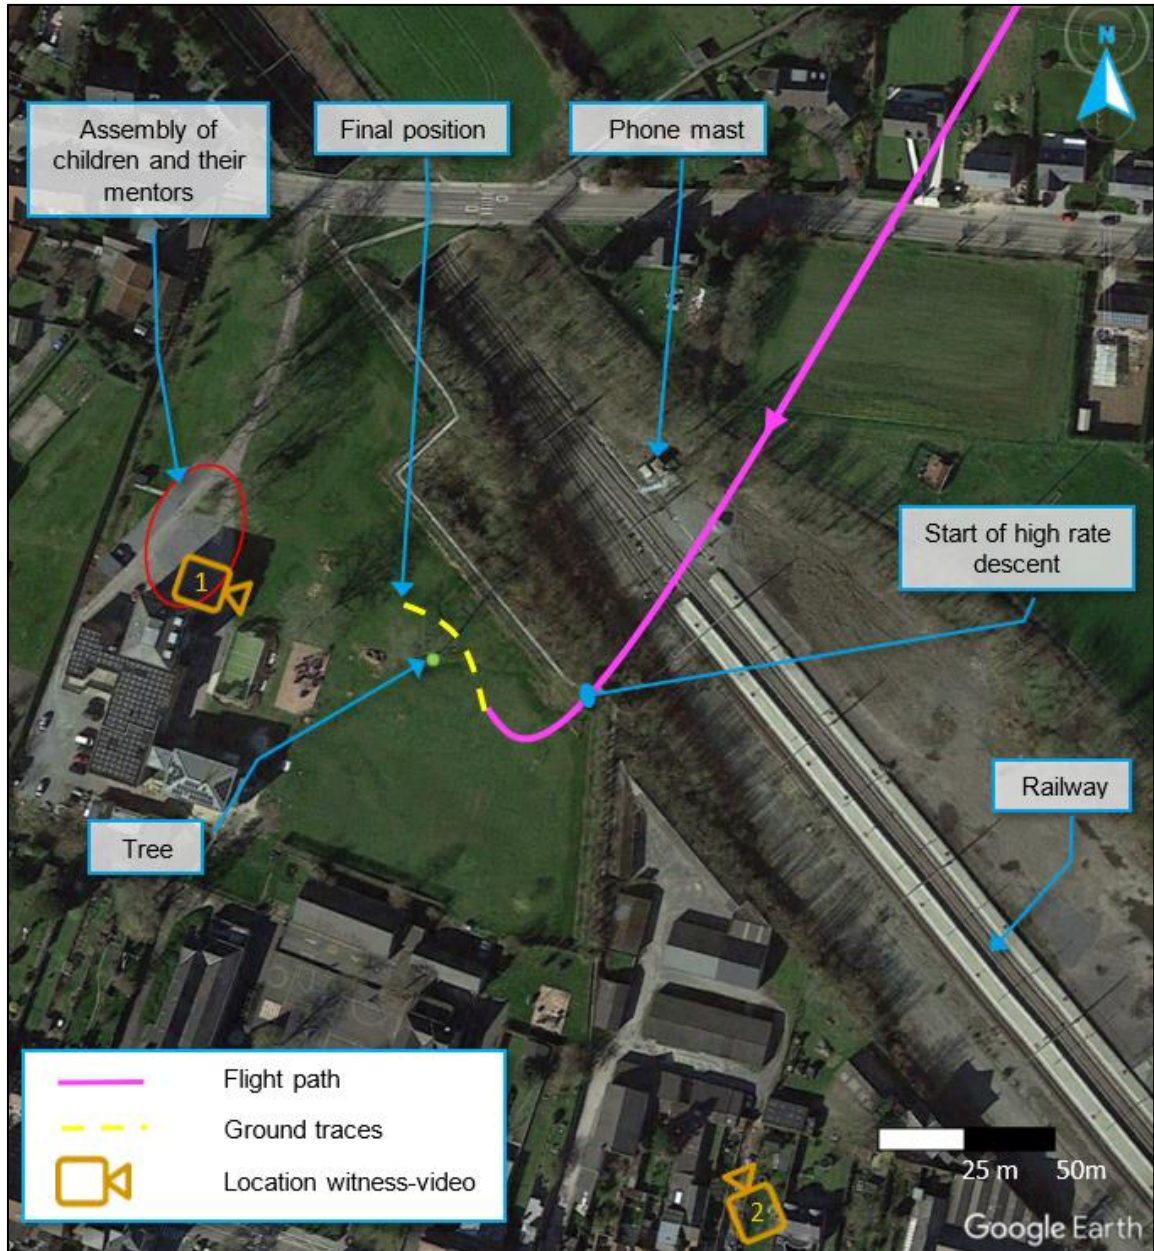
The aircraft was not equipped with any flight recorder, nor was it required by regulations. However, the final portion of the flight was filmed by by-standers with a smartphone. Their position is indicated on Figure 6.

Figure 6 : reconstructed flight path based on pilot's statement and video-recordings of eye-witnesses

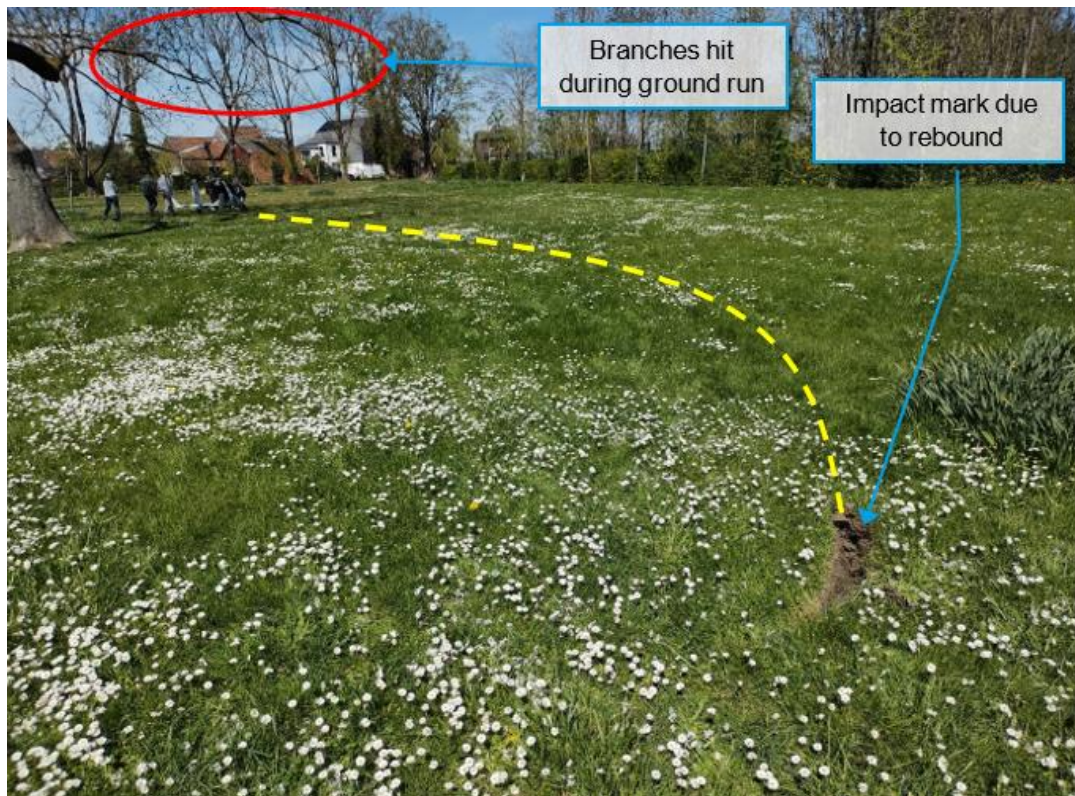
Distance between point of first touchdown and final position was about 30 meters

Figure 7 : ground path

The second ground impact due to the rebound left a 10 cm deep ground trace.

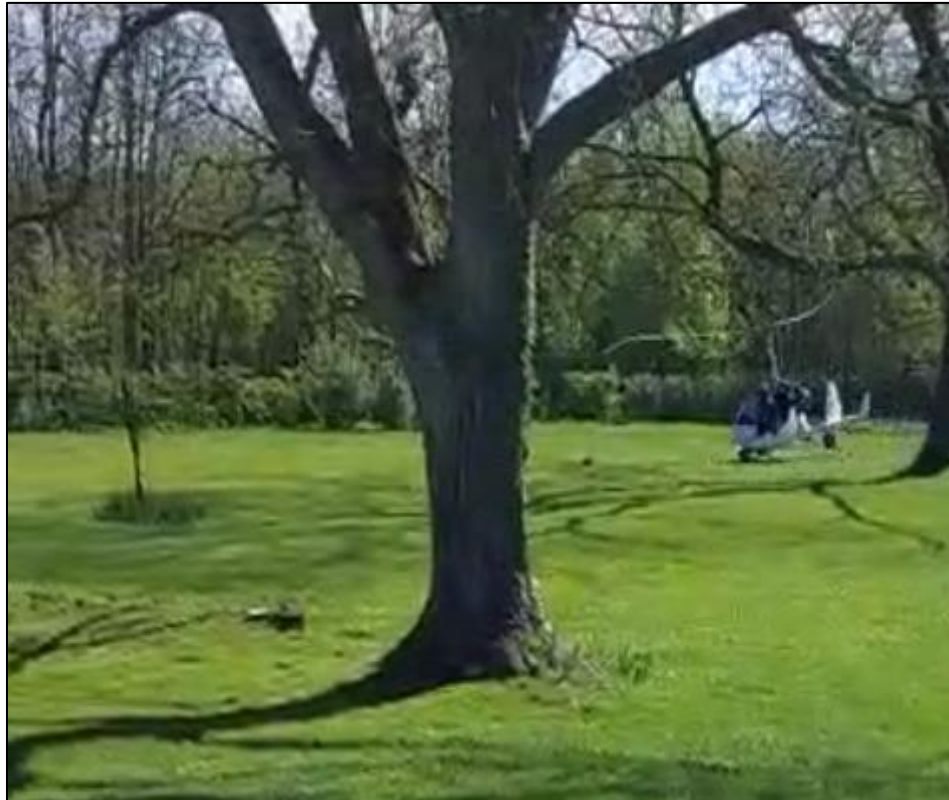
Figure 8 : gyroplane after rebound and touching the tree's branch. Video taken from location #1 (see Figure 6)

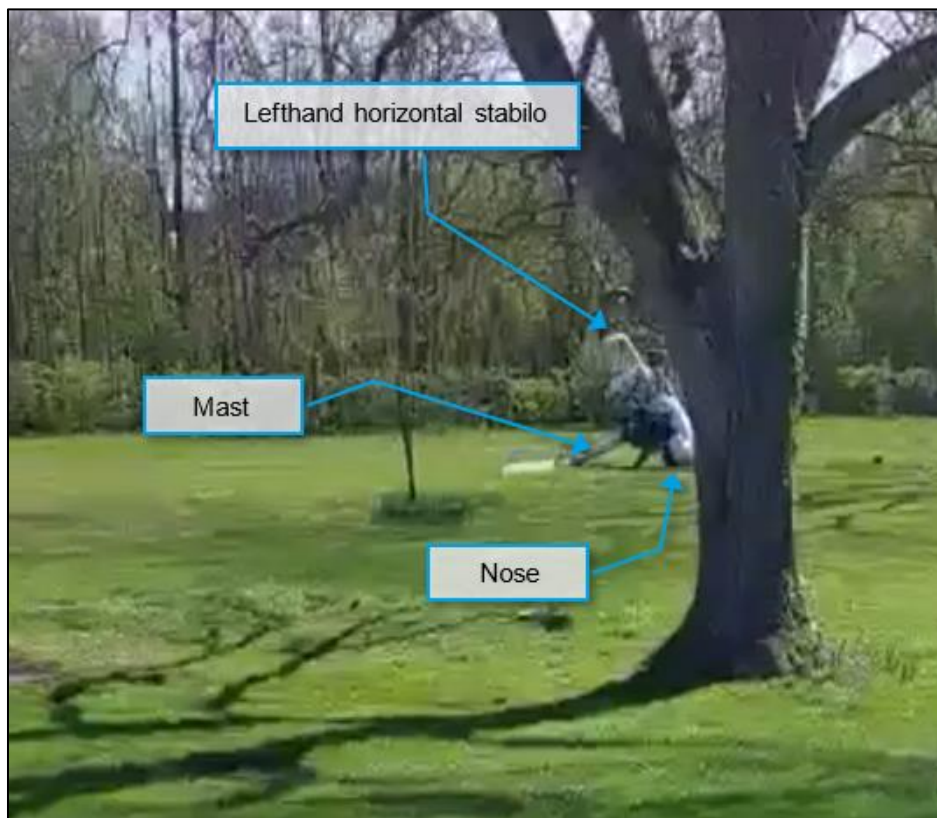
Figure 9 : Final position of the gyroplane, laying on its right hand side

Both occupants wore their seat belts and none were injured when the aircraft fell on its right side.

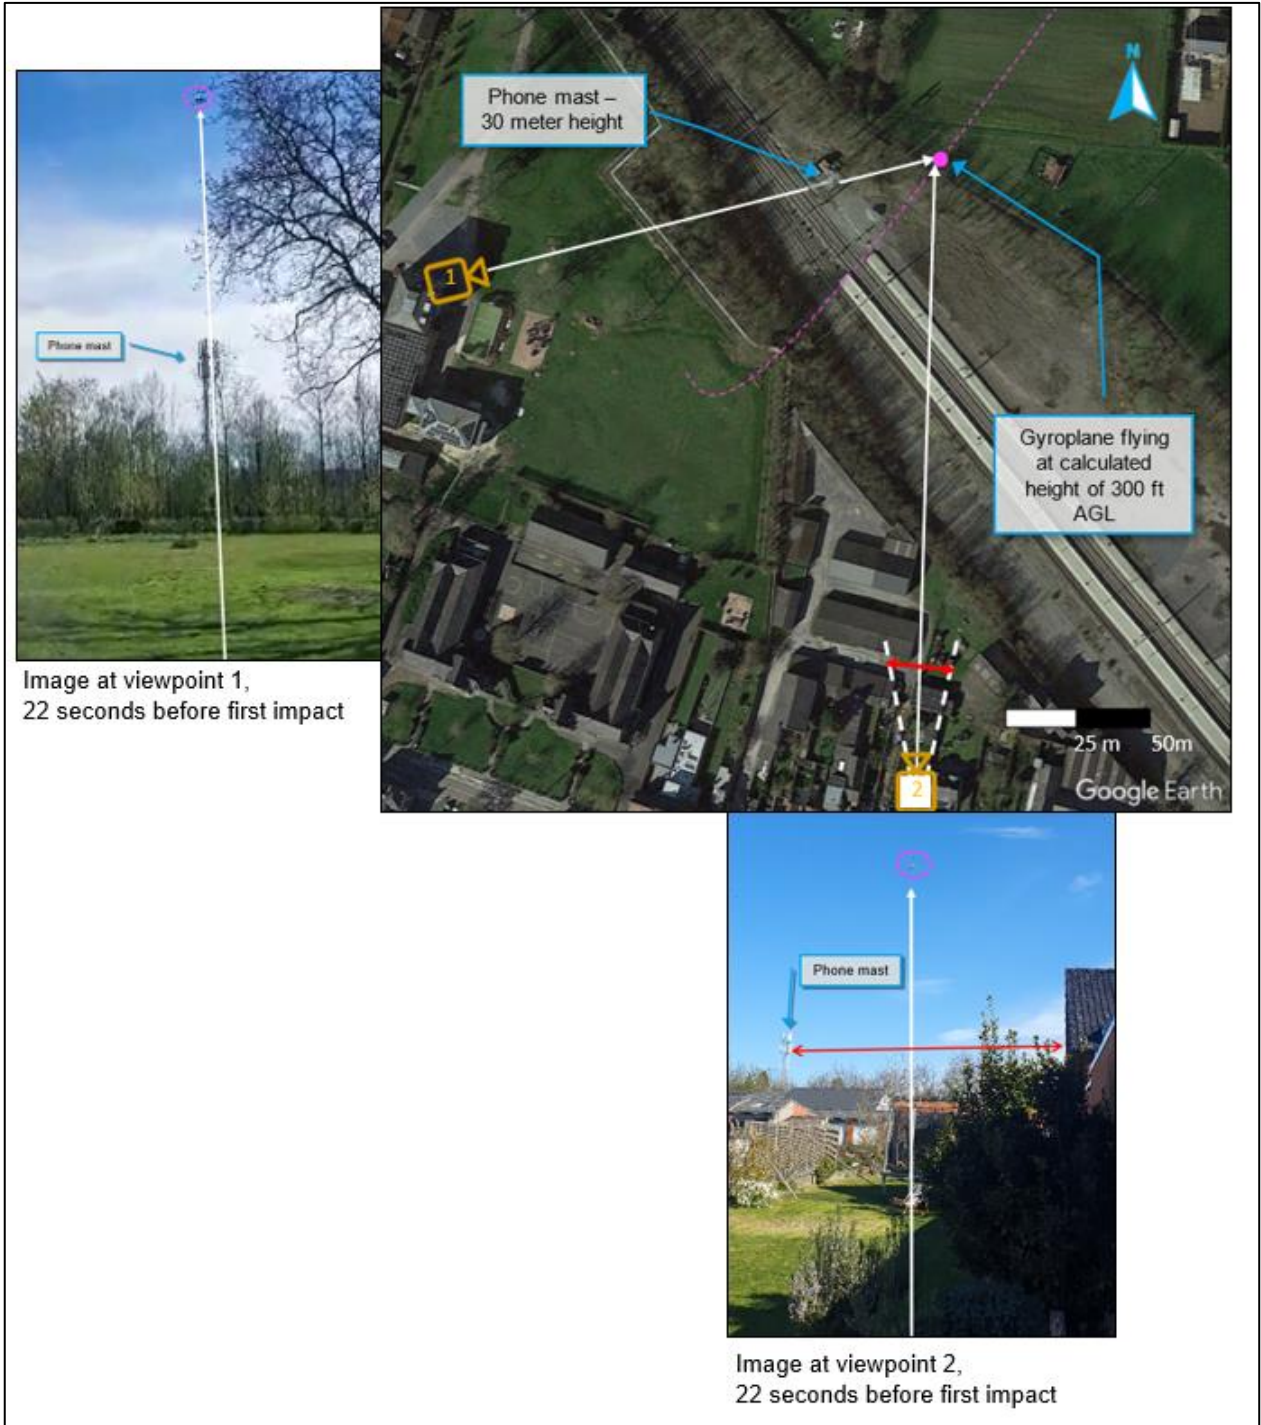
At 22 seconds before that first impact, a phone mast - of which the height is known, being 30 meters - was clearly visible on both recordings. Via measurement and triangulation, the height of the gyroplane was at that moment calculated as already being 300 ft AGL (650 ft AMSL).

Figure 10 : Determination of position and height above ground based on 2 video recordings

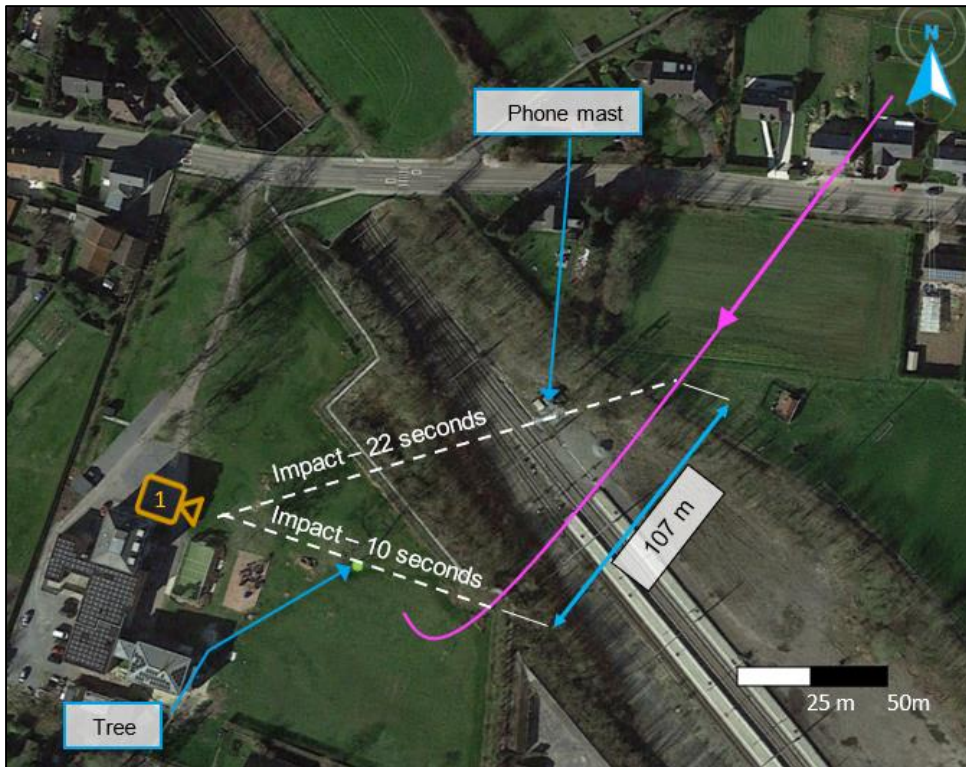
Based on the video #1 recordings, the travelled distance on a time interval could be measured and hence the speed calculated. The first position was when the gyroplane was lined up with the phone mast (time: impact – 22 seconds) and the second position when the aircraft was lined up with the trunk of the tree in the garden (time: impact – 10 seconds). It was measured that the gyroplane flew a ground path of 107 m in this 12 seconds interval, giving a groundspeed of 32 km/h. With a headwind component of 5 kt/ 9 km/h this results in an average airspeed of 41 km/h at that time (so close to or at the minimum level flight speed).

Figure 11 : calculation of travelled distance

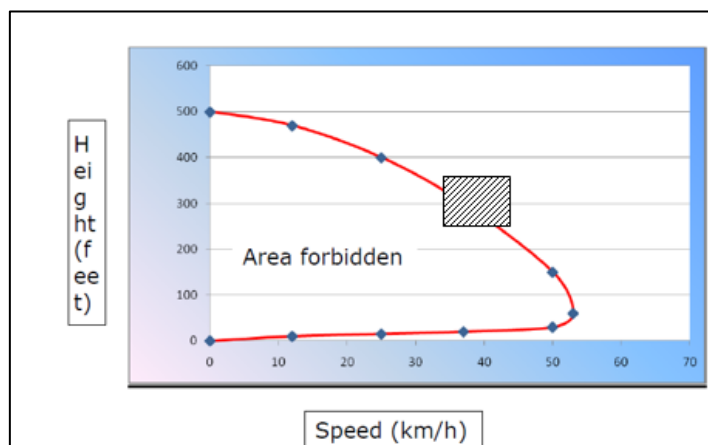
Taking into account some accuracy errors, it is acceptable to state that the gyroplane was flying in the dashed zone on the height-velocity diagram, so close to or even in the so-called 'forbidden area'.

Figure 12 : gyroplane was flying in dashed zone before loss of power and steep descent

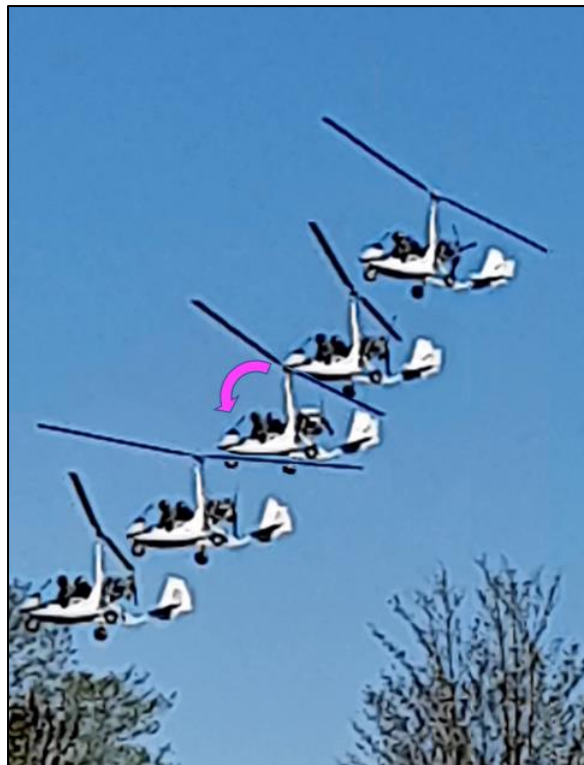
It is seen that at 4 seconds before impact and from the video estimated at about 100 ft AGL, the nose is slightly lowered, however the gyroplane was already too close to the ground to regain sufficient airspeed.

Figure 13 : nose pitching down at 4 seconds before impact. Video taken from location #2 (see Figure 6)

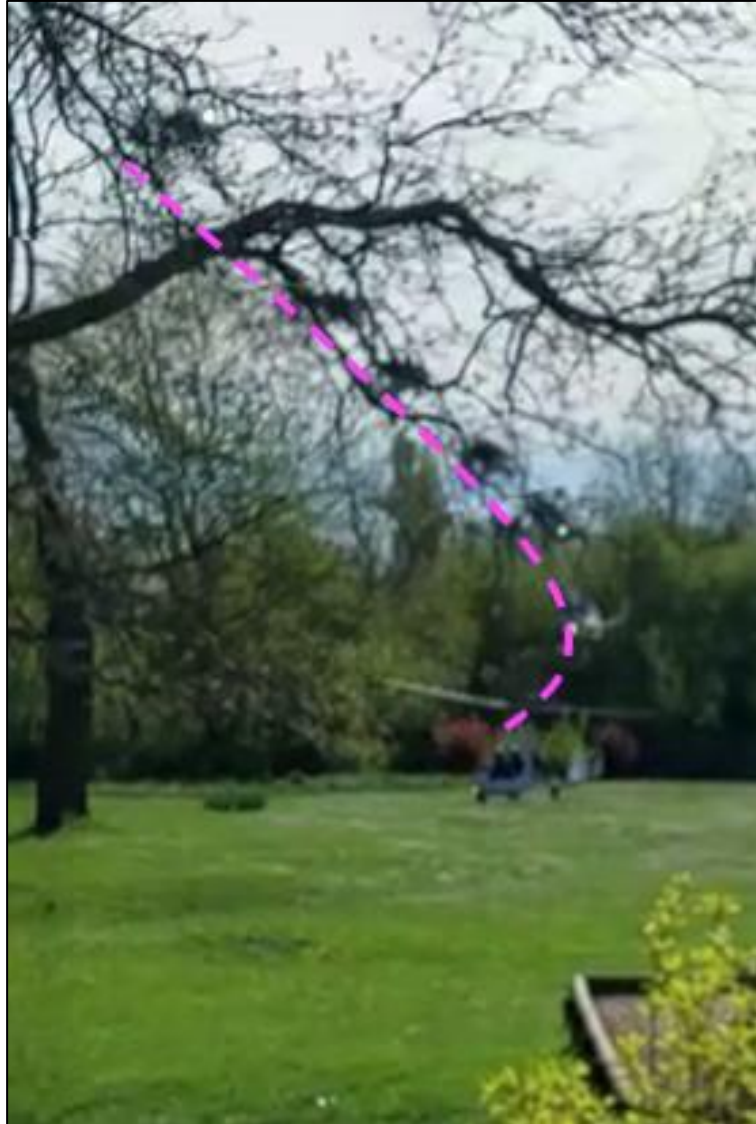
**Figure 14 : Showing descent, righthand turn and first touchdown.  
Video taken from location #1 (see Figure 6)**

The only option left was to land in the garden of the orphanage. At the end of the descent, he turned right before touching down with a rather high vertical speed, causing the gyroplane to bounce. During the landing run, due to the engine running at high power setting, the rotor blades hit a low hanging branch of a tree.

Because the engine was powered up before touchdown and throttle wasn't brought back to idle, there was still some excessive thrust left, causing an acceleration and quite a violent impact due to this acceleration.
