Safety Investigation Report

Ref. AAIU-2022-07-19-01
Issue date: 21 February 2023
Status: Final

Occurrence class	Serious Incident
Occurrence category	Loss of control - ground (LOC-G) Runway excursion (RE) - veer off
Date and time ¹	Tuesday 19 July 2022 07:10 UTC
Location	Airport of Kortrijk-Wevelgem (EBKT)
Aircraft	Europa (Classic)
Aircraft category	Fixed wing - Small aeroplane - Amateur-built
Location of departure	Brickwall Farm Airstrip, UK (ICAO: GB-0929)
Planned destination	Airport of Kortrijk-Wevelgem (ICAO: EBKT)
Type of operation	Non-commercial - Cross-country
Phase of flight	Landing
Injuries	None
Aircraft damage	Minor

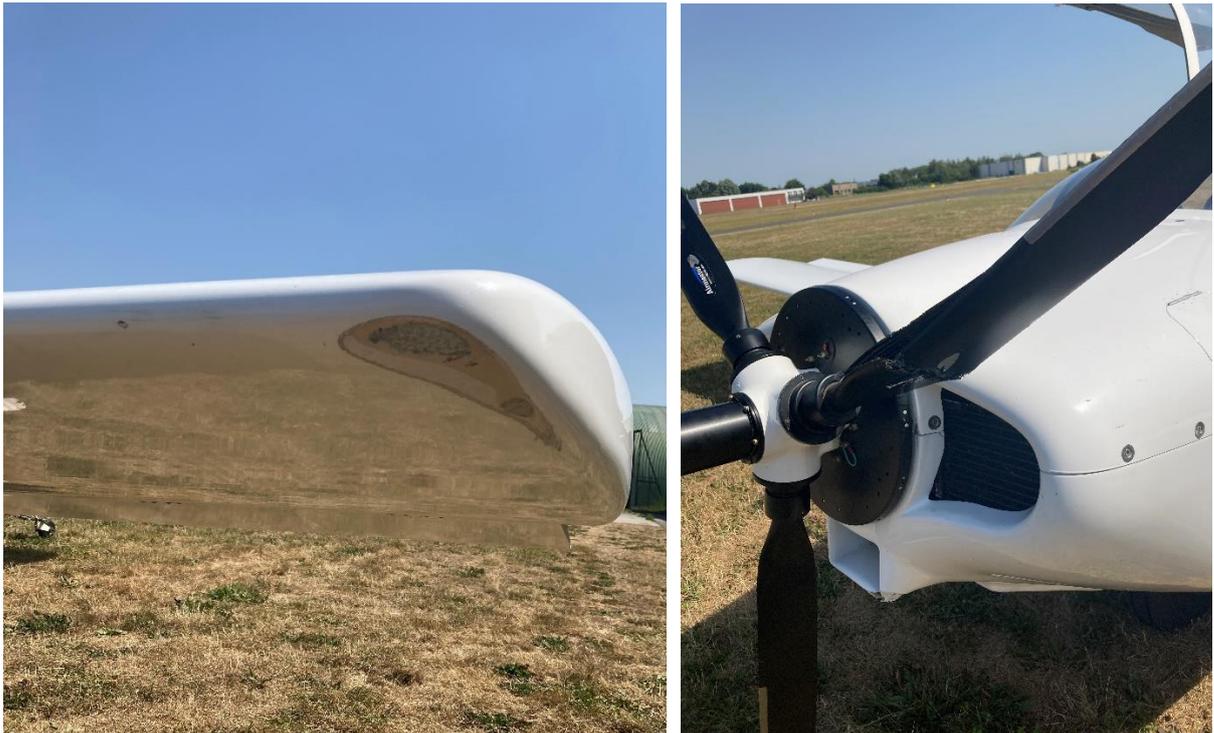
Upon landing on the runway 06 at Kortrijk during the ground run the aircraft began to swing. In hindsight, the pilot believes that he over corrected with rudder input and simultaneously pulled on the brake which exacerbated the swing to the right. This caused the aircraft to swing through 90 degrees, tipping on to the left wing tip and pitching forward breaking the propeller and causing a scrape on the

Limited to broken propeller and scratches on cowling and lower left wing.
No damage to other objects.

Figure 1 : Pictures of the damage taken when aircraft removed from the runway
