Preliminary Safety Investigation Report

Ref.:
AAIU-2026-02-05-01
Status:
Preliminary
Issue date:
06 March 2026

**SERIOUS INCIDENT
A320 NEO
AT BRUSSELS AIRPORT
ON 05 FEBRUARY 2026**

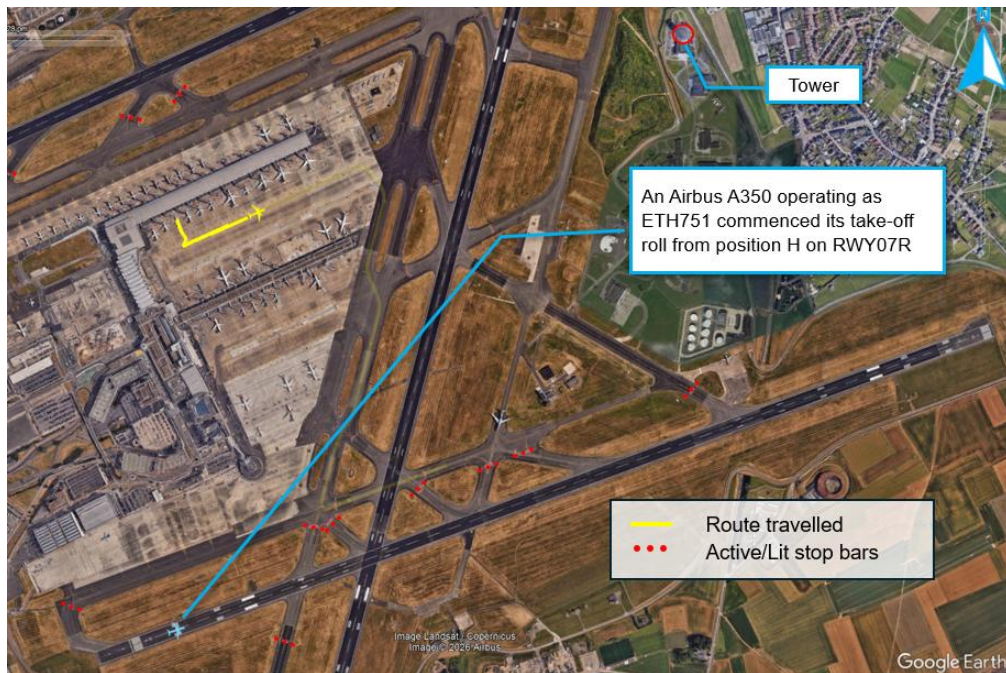
Figure 2 : 20:59:46 last departure from RWY07R before SAS43M

At 20:59:46, an Airbus A350 operating as ETH751 commenced its take-off roll from position H on Runway 07R. This was the final departure from Runway 07R prior to SAS43M. At that moment, SAS43M was still taxiing on taxiway R4, between Apron 1 South and Apron 2 North.

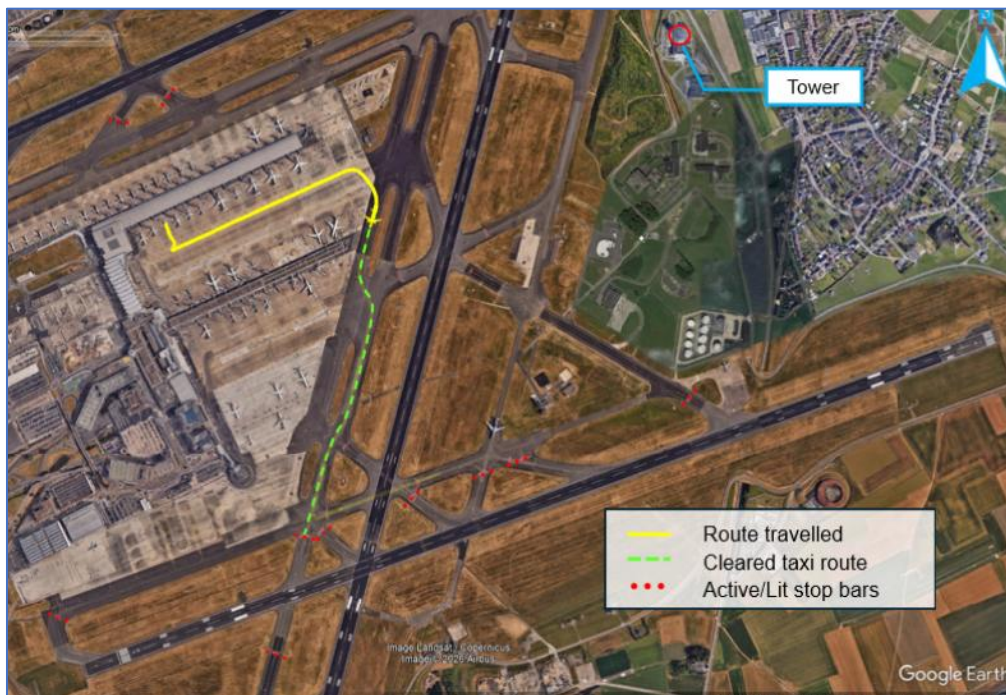
Figure 3: 21:01:09 New taxi clearance to C6

At 21:00:11 during taxi, the cabin crew notified the flight crew that they were ready for departure. This was followed by the execution of the taxi checklist at 21:00:43. The flight crew then discussed the possibility of requesting the intersection departure from Runway 07R to save time. Shortly thereafter, at 21:01:09, Brussels Tower independently proposed this option by asking, "Scandinavian 43M able C6?". Following the crew's confirmation, ATC issued a revised taxi clearance routing the aircraft via taxiway Outer toward intersection C6.

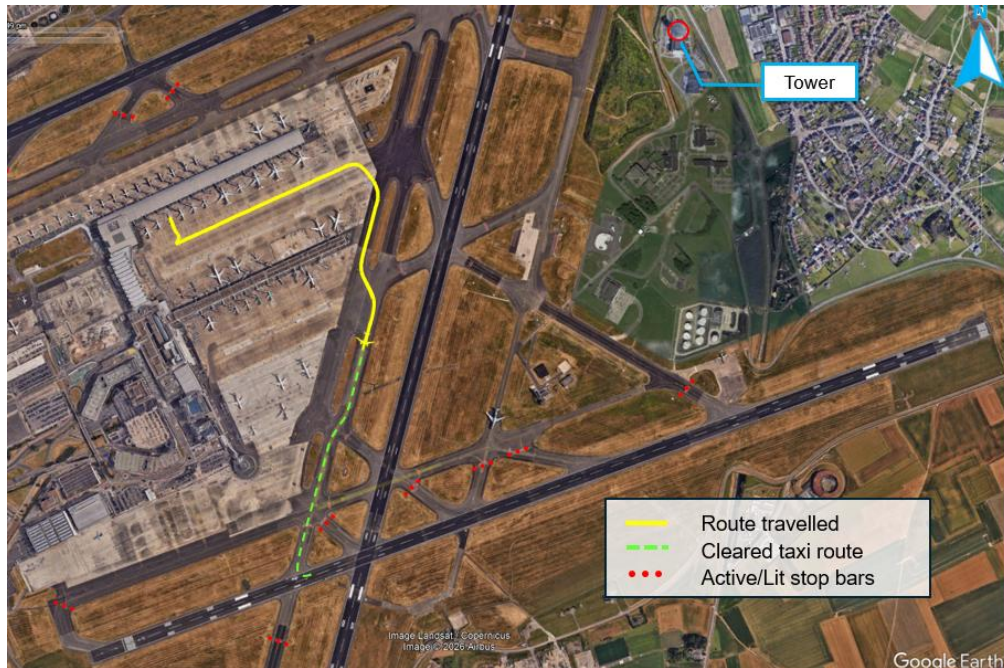
Figure 4 : 21:02:05 Line-up clearance, stop bar at C6 extinguishes

At 21:02:05, when the aircraft just entered taxiway Outer 9, the flight crew received the instruction "Line up and wait." At that time, the red stop bar at holding point C6 was extinguished. The captain remarked in the cockpit, "And then the red line disappeared."

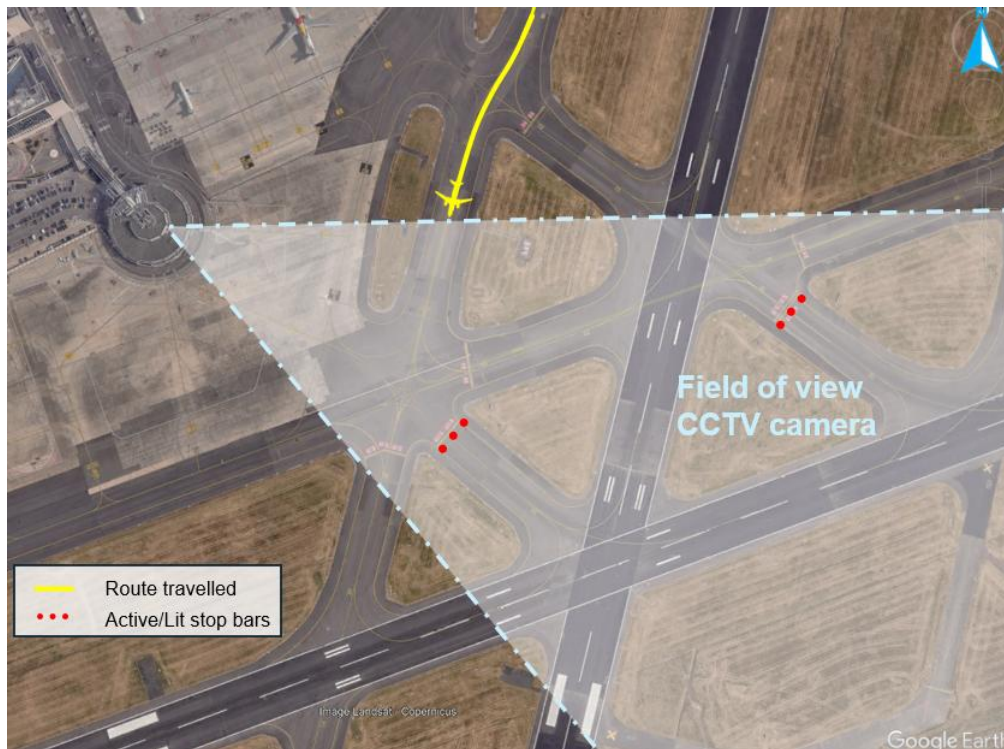
Figure 5 : 21:02:52, SAS43M still on taxiway Outer 10, starting line-up checklist

At 21:02:52, roughly 45 seconds later, the aircraft had entered Outer 10, which the crew apparently mistook for Taxiway C6. The captain stated, "We are at Charlie six and we are cleared to enter. Entering active - clear left," and the first officer responded, "Clear right."

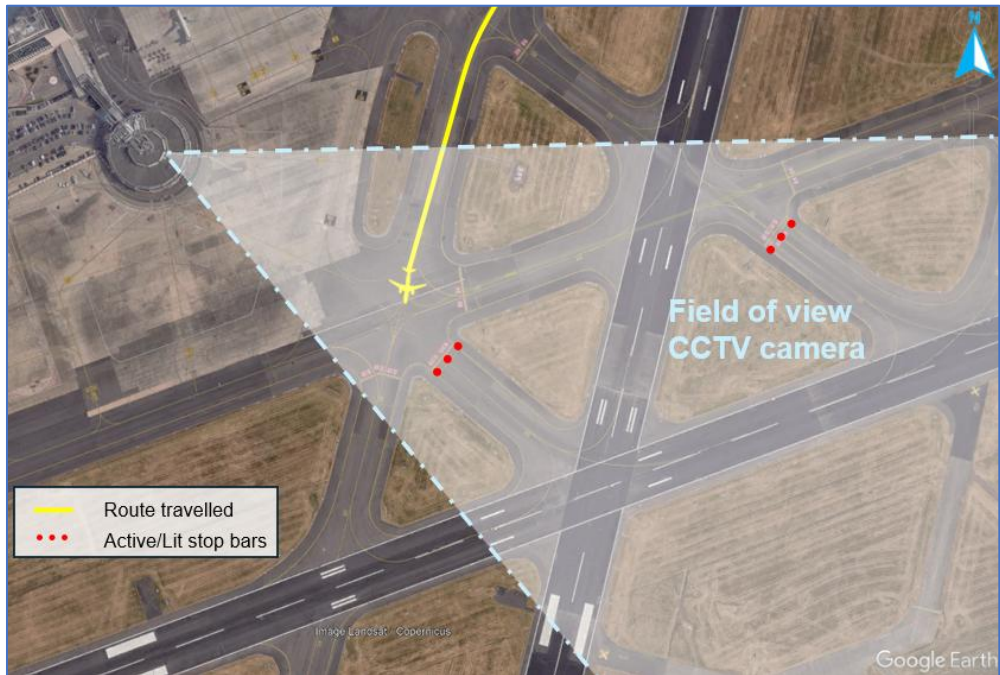
Figure 6 : SAS43M at 21:03:16 when receiving take-off clearance

A left turn toward Taxiway E1 was just initiated when, at 21:03:16, the crew received the take-off clearance. At that moment, the aircraft was on a heading of 186° (while the Outer Taxiway follows a heading of 194°).

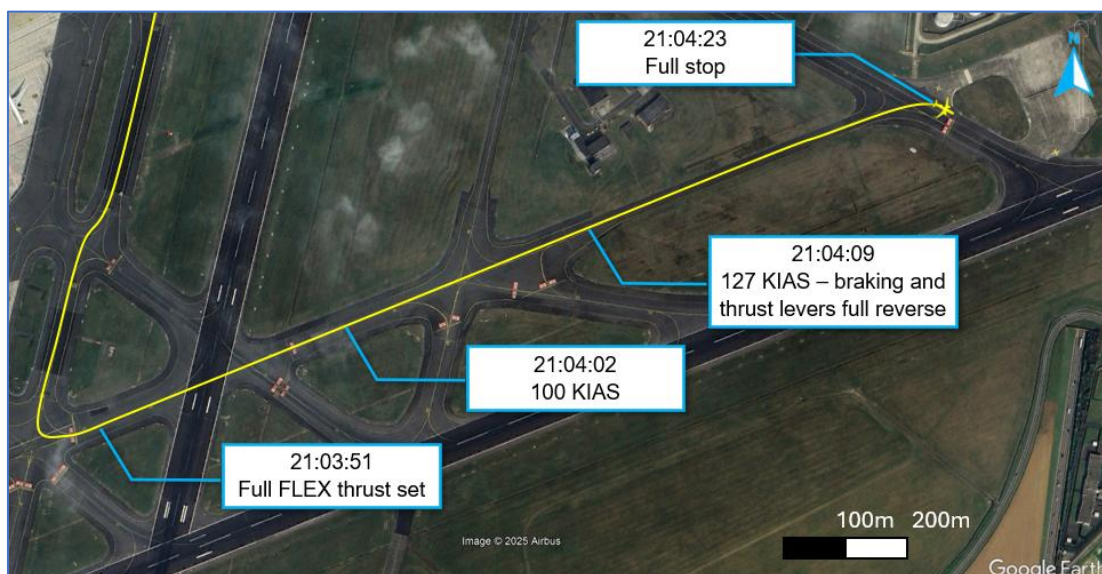
Figure 9 :different stages of the attempted take-off

At 21:04:02, the aircraft passed 100 kt IAS. The first officer made the "100 knots" callout, a critical crosscheck that verifies both pilots' airspeed indications are consistent and signals the transition from the low speed to the high speed regime. The captain, having observed that the forward view appeared increasingly narrow, did not respond immediately.

The first officer later reported finding it unusual that the captain did not respond in accordance with SOPs, as normally expected. The first officer looked outside and immediately recognized that the aircraft was not on a runway. The first officer stated, "No, this is wrong," and subsequently issued the command, "Stop, stop, stop, stop." The captain initiated the stop almost immediately.

At 21:04:09, the thrust levers were moved to full reverse, and braking was applied. At this moment, the aircraft had reached 127 kt IAS. Observing the end of the taxiway and a fence approaching, the first officer instructed a right turn.

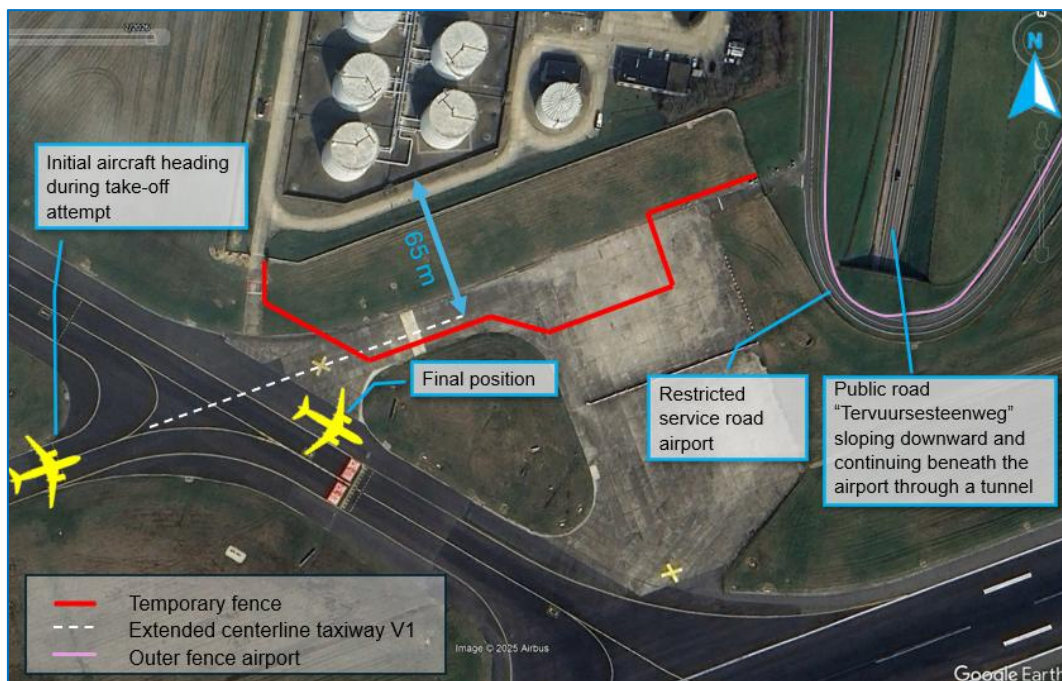
Figure 10: sketch of the final position of the aircraft

After initiating a right turn, the aircraft eventually came to a stop on a section of asphalt pavement adjacent to the taxiway edge at the intersection of taxiways V1 and C1, on a heading of 120°, with the nose gear coming to rest a few meters away from the runway guard lights. Behind taxiway V1 was tarmac P5, which was fenced off due to planned construction works. At a distance of 65 meters from the centerline of this taxiway is the airport's fuel station.

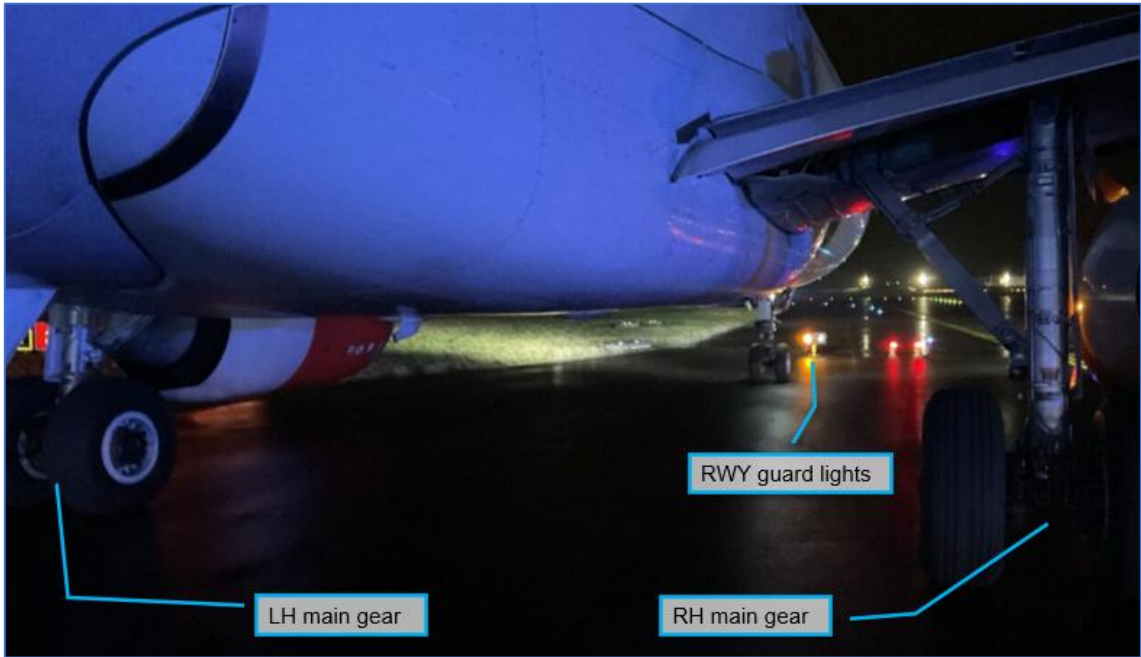
The initial intention of the flight crew was to taxi the aircraft back to the gate. However, following consultation between the crew, airport operations, and the ARFF, it was decided that the passengers would be disembarked on site and the aircraft would be towed. Although no impact had taken place, the nose landing gear was positioned immediately in front of the runway guard lights (wigwags) left of the stop bar at C1 (see also Figure 11), which required removal prior to towing.

Figure 11 : Photo taken from behind, a couple of minutes after the incident (source: Brussels Airport Company)

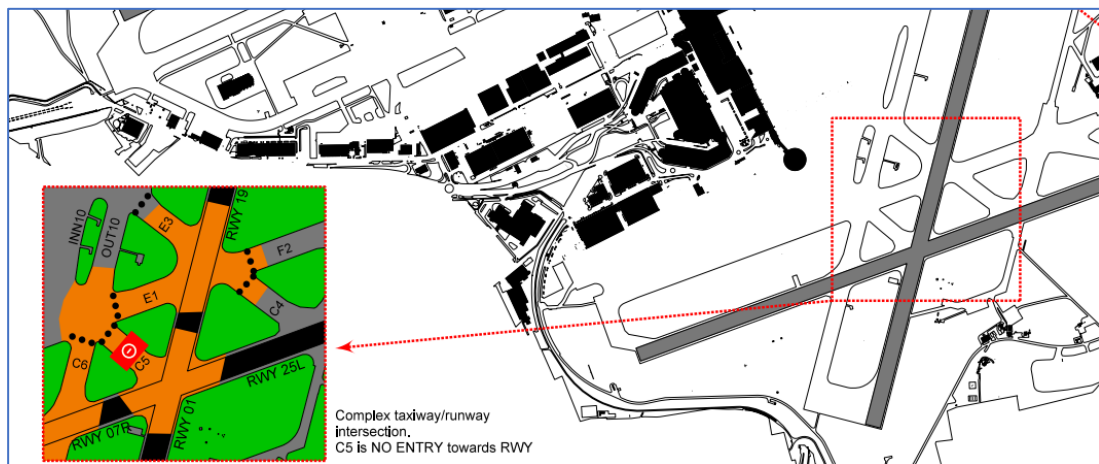
Figure 20 : extract of AIP Hot spots chart (reference AD 2.EBBR-GMC.05)

The intersection involving Outer 10, E1, C5, and C6 has been identified and depicted as a hot spot. This designation reflects its longstanding status as a complex taxiway–runway junction requiring increased vigilance.

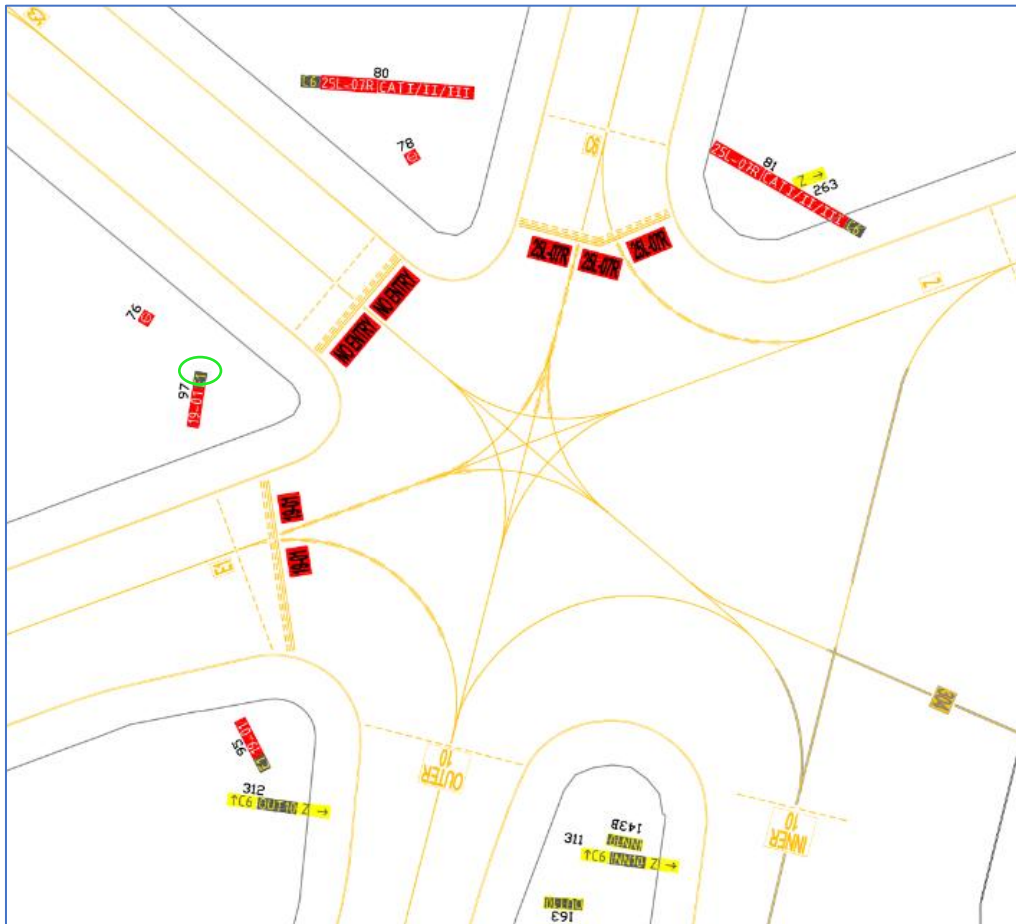
Figure 25 : indication of the signs (green encircled) and painted markings at intersection Outer 10-E1-C5-C6. The light of the information sign “E1”- highlighted in green - was not operational at the time of the event.

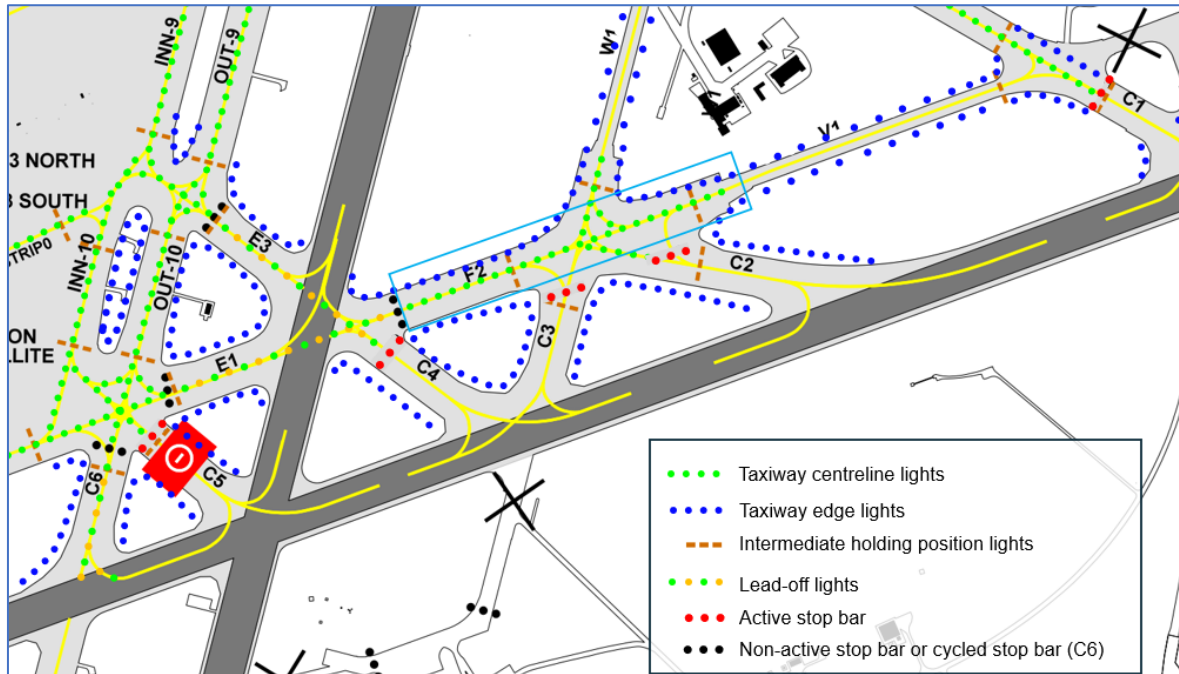
The last manipulation of the TWY lights was around 16:37 when all TWY lights were turned on at intensity level 1, the lowest level which is reportedly standard practice during clear weather conditions.

Figure 26 : sketch reflecting the situation of the taxiway centreline markings and active lights at time of the event (runway lights not included). All lights are LED except for taxiway F2 (highlighted in blue), which are halogen.
