**FINAL REPORT ON THE ACCIDENT
TO THE EUROCOPTER AS355 F1
REGISTERED OO-HSH AND THE
AGUSTA BELL AB206A REGISTERED
OO-SKE IN ANTWERP ON JUNE 25TH
2006**

Ref. AAIU-2006-04-Antwerpen-HSB
Issue date: 23 February 2009
Status: FINAL

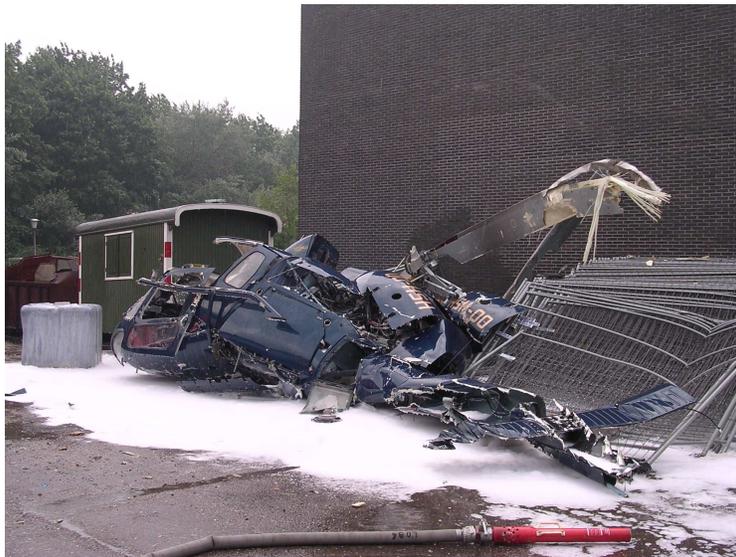
Figure 2: OO-HSH

Both helicopters were completely destroyed.

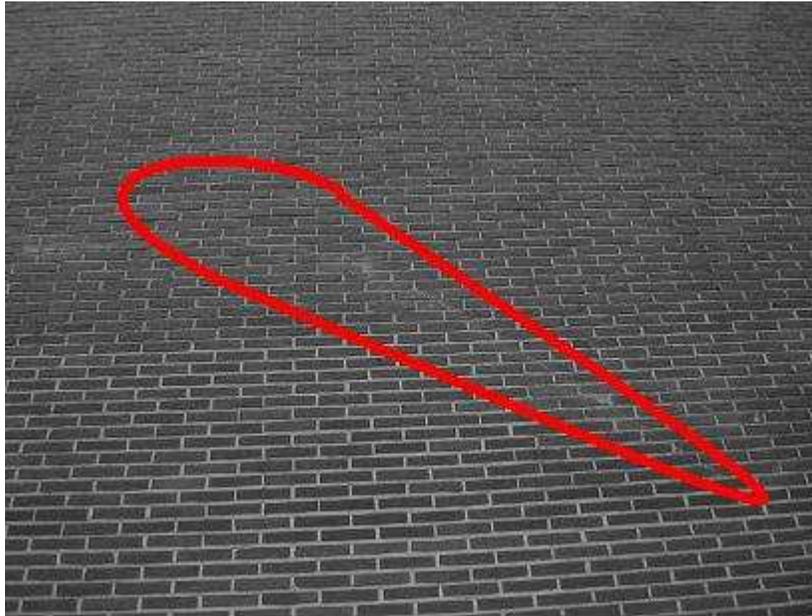
Figure 4: Building wall

The broadcasting equipment of the Belgian broadcasting company (camera, emitters, receivers, ...), on board of both helicopters was destroyed. The wall of the building on which OO-HSH impacted, was slightly damaged (scratched by the main rotor blades).

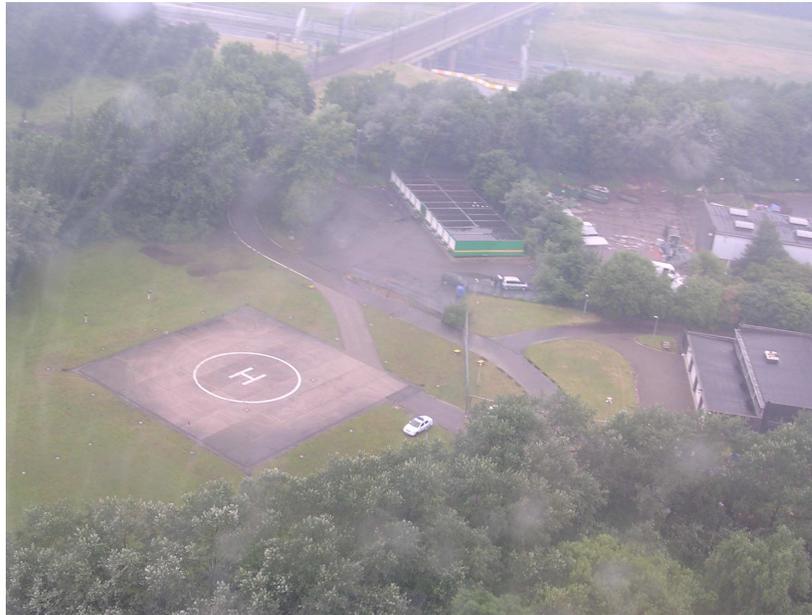
Figure 5: Overview of heliport

The heliport has two main take-off axes:

- 090° (MAG) with no obstructions.
- 270° (MAG) with 15% obstructions.

The heliport does not comply (section 2.2) with the ICAO/Belgian requirements for a permanent heliport, which needs at least two take-off axes without obstructions (Royal Decree 24/12/1970).

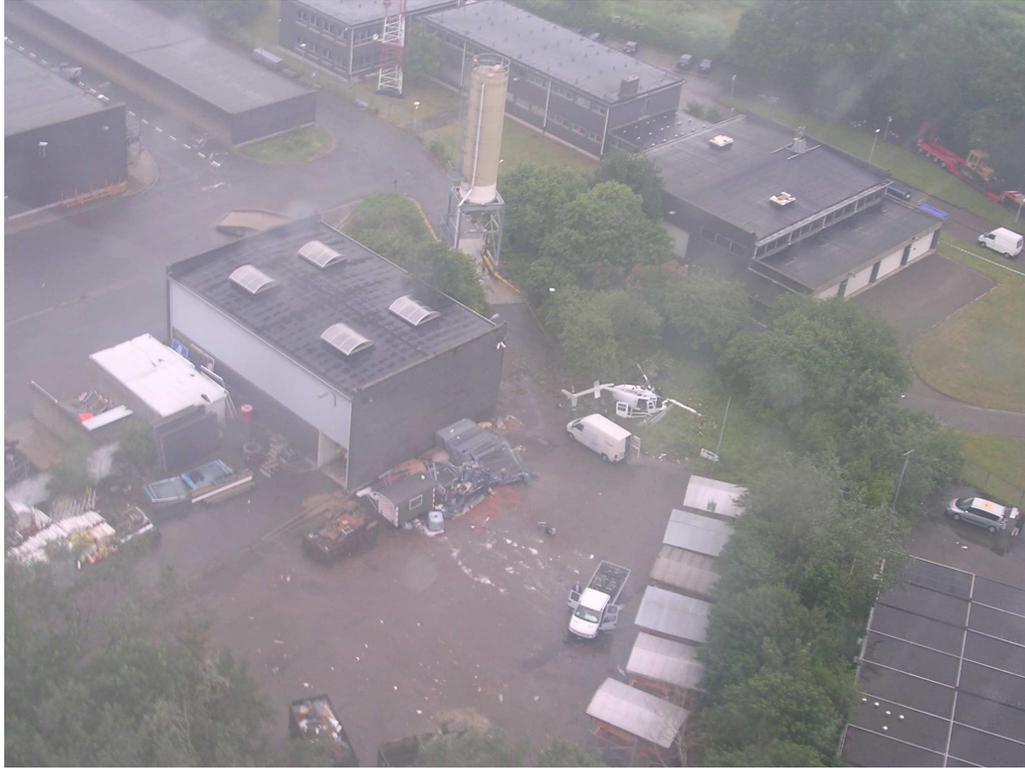
Figure 7: Wreckage distribution 1

Inspection of the wreckage of both helicopter showed that all damages were caused by either the collision of both helicopters, or the impact of the crash (for the OO-HSH). No evidence of failures or damages dating from prior to the accident was found.

Several pieces of debris were found scattered on the site. The lower piece of the tail boom section of the OO-HSH was found at a distance of approximately 50m from the wreckage. Also the tail rotor and the vertical fin of the OO-HSH were severed found at a distance of about 20m from the wreckage.
