## Investigation Report.

Status: **Final**  
Date: **27 JAN 08**  
Time: **11.30 UT**  
Type: **Piper PA 18-150 (180 HP)**  
Operator: **Royal Verviers Aviation**  
Registration: **OO-OAW**  
C/N : **4828**  
msn : **18-5346**  
Manufacturing Date: **1957**  
Engine(s): **Lycoming O-360-A4P**  
Crew: **Fatality: 0 / Occupants: 1**  
Aircraft Damage : **Total Loss**  
Location: **EBTX.**  
Phase: **Landing.**  
Nature: **Aerial works, glider towing**  
Departure Airport: **EBTX**  
Destination Airport: **EBTX**  
Flight Number: **N/A**

REF: AAIU (Belgium) 2008-3.

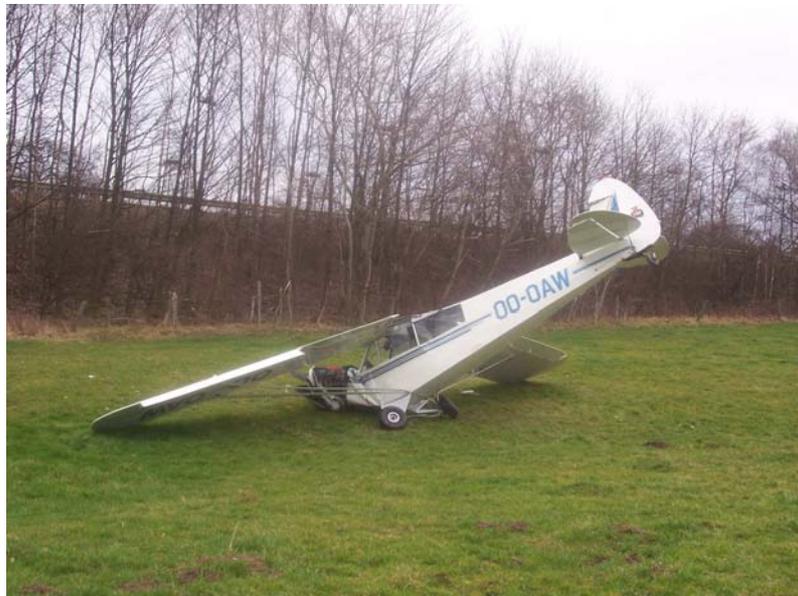
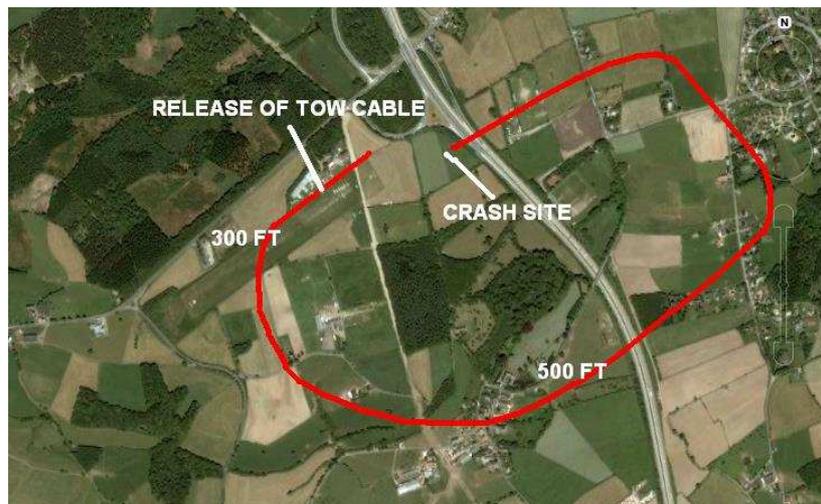
**Flight Path**

The aircraft, at that point, was going down, aiming at the tree line bordering the airfield.

The pilot tried to reduce the speed as much as possible, in the hope of going through the tree tops without too much damage.

Upon hitting the tree, the left wing hit a bigger tree trunk, and the aircraft veered to the left. All efforts of the pilot to keep the aircraft straight were unsuccessful. The aircraft rotated 180° during its fall down and crashed on the nose and undercarriage five meters behind the tree line.

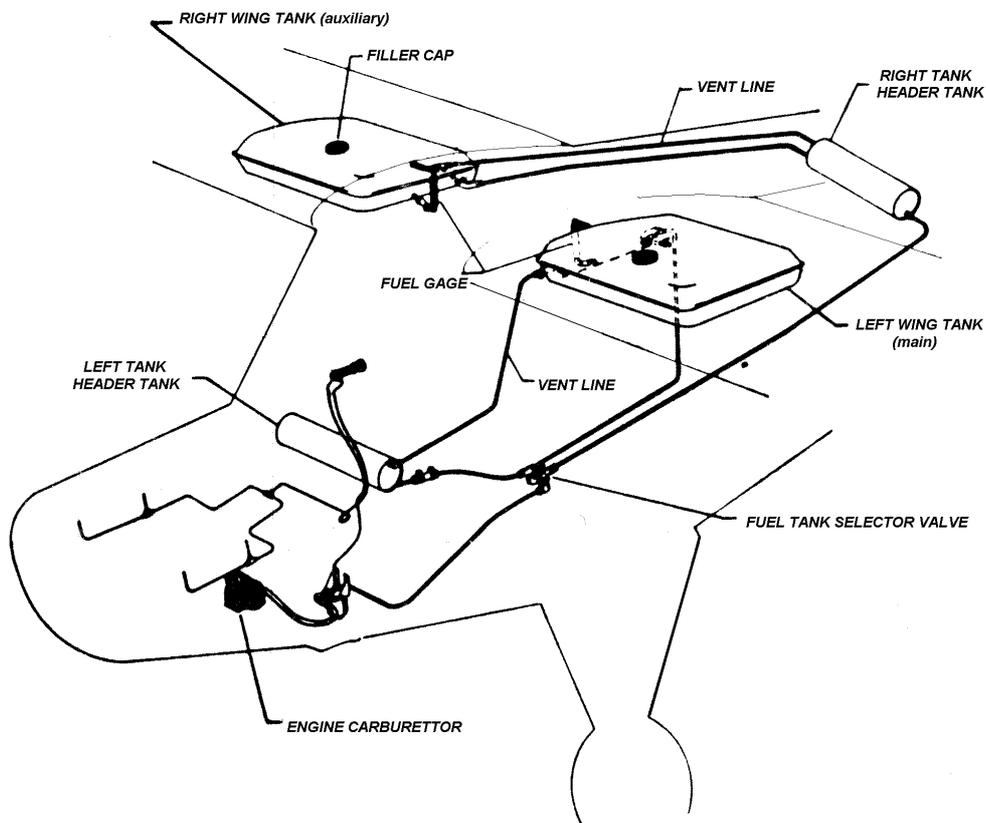
### Aircraft Fuel System

The Piper PA-18 is equipped with 2 Fuel Tanks (capacity 18 USG). A small (approx. 2 quarts) header tank which serves to maintain constant fuel flow regardless of the normal attitude of the airplane is included in the installation of each fuel tank. The header tank for the left fuel tank is located forward of the instrument panel; for the right tank it is concealed behind the rear seat.

Fuel indicator gauges are installed in the upper cabin panels, and are visible from either seat. The fuel tank selector valve is mounted on the left cabin panel near the front seat.

The engine is fed through a line going from the fuel tank selector valve to the carburettor.

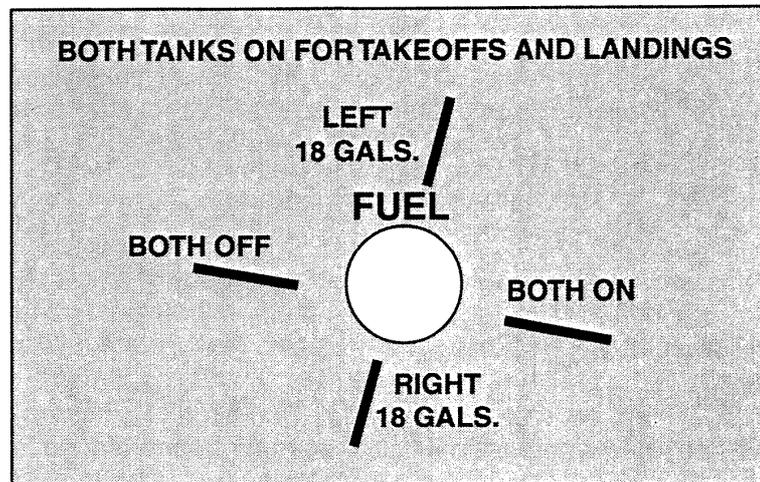
**For the STC fitted on OO-OAW**, (Penn Yann Aero Service, FAA STC SA-00035-NY), the changes to the fuel system include:

- modifying the Fuel Filler Caps of both tanks (vented caps)
- modifying the Fuel Selector Valve, to interconnect the left and right fuel tank, to create a "both tank" selection for feeding the engine.

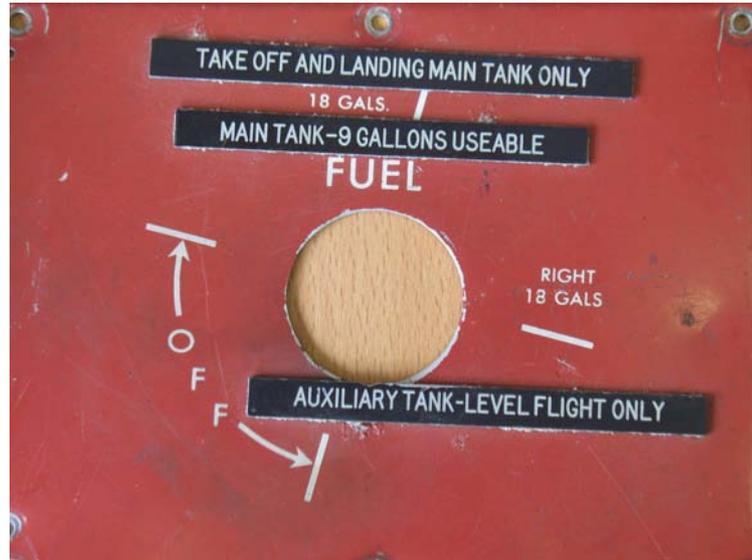
**For the other STC** (David Johnson FAA STC SA36RM) the changes to be introduced in the fuel system are evenly important. These changes include:

- improving the fuel flow coming from the LH Fuel Tank, by replacing the 3/8" fuel line of the LH fuel tank by a 1/2" line.
- modifying the Fuel Filler Caps of both tanks (vented caps)
- limiting the usable fuel quantity in the LH Tank (9 USG).

In Belgium, both configurations of modified PA18 "180 HP" exist, and there is a limited number of aerotow-qualified pilots. This means that this situation may lead to confusions in the fuel tank selection.

Take note of the conclusions of this report, in order to make all concerned pilots sensitive against:

- the possible big differences that may exist between aircraft of the same type.
- the importance of taking sufficient safety margin, also in matter of fuel management.
