Investigation Report.

Status: **Final**
Date: **22 JUN 08**
Time: **11.40 UT**
Type: **Piper PA 18-150**
Operator: **Private**
Registration: **D-EFXY**
C/N : **4891;**
msn : **18-4963**
Manufacturing Date: **1956**
Engine(s): **Lycoming O-360-A3A**
Crew: **Fatality: 0 / Occupants: 1**
Aircraft Damage : **Total Loss**
Location: **In a hangar, near the Luchtvaartstraat, Kiewit.
N 50°58,148'
E 05°21,825.**
Phase: **In Flight.**
Nature: **Aerial works, glider towing**
Departure Airport: **EBZH**
Destination Airport: **EBZH**
Flight Number: **N/A**

REF: AAIU (Belgium) 2008-14.

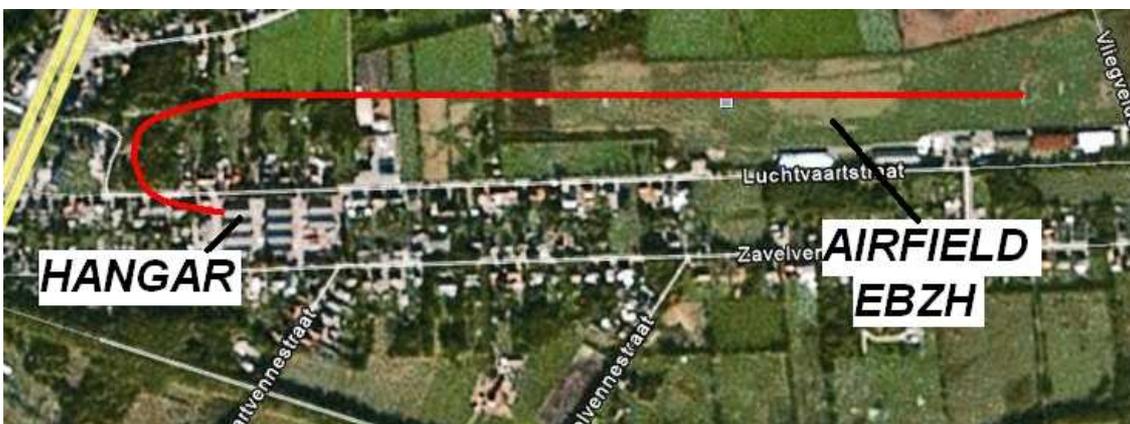
Flight Path

The pilot realized he could not continue straight ahead, due to the presence of houses and trees. He was also too low to hope to return to the airfield. He decided to turn to the left, and attempt to land on the roof of hangars adjoining the road leading to the airfield (Luchtvaartstraat).

The towing pilot concentrated on flying the aircraft. After having hit a tree, the aircraft went straight into the sidewall of the hangar, hitting a frame supporting the roof.

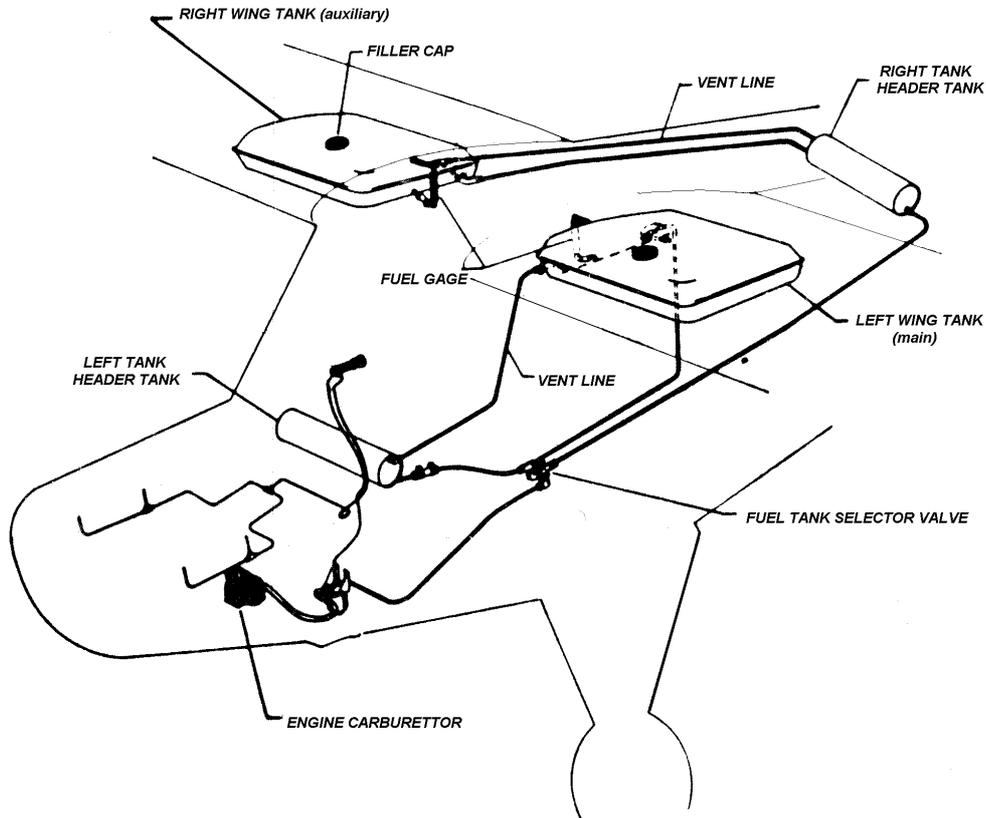
Aircraft Fuel System

The Piper PA-18 is equipped with 2 Fuel Tanks (capacity 18 USG). A small (approx. 2 quarts) header tank which serves to maintain constant fuel flow regardless of the normal attitude of the airplane is included in the installation of each fuel tank. The header tank for the left fuel tank is located forward of the instrument panel; for the right tank it is located behind the rear seat.

With the installation of a 180 HP engine (replacing the original 150 HP engine), important changes were introduced in the fuel system. These changes included:

- a new carburettor air box
- replacing the 3/8" fuel line of the LH fuel tank by a 1/2" line
- modifying the Fuel Filler Caps of both tanks (vented caps)

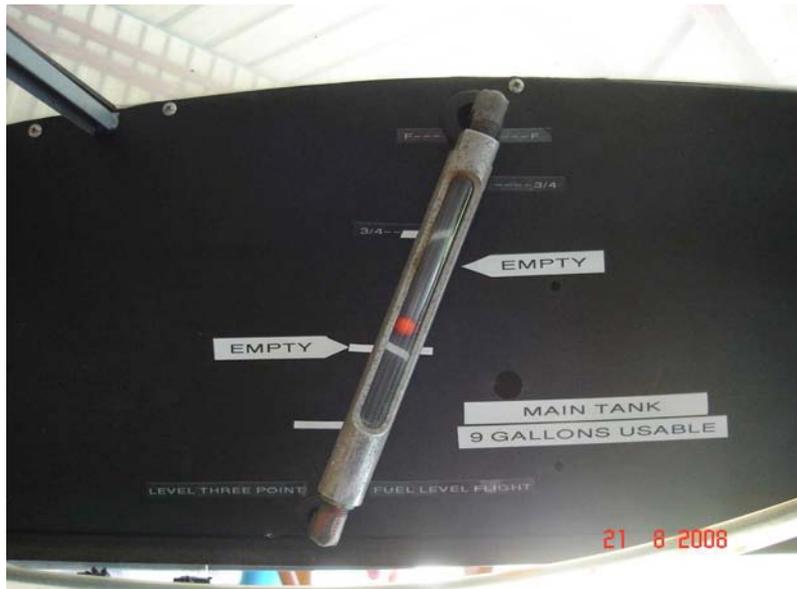
**LH Fuel Tank (Main) gage
as per STC SA36 RM**

- the LH Tank is to be considered as the main tank,
- only the LH Tank is to be used for take-off and landings.
- the LH Tank usable fuel quantity is reduced to 9 USG.
- the RH Tank is to be considered as an auxiliary tank, and be used only for level flights.

- On the fuel selector valve, there were no indication of Main /Auxiliary tank
- The graduation on the LH gauge was not modified to show the “empty” graduation at 9 USG.
- On the LH fuel gauge, the text indicating the use of the main tank was repeated.

The pilot used first the LH Tank, at the beginning of the day, until the fuel reached the ½ (empty) marker, then he used the RH Tank. He stated he was puzzled by the markings next to the LH Fuel Tank gauge, (Start und landung auf linkem tank – nur 36 ltr ausfliegbar), but could not get an explanation.

Make sure that the STC Nr SA36RM is correctly applied, in particular the markings on the gauges and selector valve plate, on all OO-registered aircraft
