FINAL REPORT ON THE ACCIDENT TO AN ULTRALIGHT AIRCRAFT ON 2 MAY 2009 IN LOKEREN

**Ref. AAIU-2009- 6
Issue date: 4 December 2009
Status: Final**

Type: Self-designed weight-shift controlled ultra-light aircraft.
Referred further to "DPM" – Delta Plane Motorized - in the text.

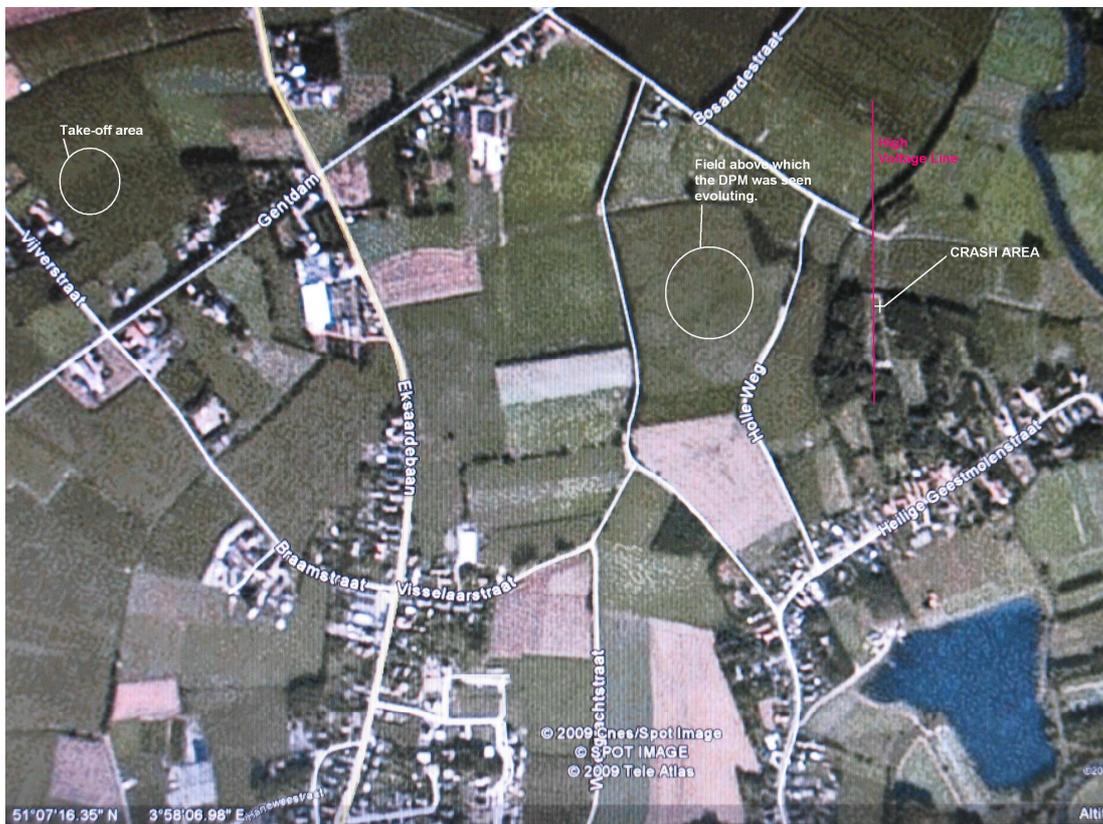
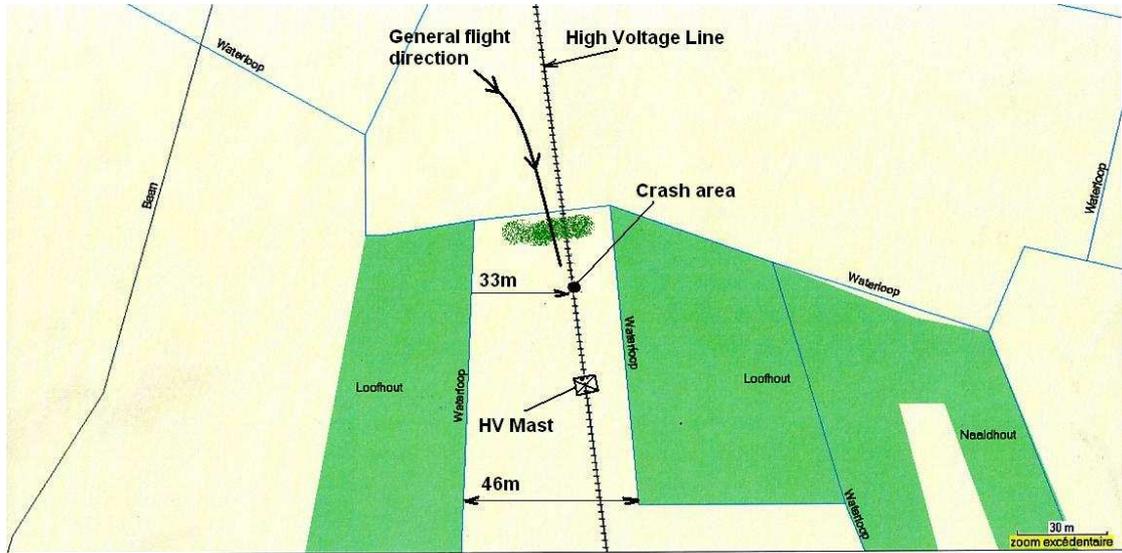
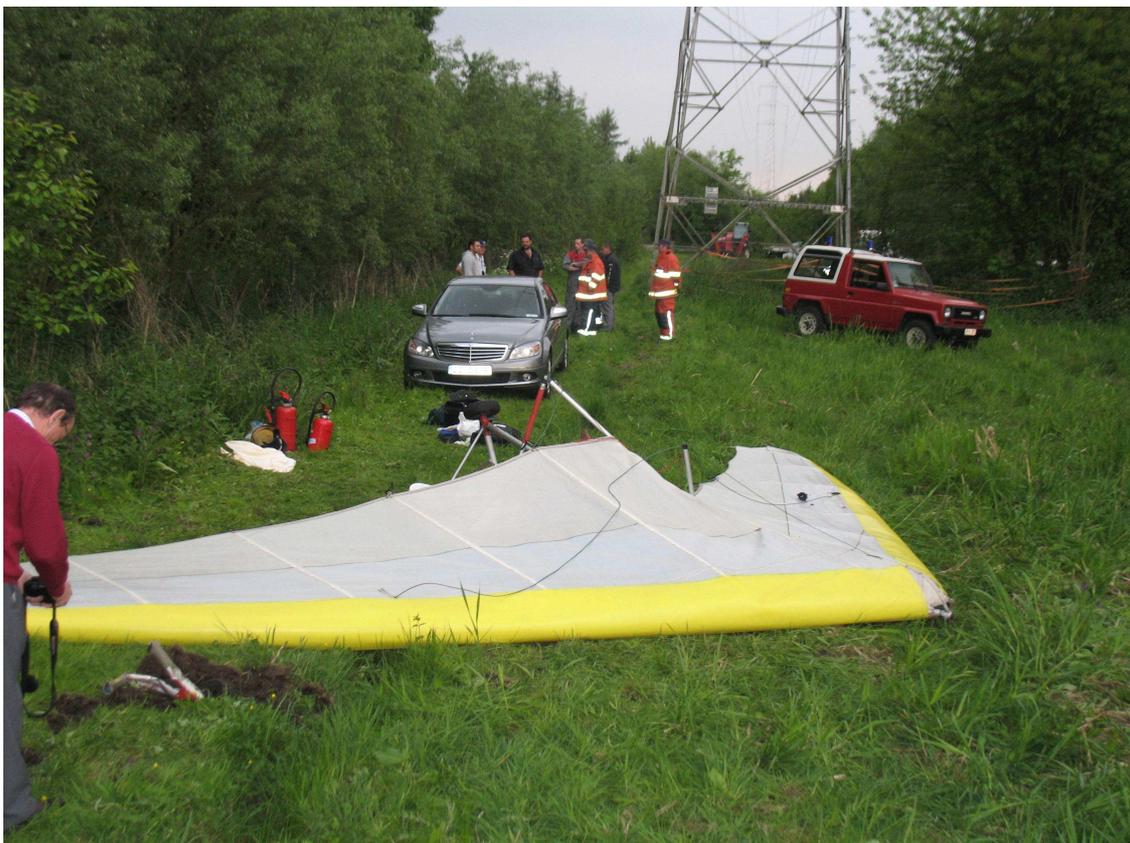
Witnesses saw the aircraft in a tight right turn, at the height of the High Voltage line in the neighbourhood.

The aircraft dove below the High Voltage Line. The aircraft went down at an angle of 30-45° in an area bordered by trees. When levelling off, the LH Landing gear impacted the ground, and the aircraft crashed 5m further.

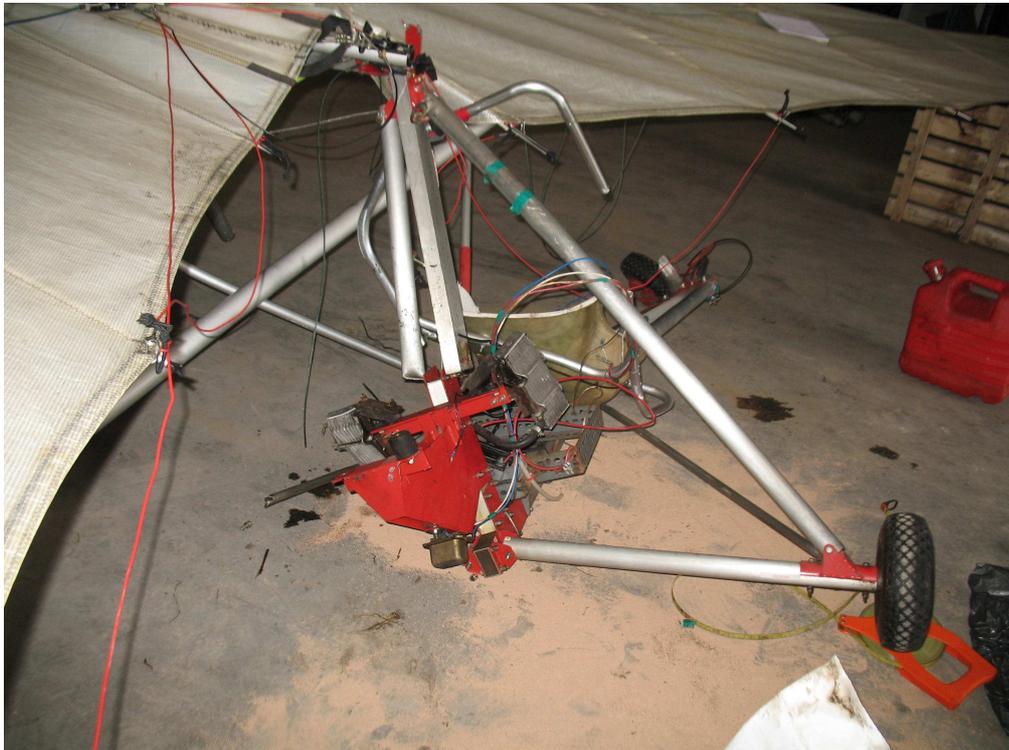
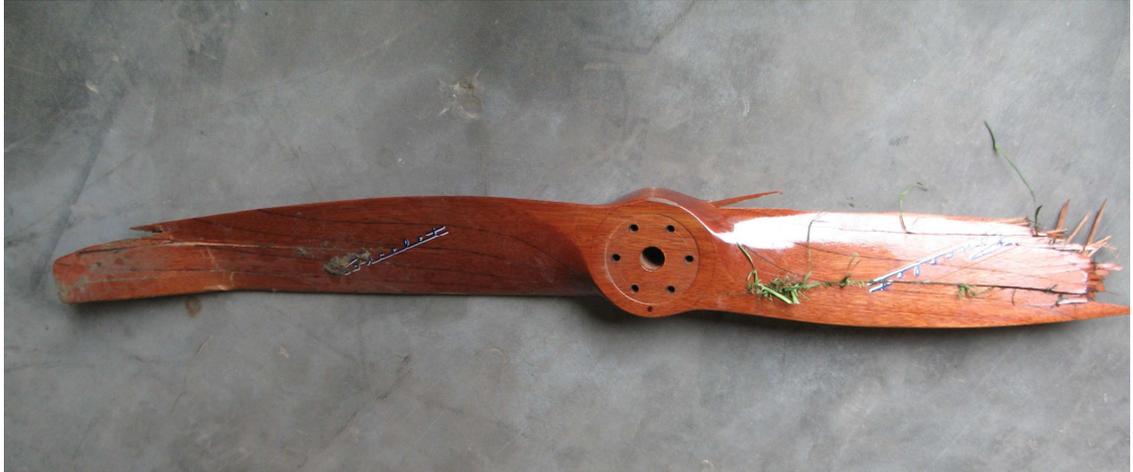
The aircraft was totally destroyed.

The structure of the kite was heavily damaged;

- the forward beam was severed from the main structure;
- the RH landing gear leg was ruptured in 2 points and severed from the main structure;
- the LH landing gear was bent.
- the roll bar (attachment of the seat) was ruptured.
- the wing attachment bar was ruptured

The structure of the wing was intact, but the connection to the basebar was ruptured.

The propeller was broken upon impact

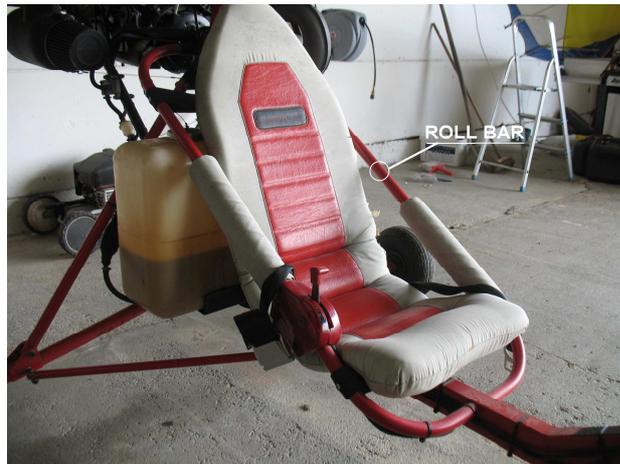
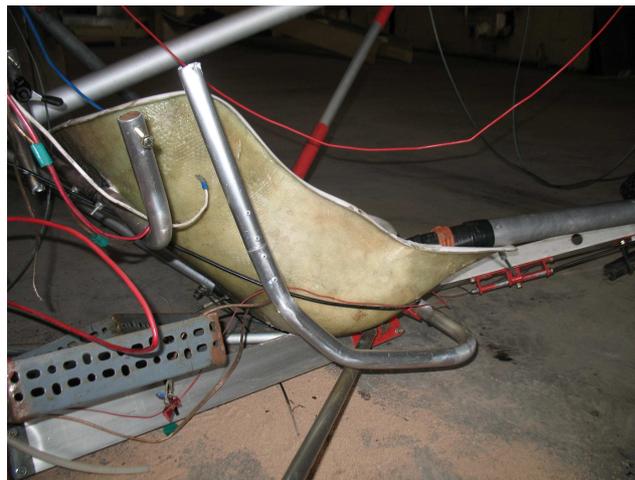
When comparing the design with a similar DPM, one major difference we found concerned the roll bar. In the comparison DPM, it is designed to absorb the energy of impact. It is an essential element for the safety of the pilot, and reportedly, in high energy impact, this element bends but does not break.

The tubing used on the accident DPM for the roll bar is not of the material, thickness and construction adequate for the primal function of crashworthiness. It seemed to be designed primarily to hold the seat in position.
