FINAL REPORT ON THE ACCIDENT TO THE SAILPLANE LAK-17 AT REGISTERED D-KJGA IN SUARLEE - NAMUR ON 09 MAY 2009

Ref. AAIU-2009-7
Issue date: 25 January 2011
Status: FINAL

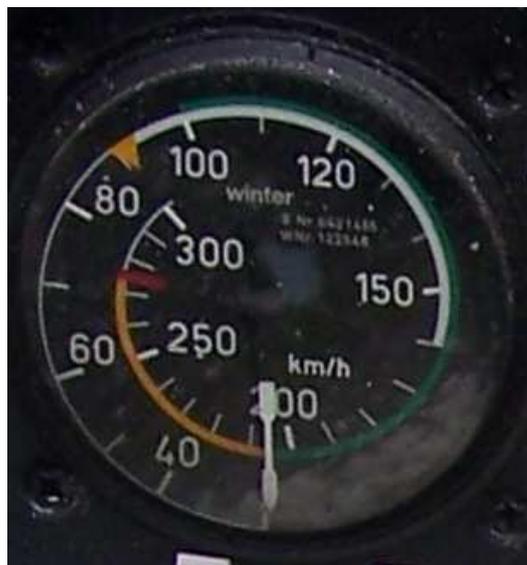
The airspeed indicator (Winter Bordgeräte Type 6 FMS – S. Nr 6421455 – W. Nr 122548) found on the wreckage of D-KJGA bore the markings adequate for a LAK-17A (instead of LAK-17 AT).

Nevertheless, the inadequate markings on the airspeed indicator could have led the pilot to fly the sailplane with a reduced stall speed margin.

AAIU(be) recommends Lithuania to require the Joint Stock Company “Sportine Aviacija” to revise the Information Bulletin N°017.A.8.65.0121I in order to incorporate all instructions needed to ensure the conformity of a modified LAK-17A with the requirements of the Flight Manual.

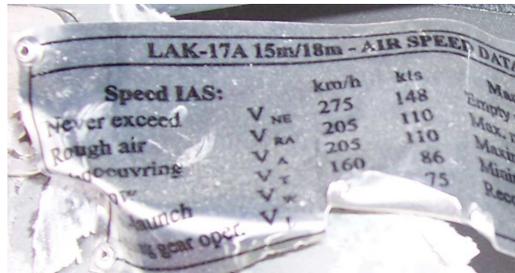
The Limitation placard found inside the cockpit was also referring to the non-powered version LAK-17 A.

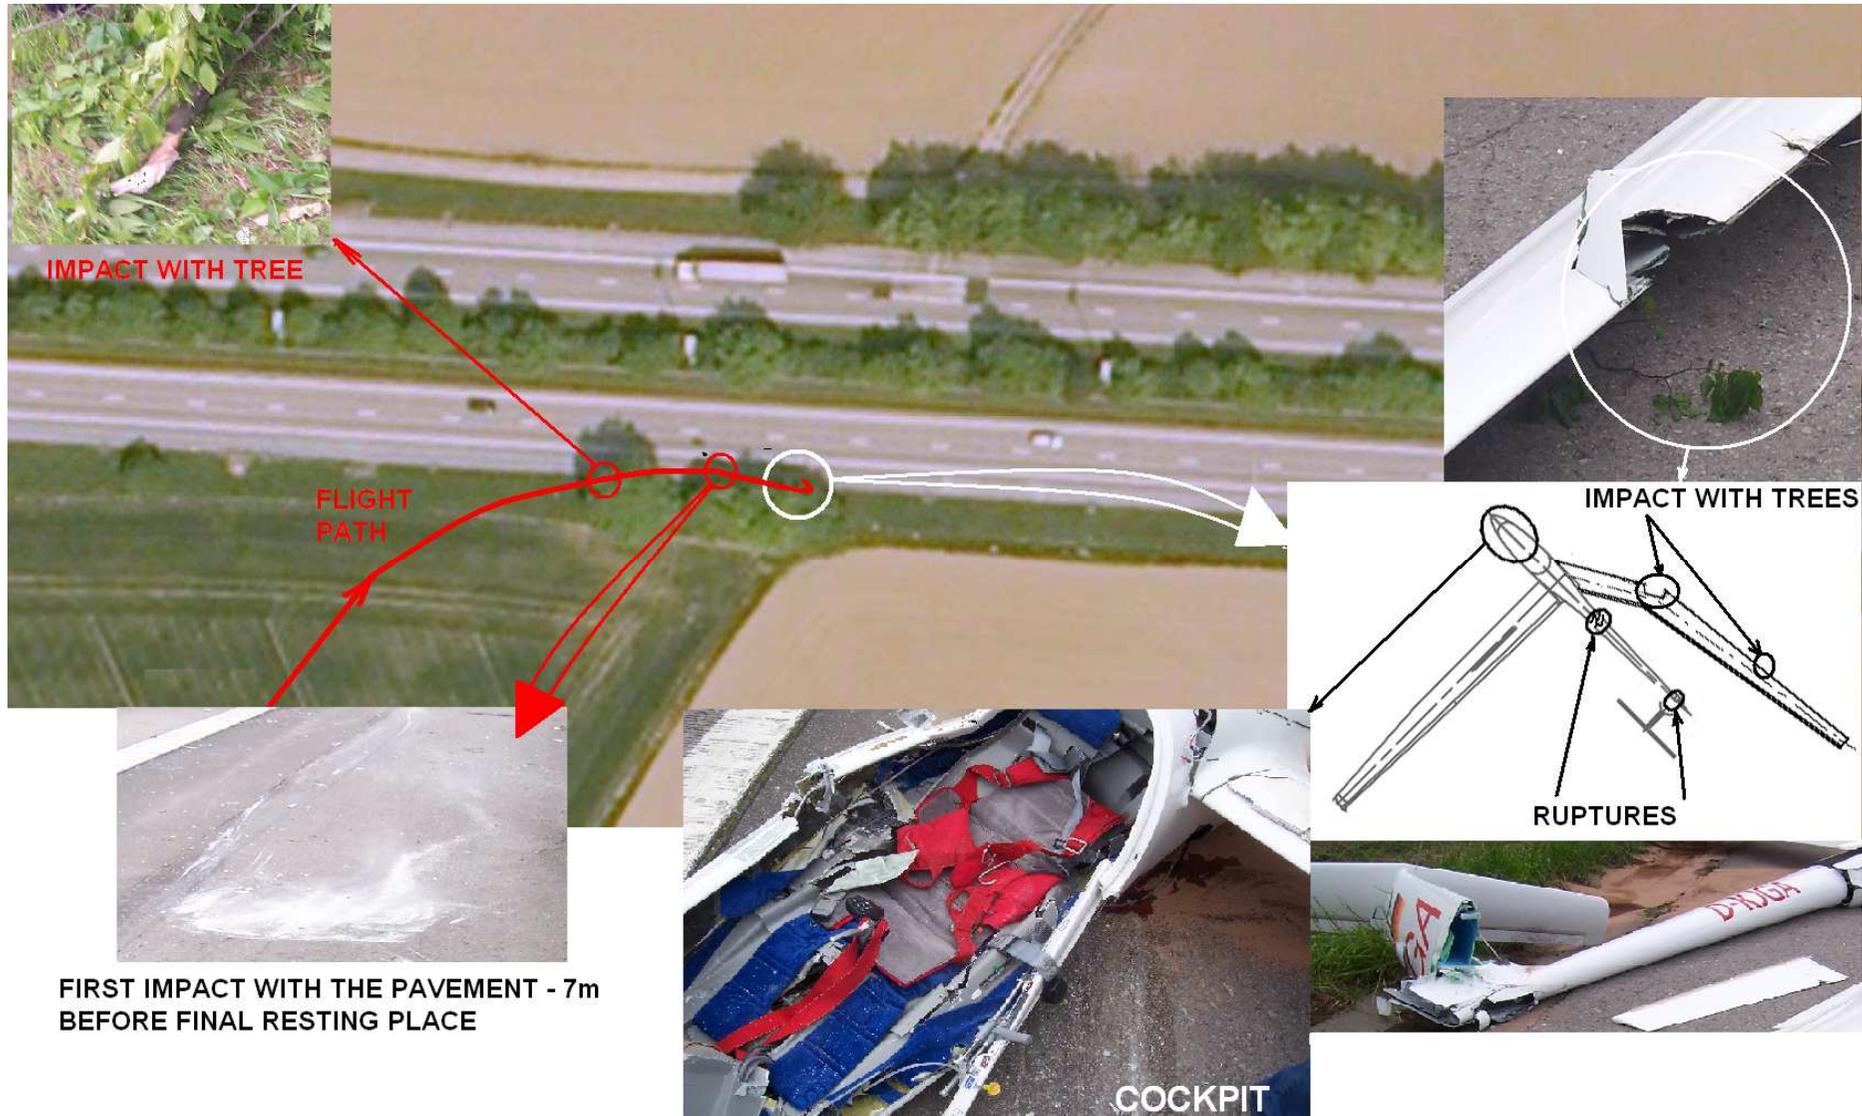
The sailplane was seen in a RH spin. It hit the pavement of the motorway E42 after having hit several trees bordering the road.

The cockpit hit first the ground and left a visible white mark on the pavement. It skidded a further 7m, turned around, and finally rested on the RH border of the road.

The cockpit broke up on impact.
The RH wing bears traces of impact with the vegetation, and is torn from the wing root.

The fuselage is broken in two parts and the rudder section is broken at its connection with the fuselage.

The winglets are separated from the wings.

The airbrakes are out, and the landing gear was still retracted.
