FINAL REPORT ON THE ACCIDENT TO RYAN ST3KR REGISTERED N 56028 AT EBDT ON 15 AUGUST 2009

Ref. AAIU-2009-13-EBDT-N 56028
Issue date: 24 October 2011(REV. 21/05/2012)
Status: FINAL

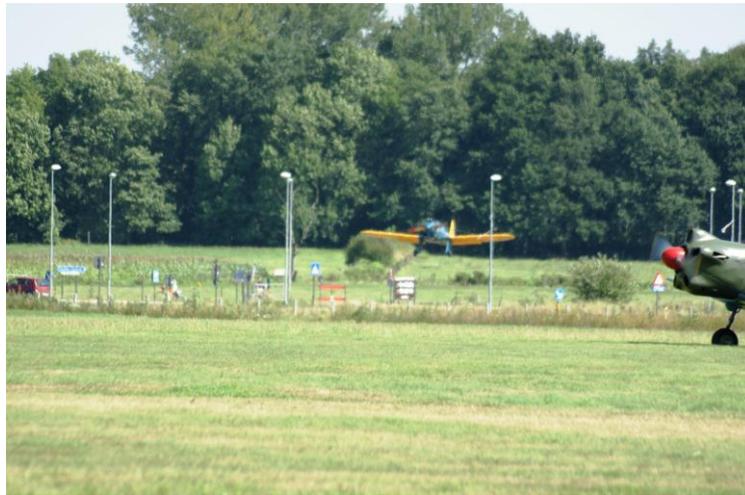
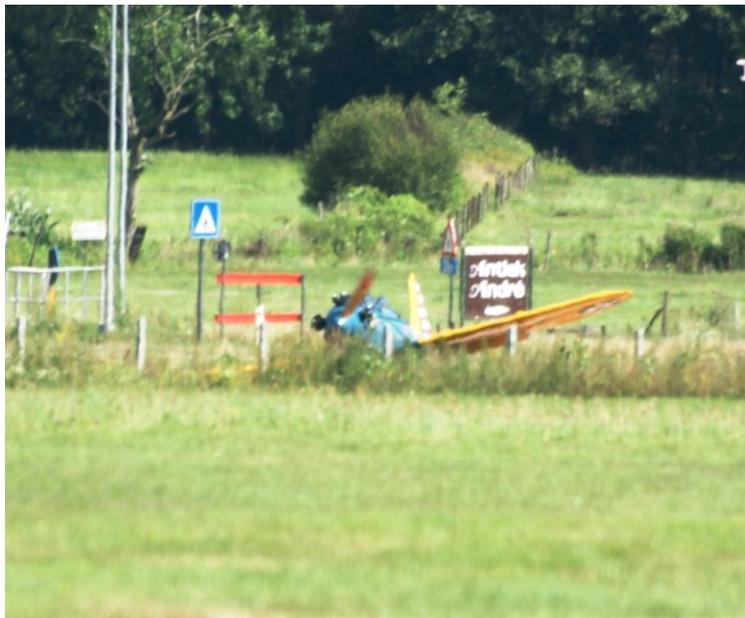
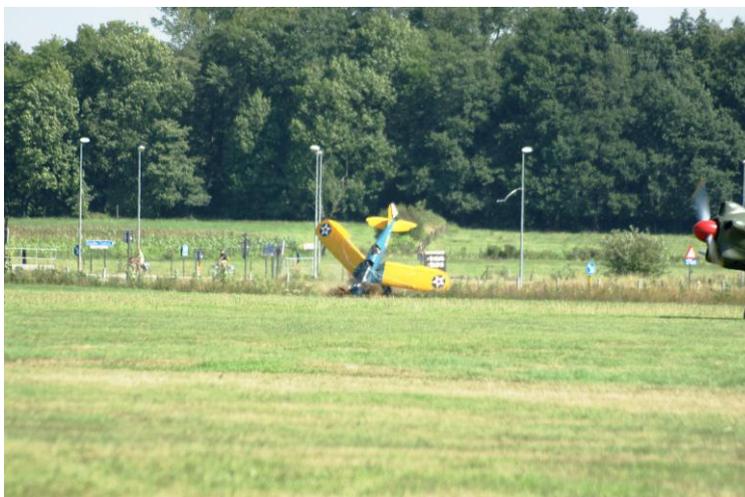
He ended up coming in very low, between 2 lighting poles and touched down on the shoulder behind the ditch along the road bordering the airfield.

The main wheels hit the shoulder behind the ditch located along the road and immediately after, a fence and one meter high concrete poles.

The airplane followed this track on the grass of the airfield and flipped over. It stopped upside down leaving the entire airplane severely damaged.

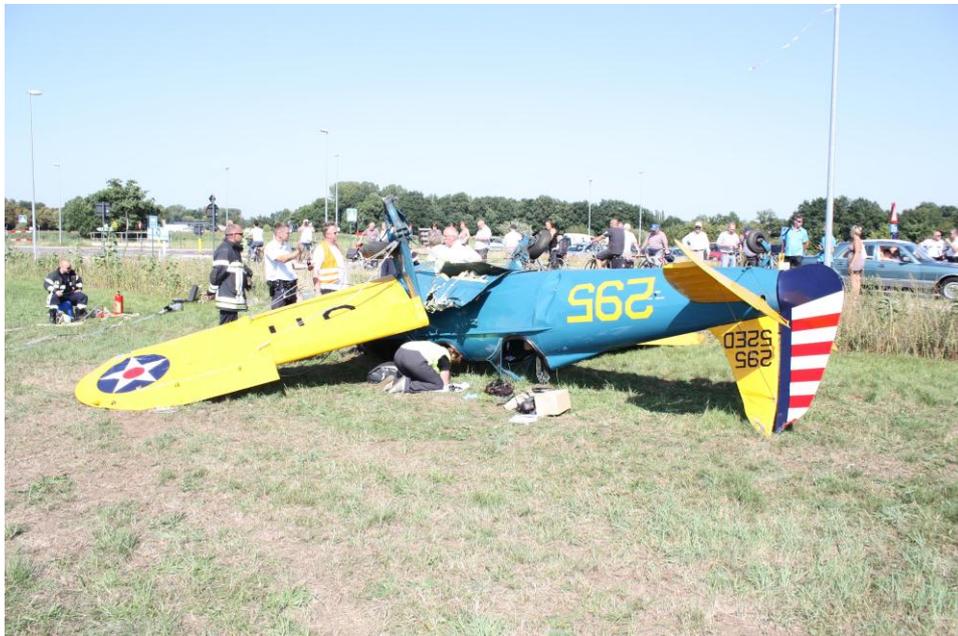
Figure 5

The entire airplane was substantially damaged.

Only one propeller blade was broken by impact.

The right hand wing was separated, the right hand main wheel was torn away and the fuselage and both wings were distorted.

The fuel system was thoroughly inspected and despite the fuselage resting upside down, there was no significant sign of fuel spillage.

The fuel gauge was broken by impact.

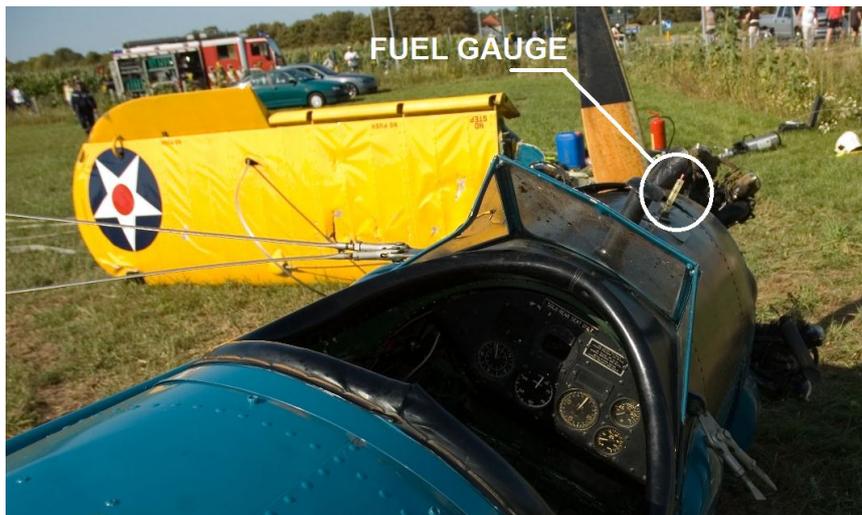
Figure 7

The tank is equipped with a float type direct reading fuel capacity gauge located on the top of the fuel tank, forward of front windshield (figure 7).

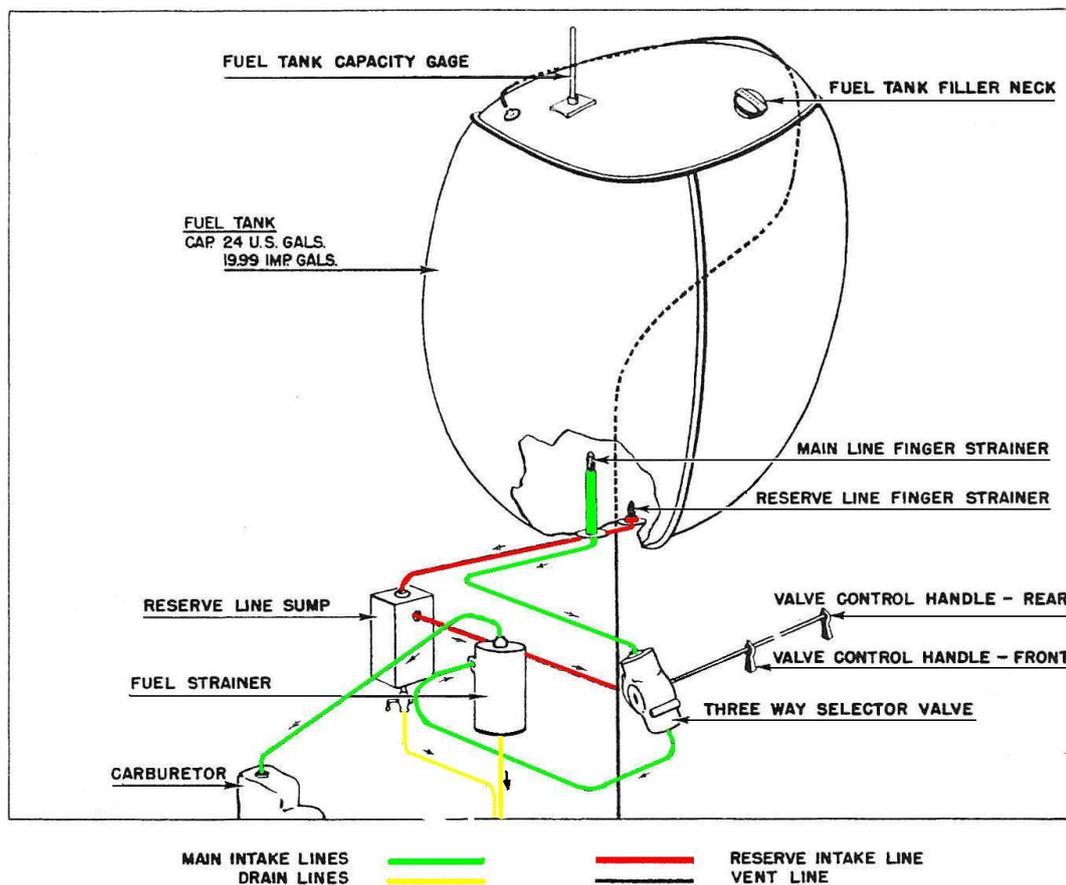
Figure 8.

As seen on the above schematic, the reserve line allows fuel to feed the carburetor when the fuel tank is almost empty.

By contrast, the main line does not allow the use of the full tanks capacity. It should warn the pilot is running out of fuel when the engine starts to sputter.

The pilot should then select the “Reserve” position to continue his flight for a short, but unknown period of time.

However, “Pilot’s Flight Operating Instructions” don’t indicate the amount of fuel for reserve and no information was available to determine the remaining fuel quantity and consequently the range.

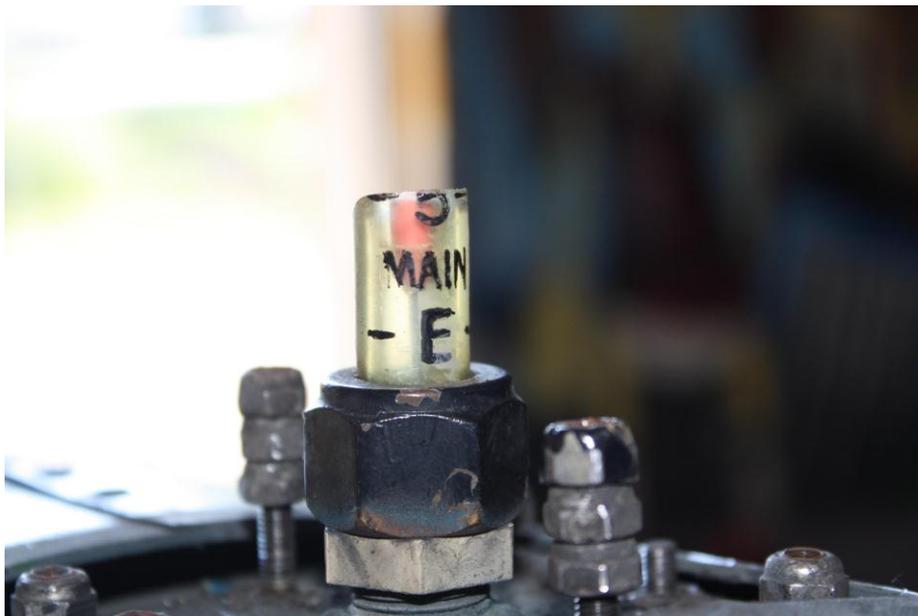
However, as seen on the following picture, the fuel gauge indicates around 3 gal fuel remaining when the fuel tank is empty and it was established that it was already inaccurate before the crash.
