FINAL REPORT ON THE ACCIDENT TO JODEL DR1050 REGISTERED OO-MOU ON KIEWIT AIRFIELD ON 16 AUGUST 2009

**Ref. AAIU-2009-14
Issue date: 15 January 2010
Status: Final**

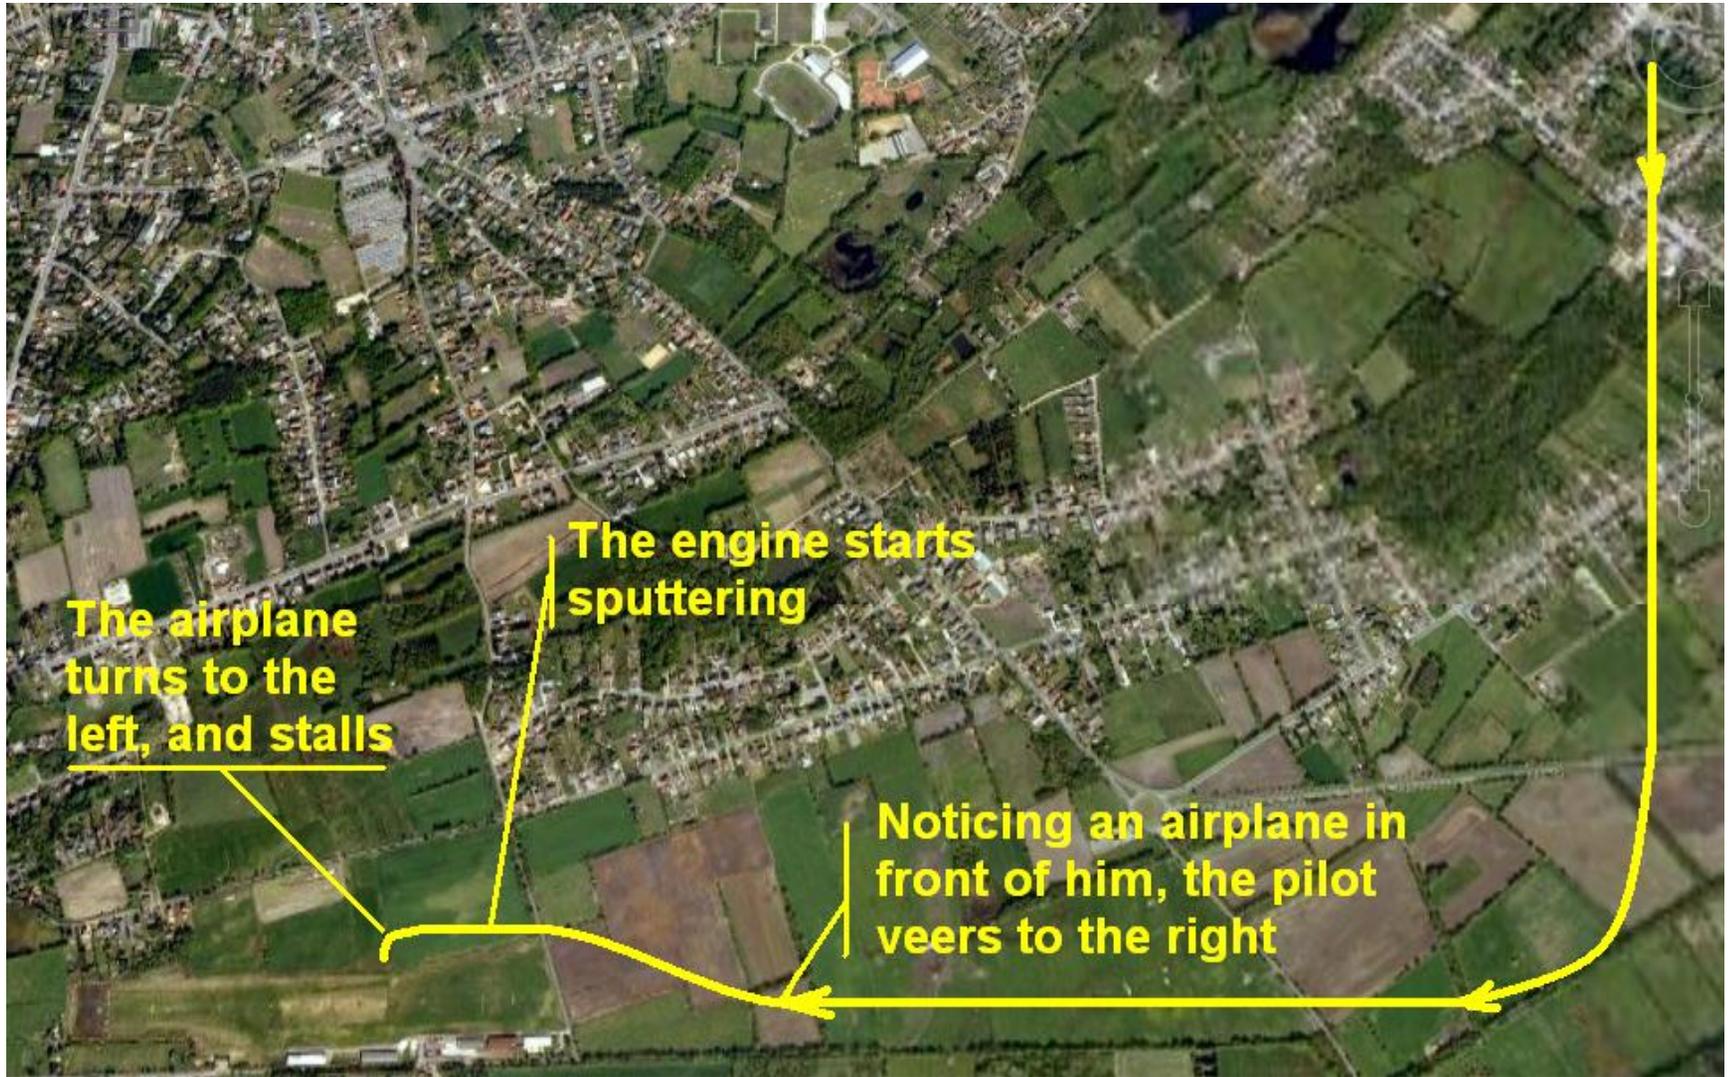
The engine starts sputtering

The airplane turns to the left, and stalls

Noticing an airplane in front of him, the pilot veers to the right

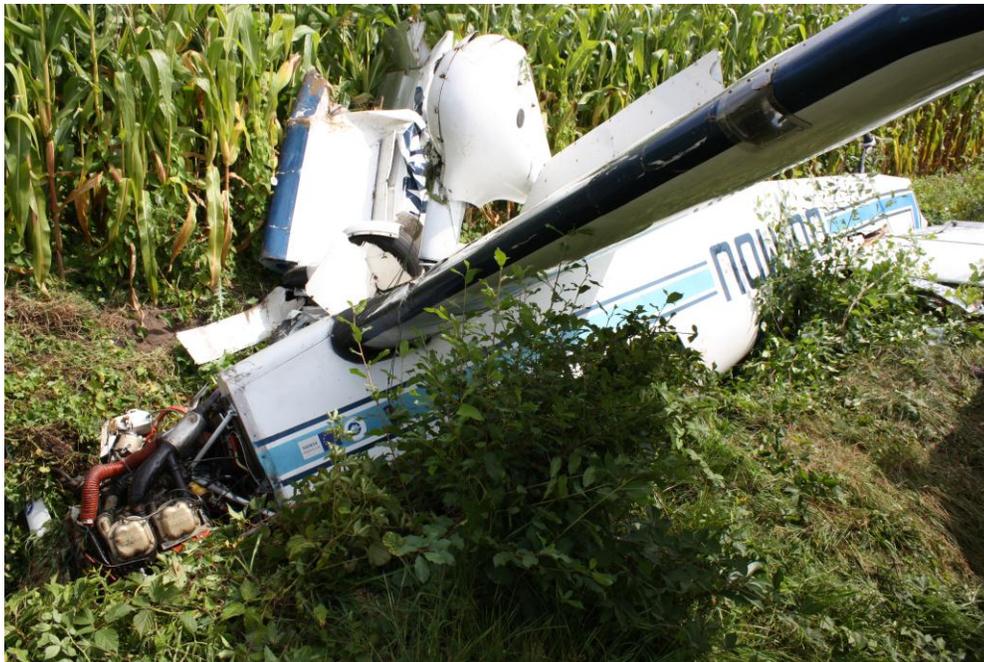
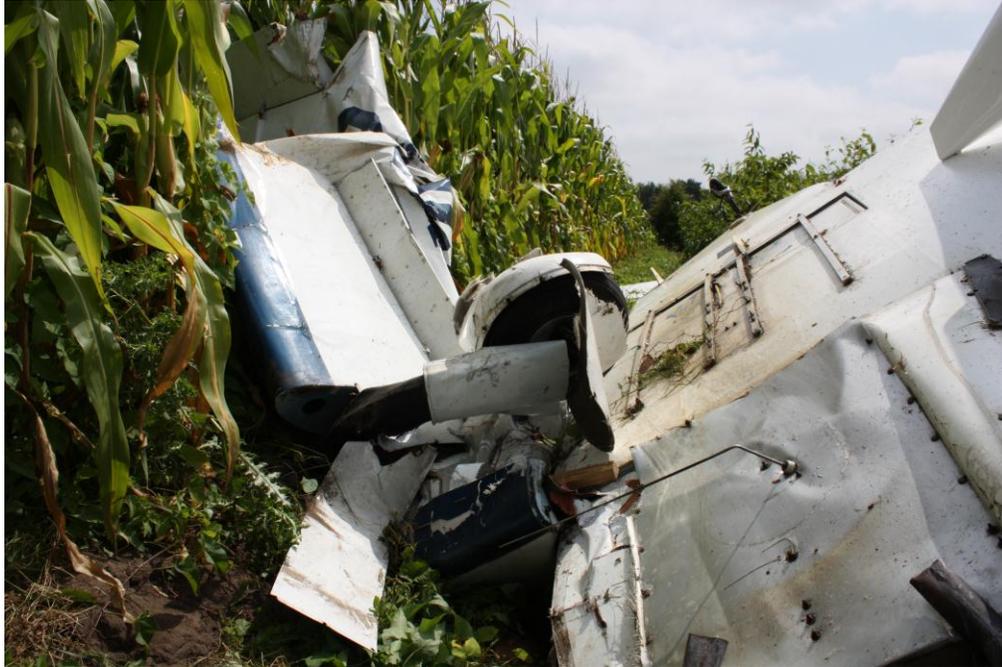
The airplane is heavily damaged.

The wooden structure of the LH wing is broken, having suffered the initial impact.

The tail structure is shattered.

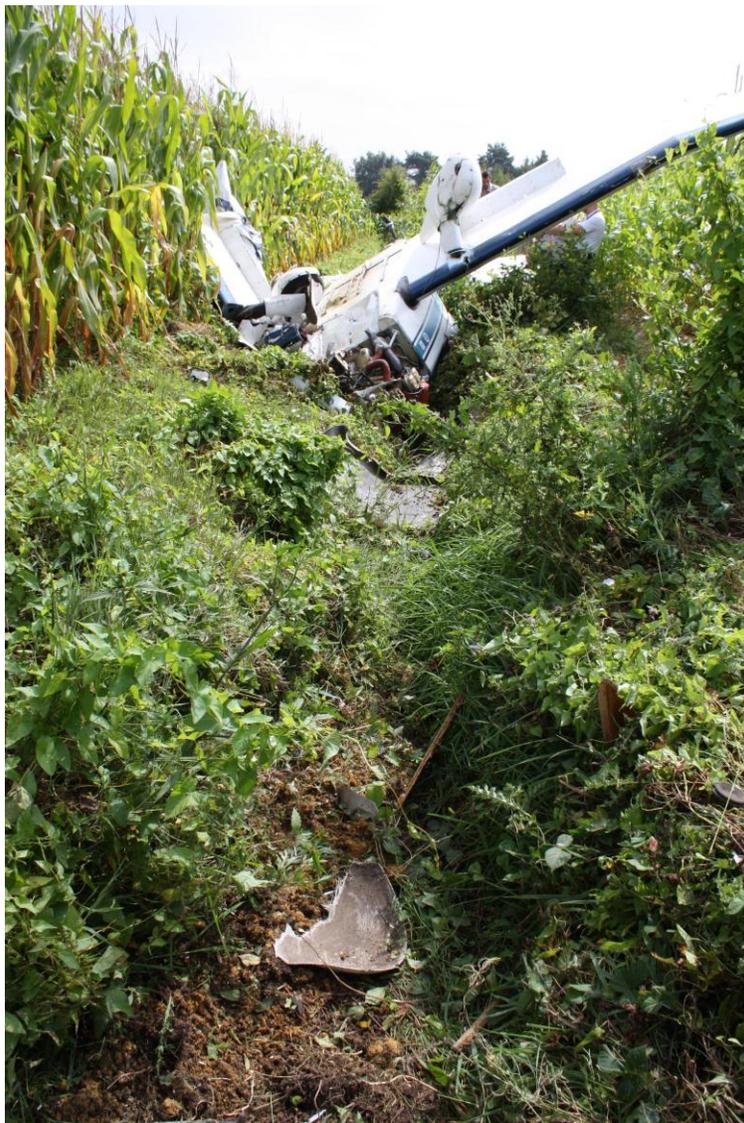
The airplane fell down in a stall. The left wing hit the ground first, and the airplane crashed, inverted, with the fuselage into an irrigation ditch.

This protected the cabin to be further crushed by the airplane hitting the ground.
