FINAL REPORT ON THE ACCIDENT TO THE MISTRAL-C SAILPLANE REGISTERED OO-ZTV IN GOETSENHOVEN ON 23 AUGUST 2009

Ref. AAIU-2009-17
Issue date: 03 SEP 2010
Status: FINAL

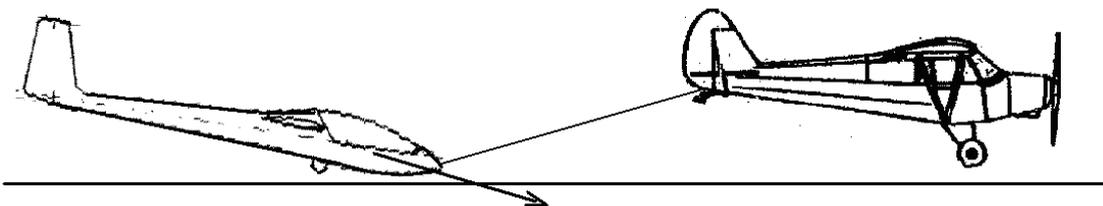
When the two aircraft were airborne, the sailplane was seen porpoising – a pitching oscillation; the sailplane going up and down – two or three times.

The last downward movement led the sailplane to hit the runway pavement.

Note: the tow cable is 40m long and is not represented to scale.

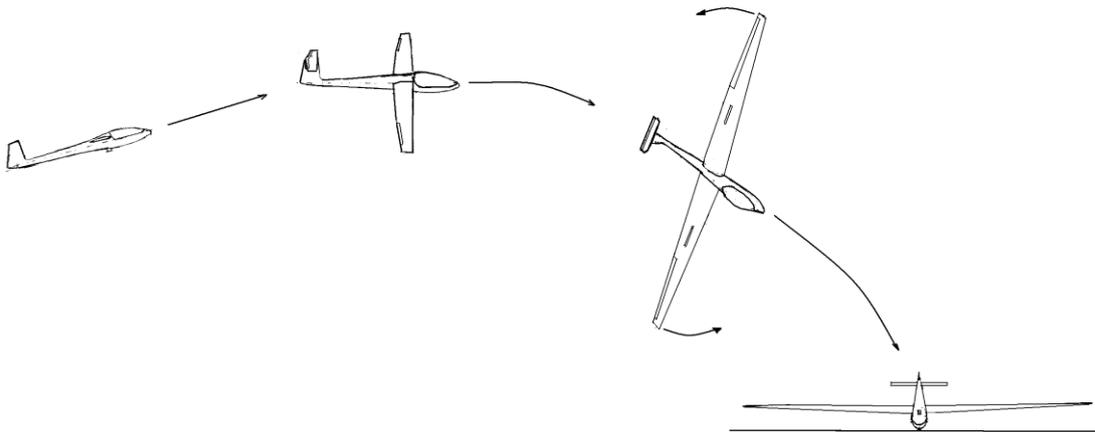
The tow cable got detached. The sailplane climbed, turning to the right in a roll movement, going down. The sailplane went inverted, and crashed on its back at the RH side of the runway 24. The height reached by the sailplane is stated by several witnesses to be 50m, although this seems quite high, and is more believed to have been between 10 - 15 m.

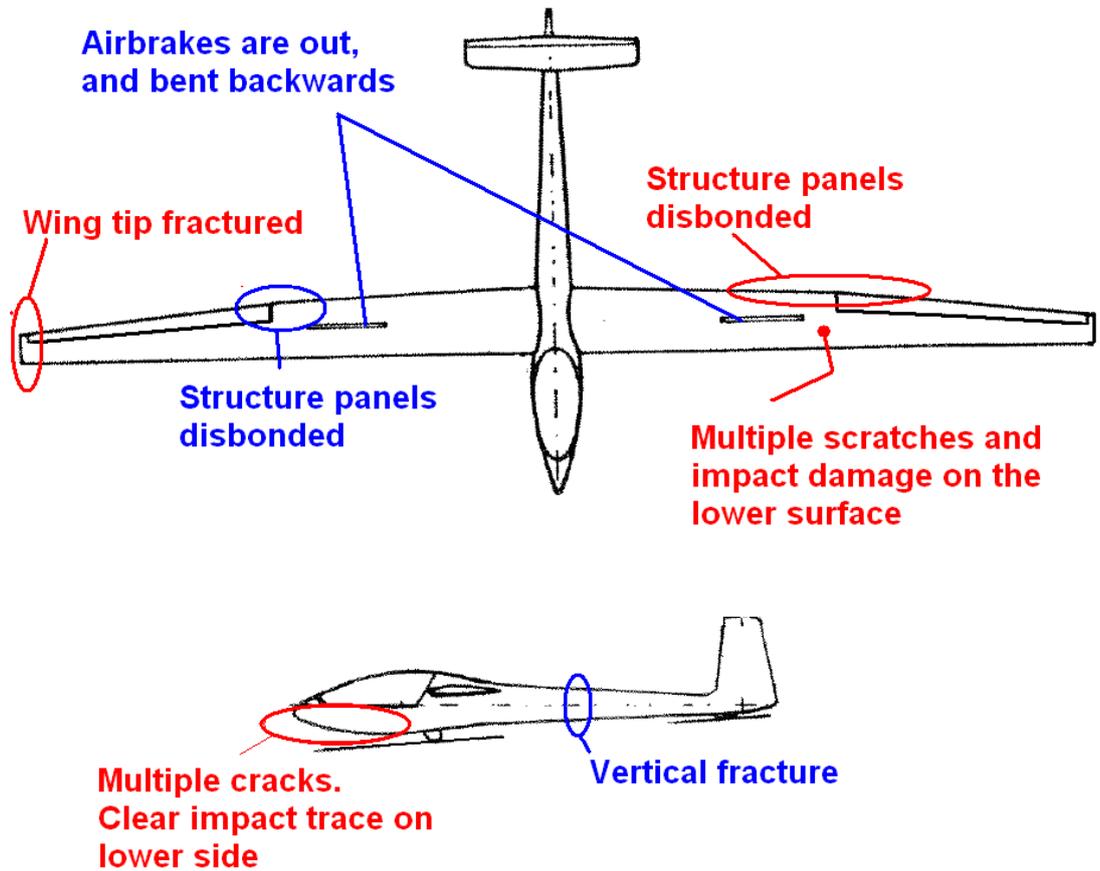
Damage description

The damage on the sailplane was assessed by a team from the Aviation Accident Investigation Service (SEAA – ODOV) of the Air Component – Belgian Defense. (Report A-01-DGTA-2009).

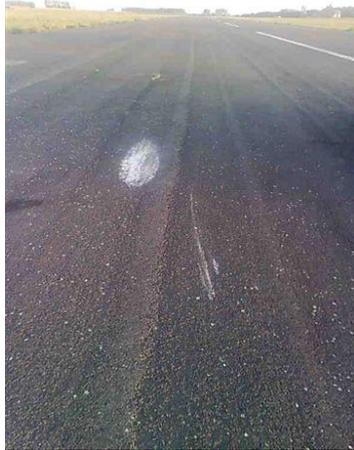
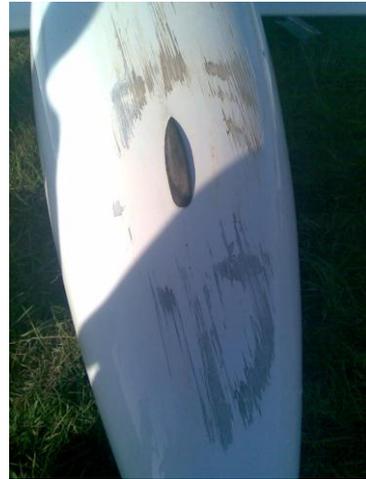
The sailplane impacted the runway two or three times; the last impact was quite violent, and left a white mark on the runway. During this impact, the wing bent downwards and impacted the runway surface.

The first impact was located below the nose of the sailplane, under the cockpit.

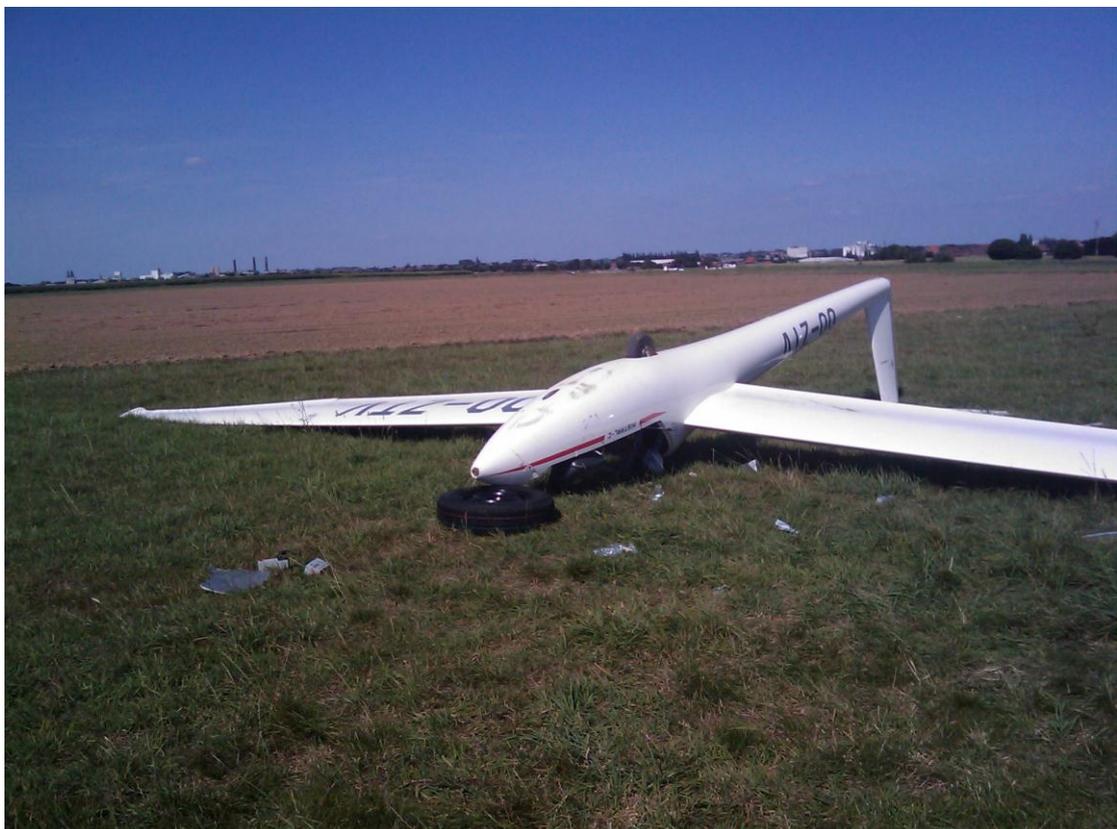
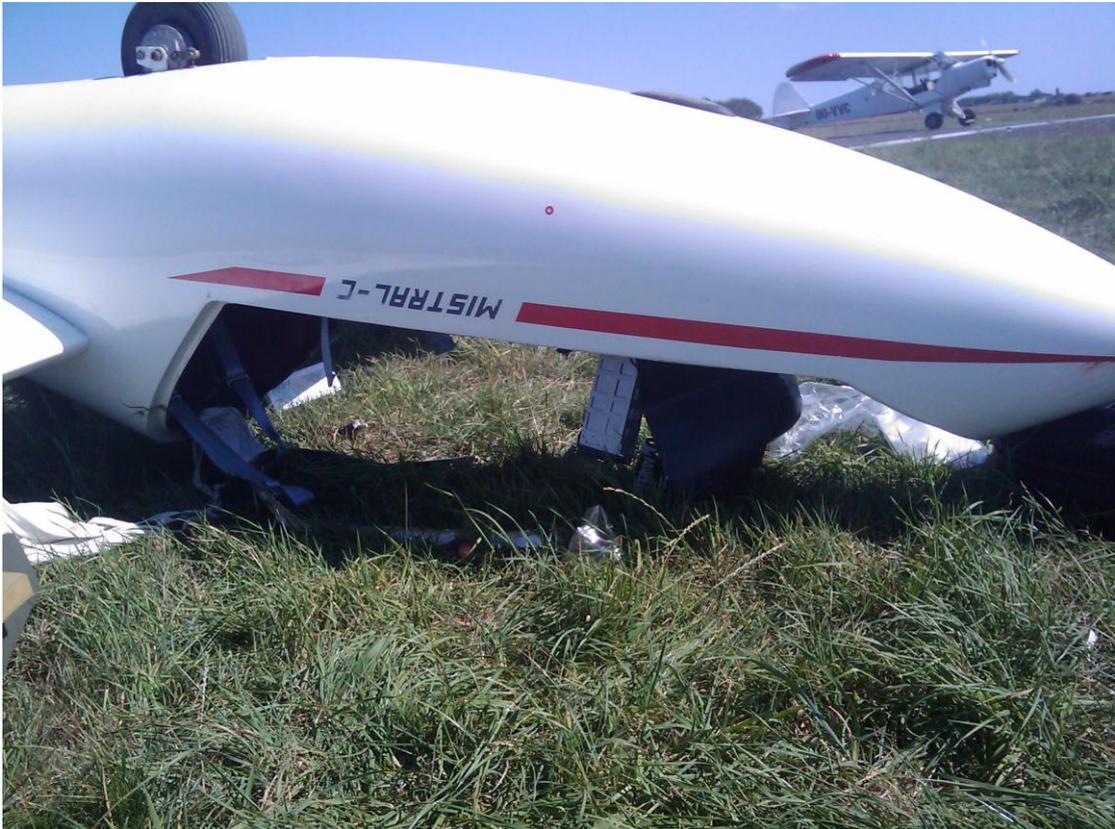
A second shock occurred when the sailplane impacted the ground, inverted. It slipped on the grass for several meters before the final stop.

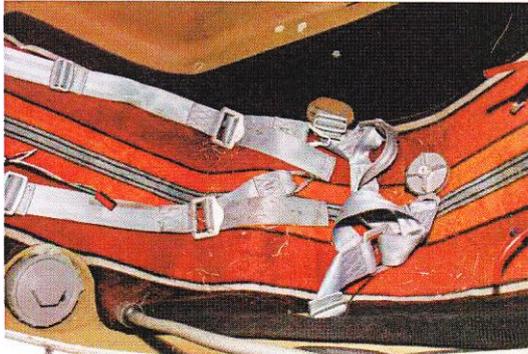
The pilot was seated correctly, with seat belts and straps on.

The vertical shock on the canopy was only limited by the glass canopy. The pilot had no head protection, nor was he supposed to wear one.

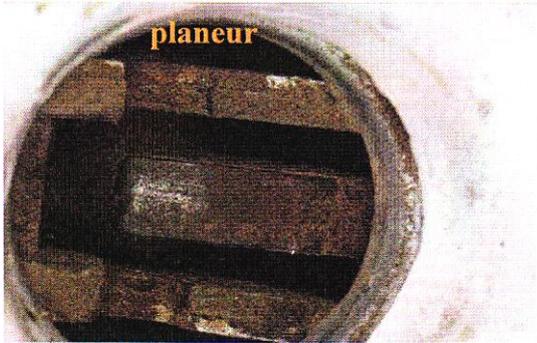
The tow release was tested after the accident, and was found to operate normally.

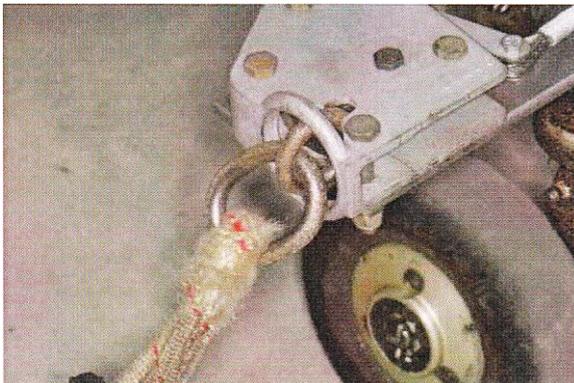
The tow release was tested after the accident, and was found to operate normally.

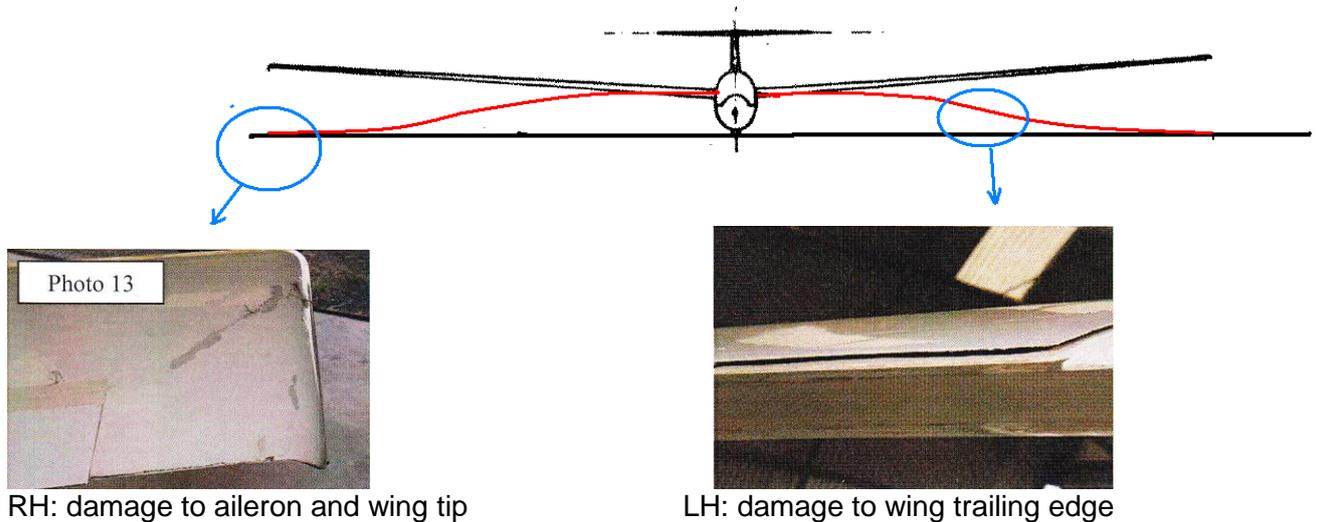
The damage during the collision with the runway was quite violent, causing the wing to bend and hit the runway surface. This would have caused a forced deformation of the wing, in turn causing structural damage, as earlier explained

In particular, the RH Wing tip was damaged, while the LH Wing tip did not show damage, indicating the shock was heavier on the RH side than on the LH side.

The wing skin de-bonded at the trailing edge, on both RH and LH wing.

The ailerons were also damaged (but probably during the second blow).

The findings were made after the second impact (inverted in grass), that would also have caused damages, but the damage seen on the RH wing tip and on the lower surface were without doubt done during the first impact.

These damage are susceptible to influence the wing performance, and could possibly lead to (RH wing more damaged) cause the sailplane to turn right, without input from the pilot. The actual influence of the damage to the flight path could not be simulated nor reproduced with absolute certainty.
