Federal Public Service
Mobility and Transport
Air Accident Investigation Unit

Safety Investigation Report

INCIDENT TO AVRO RJ100 REGISTERED OO-DWK ON 27 OCTOBER 2009

Ref. AAIU-2009-22
Issue date: 4 March 2012
Status: Final

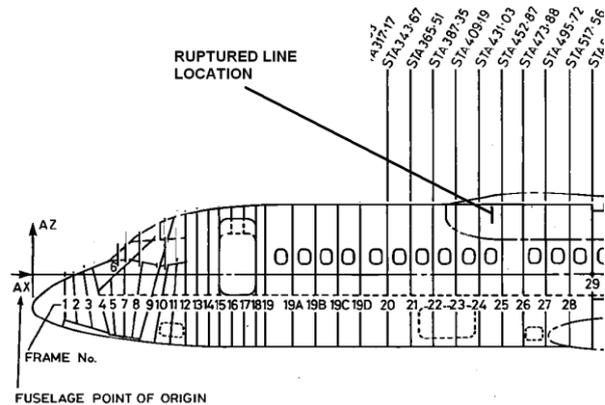
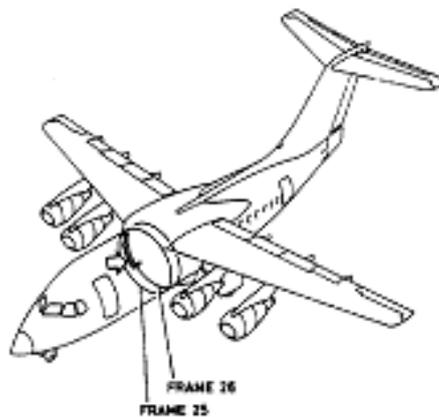
The pipe, pn HC279B004-000 ruptured at the RH side, between frame 25 and 26.

The fracture (crack) is longitudinal and 2.5 cm long, located in a curve of the line.

The hydraulic line was installed during aircraft production, and was neither removed nor replaced during the operational life of the airplane.

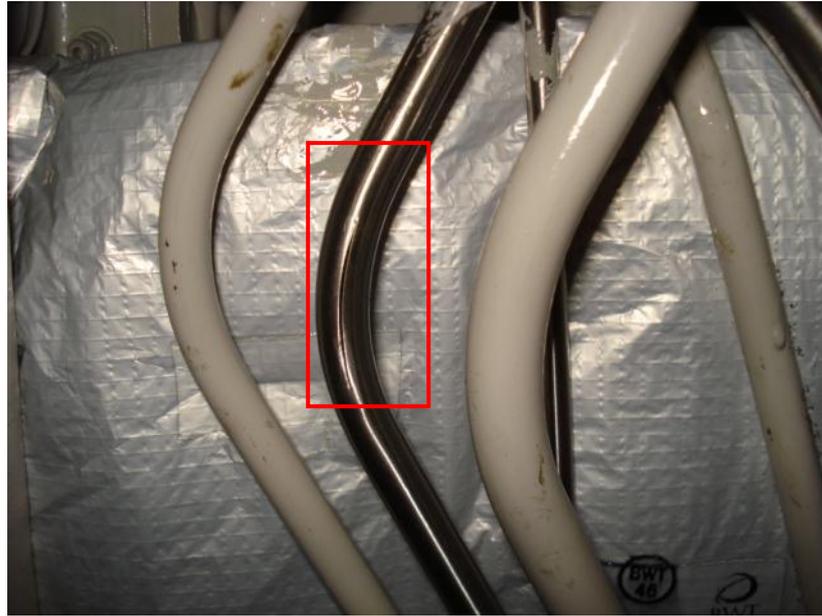
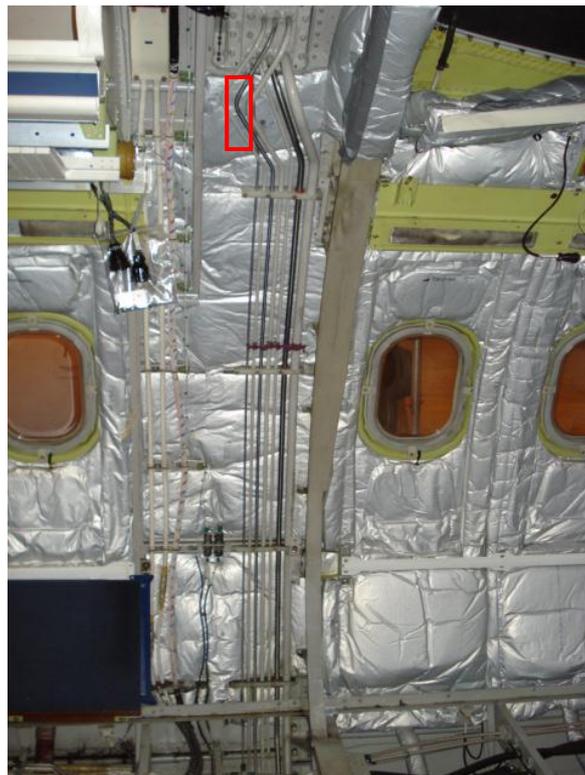
“There was a linear defect running along the inner surface of the pipe. The defect coincided with the base of the weld in the pipe and appeared to be associated with a low level of weld penetration.

The pipe had failed at one of the bends where the weld and linear defect were oriented at 90 degrees to the top of the bend. The higher level of fluctuating stresses acting on the pipe in this position were thus concentrated on a particular area of weakness of the pipe.

The pipe had failed due to fatigue originating at the edge of the linear defect and progressing through to the outer surface.

The rupture of the hydraulic pressure line was caused by metal fatigue at the weld joint of the pipe, associated with a low level of weld penetration.
