## **Safety Investigation Report**

# **TELEDYNE CONTINENTAL MOTOR IO-520-F ENGINE FAILURE ON 09 MAY 2011**

**Ref. AAIU-2011-23-FZEN-OO-A\*\***

**Issue date: 29 June 2012**

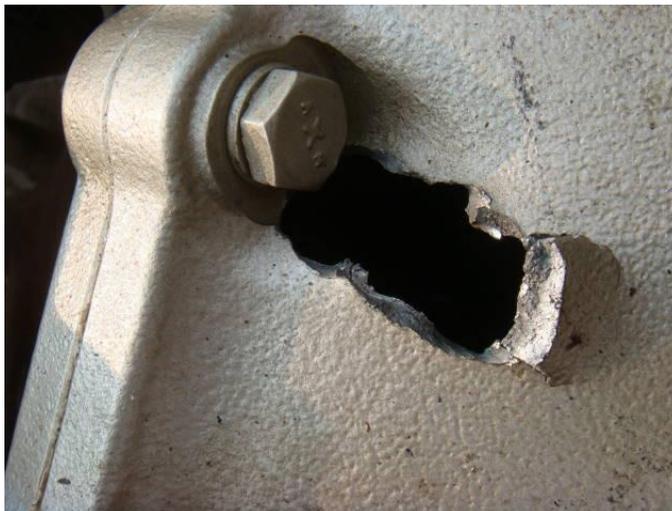
The on-site examination of the engine by the pilot immediately revealed a hole at the top of the right hand crankcase, above cylinders number 1 and 3.

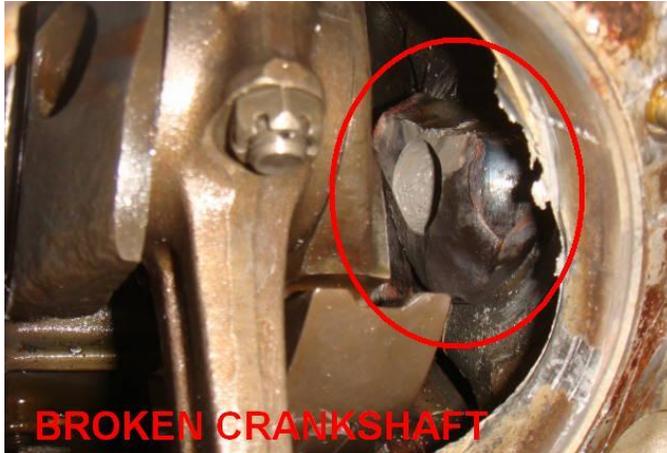
The engineer removed, with some difficulties, the cylinder 1 and could see that the crankshaft was broken at cheek number 3. Important damage was also noticed to the neighbouring parts inside the crankcase.

Figure 1: rupture of the crankshaft as seen after removal of one cylinder

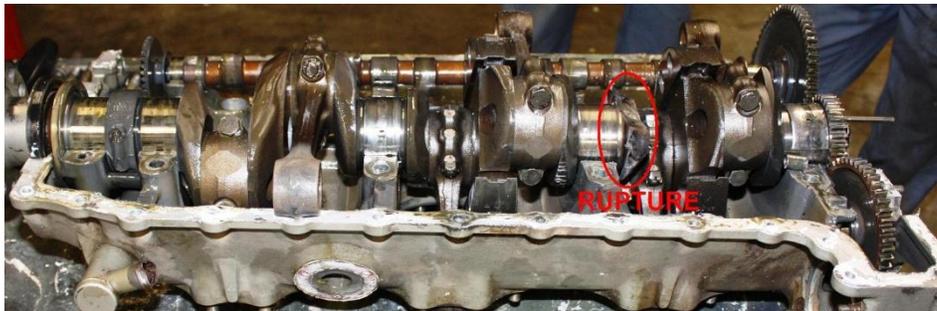
The engine accessories were removed and, after opening the crankcase, it was confirmed that the crankshaft was broken at cheek number 3, between main and rod journal number 2.

Figure 2: view after crankcases splitting

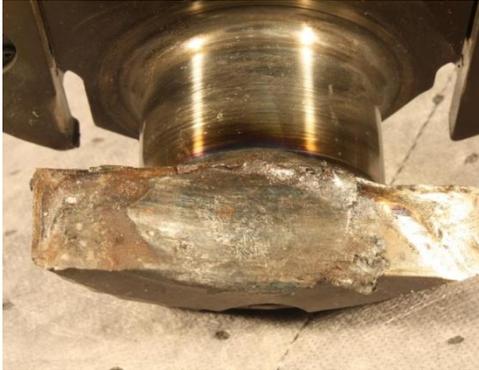
Figure 3: Rear side of the crankshaft

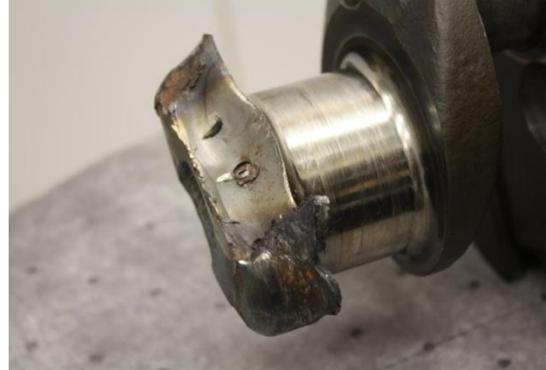
Figure 4: Propeller side of the crankshaft

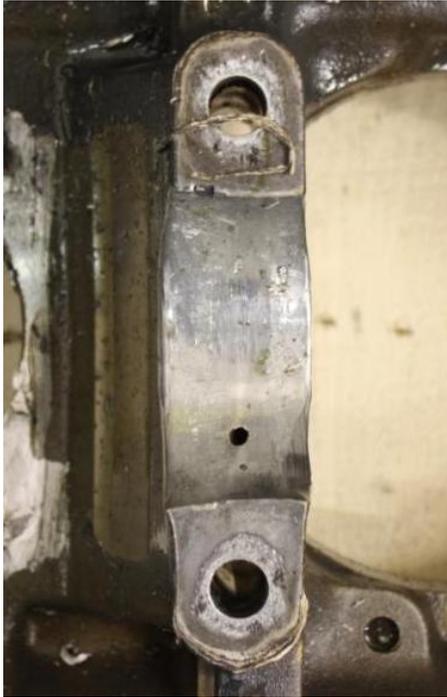
In particular, the main journal bearings number 2 and 3 had turned inside the crankcase. The crankshaft MJ number 2 housing was extremely worn due to the rotation of the bearings and the bearings were extremely worn and destroyed. This damage could not have been produced during the 4 to 10 seconds necessary to fully stop the engine after the power loss.

Figure 7: Main Journal number 2

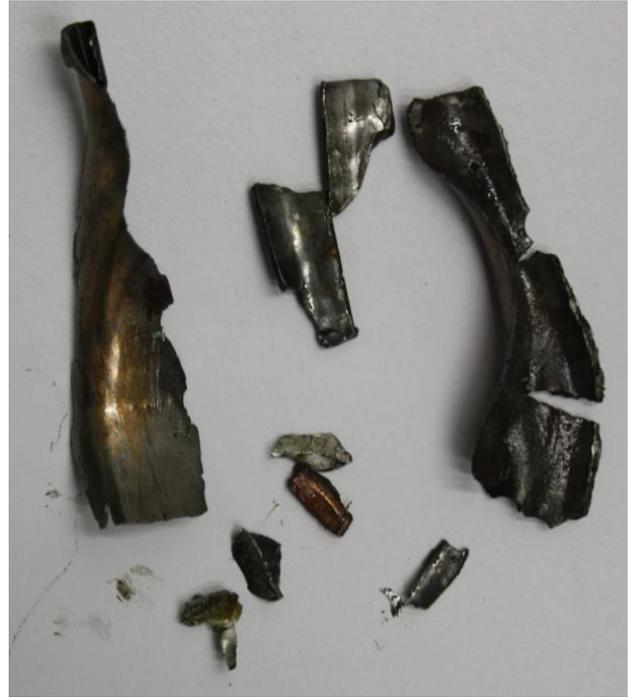
Figure 8: Main bearings number 2

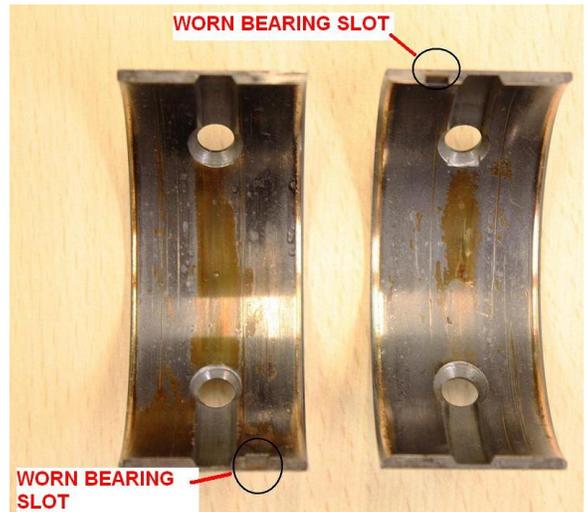
- The main journal bearings number 3 showed also evidence that they had turned inside the crankcase, but they were less damaged than bearings number 2.
- The bearings of connecting rod number 2 were extremely worn and damaged and showed traces of overheating. Additionally, one bolt of the connecting rod was broken, probably as a consequence of the crankshaft rupture.
- The crankcase halves showed evidence of fretting on the parting faces located around the thru bolts, in the area of the main journal bearing housings.

Figure 10: Main bearings number 3

The bearing slot of bearings number 3 were completely worn out and evidence of turning were visible on the outer surface of the bearings (bright appearance).

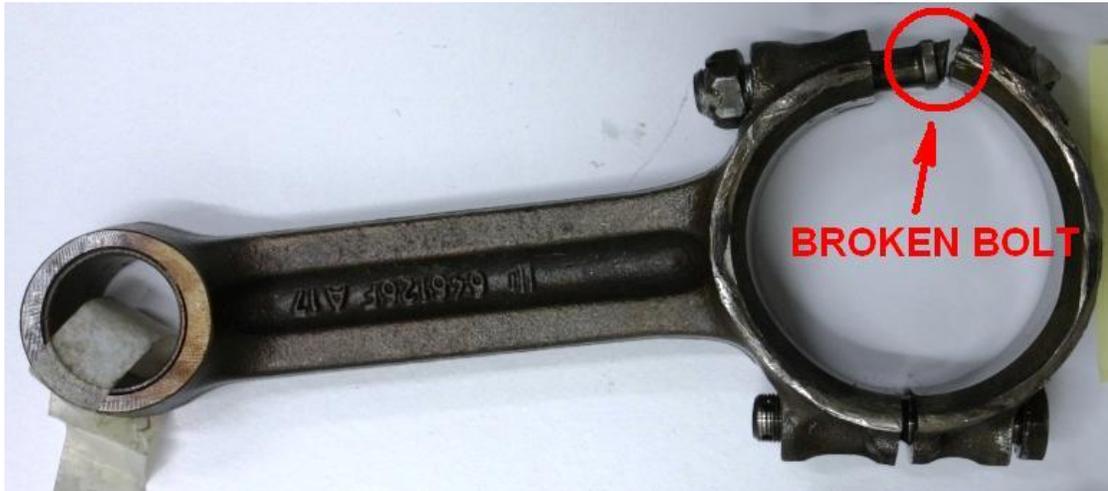
Figure 11: connecting rod number 2

- When rotating, the main journal bearings limited drastically the oil pressure necessary to properly lubricate the connecting rod number 2 the consequence being that extreme friction occurs at the connecting rod bearings.
- The extreme wear at the main journal housing did not allow the crankshaft to be adequately supported during rotation => vibration and deformation of the crankshaft.
- The friction of MJ bearings number 2 against the crankshaft main journal radius caused damage in the outer nitriding layer rendering the crankshaft brittle in this area.

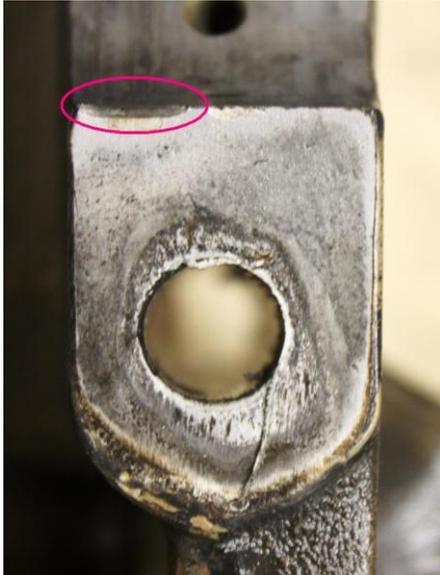
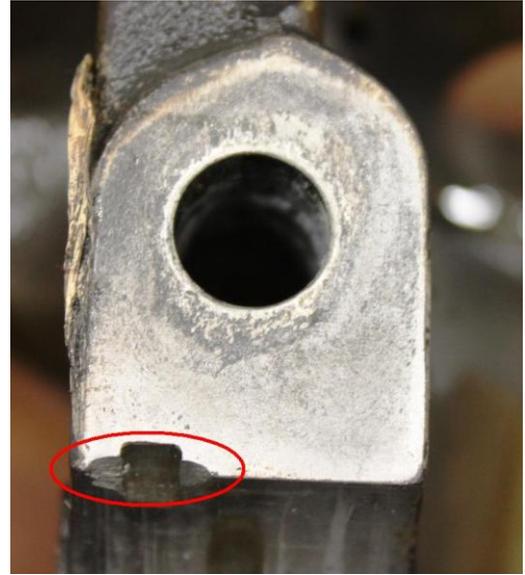
Figure 12: Examples of elongated bearing tang lock slot

It will also be noticed that the bearing begins “shifting” forward and aft also elongating the bearing tang lock slot.

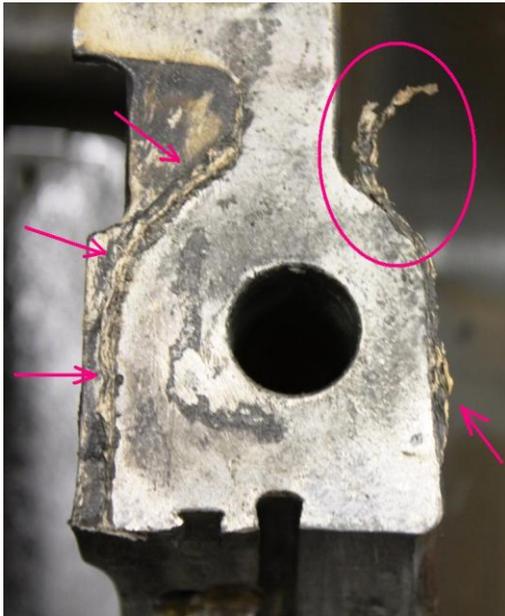
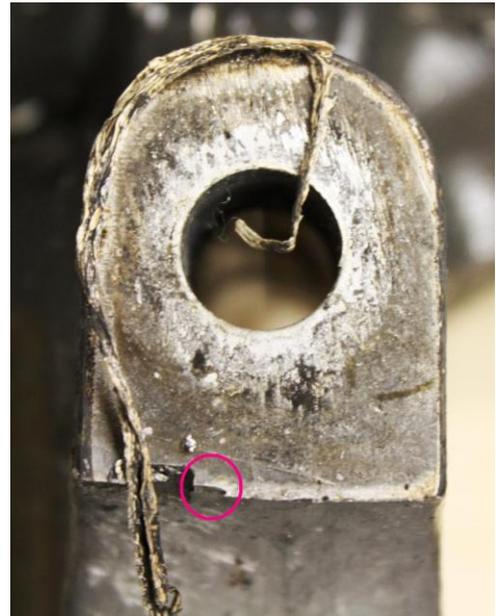
By contrast, the white sealant had completely worn out and was no more visible on the mating surface around the through bolts while a lot of remains of white sealant were present along their borders.

Figure 13: Examples of white sealant remains around the through bolts mating surfaces

Moreover, this white sealant was also installed on the parting surfaces located around the through bolts, which is not recommended by SIL99-2B.

If anything else other than Permatex and Silk string is used, the crankcase halves will move over time and wear out any type of sealant/silicon material that may have been applied.
