Safety Investigation Report

ACCIDENT TO PIPER PA-38-112 REGISTERED OO-MSG AT BETTINCOURT ON 3 MAY 2011

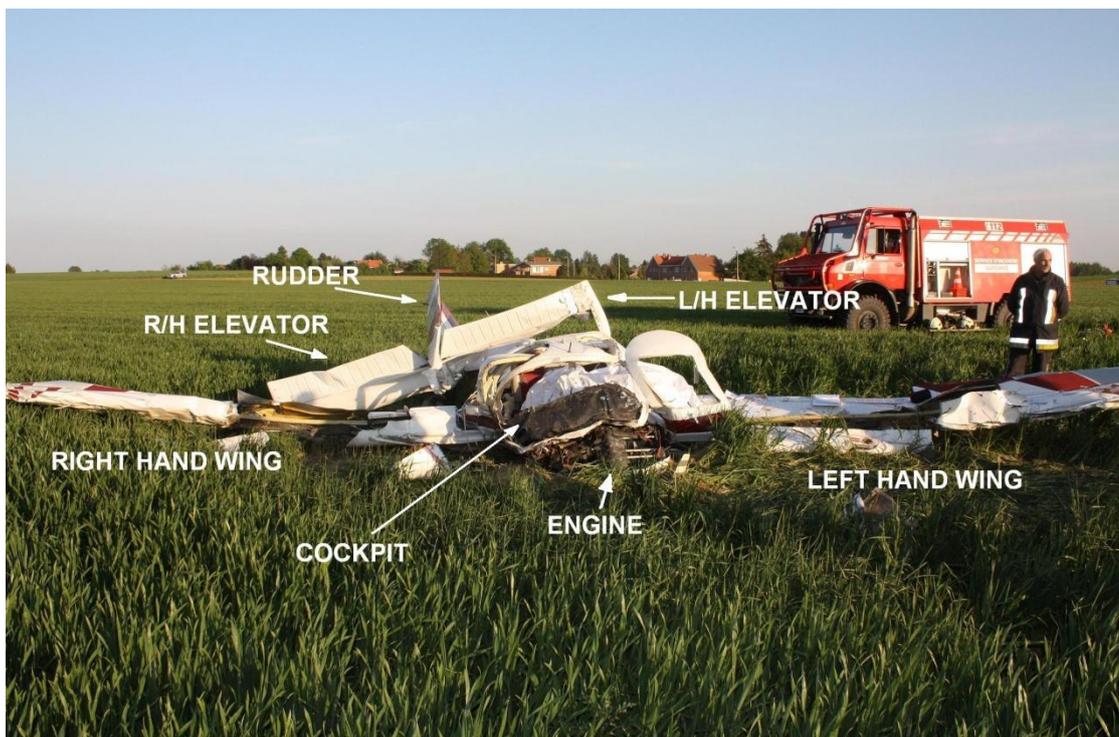
Figure 1

The airplane was totally destroyed.

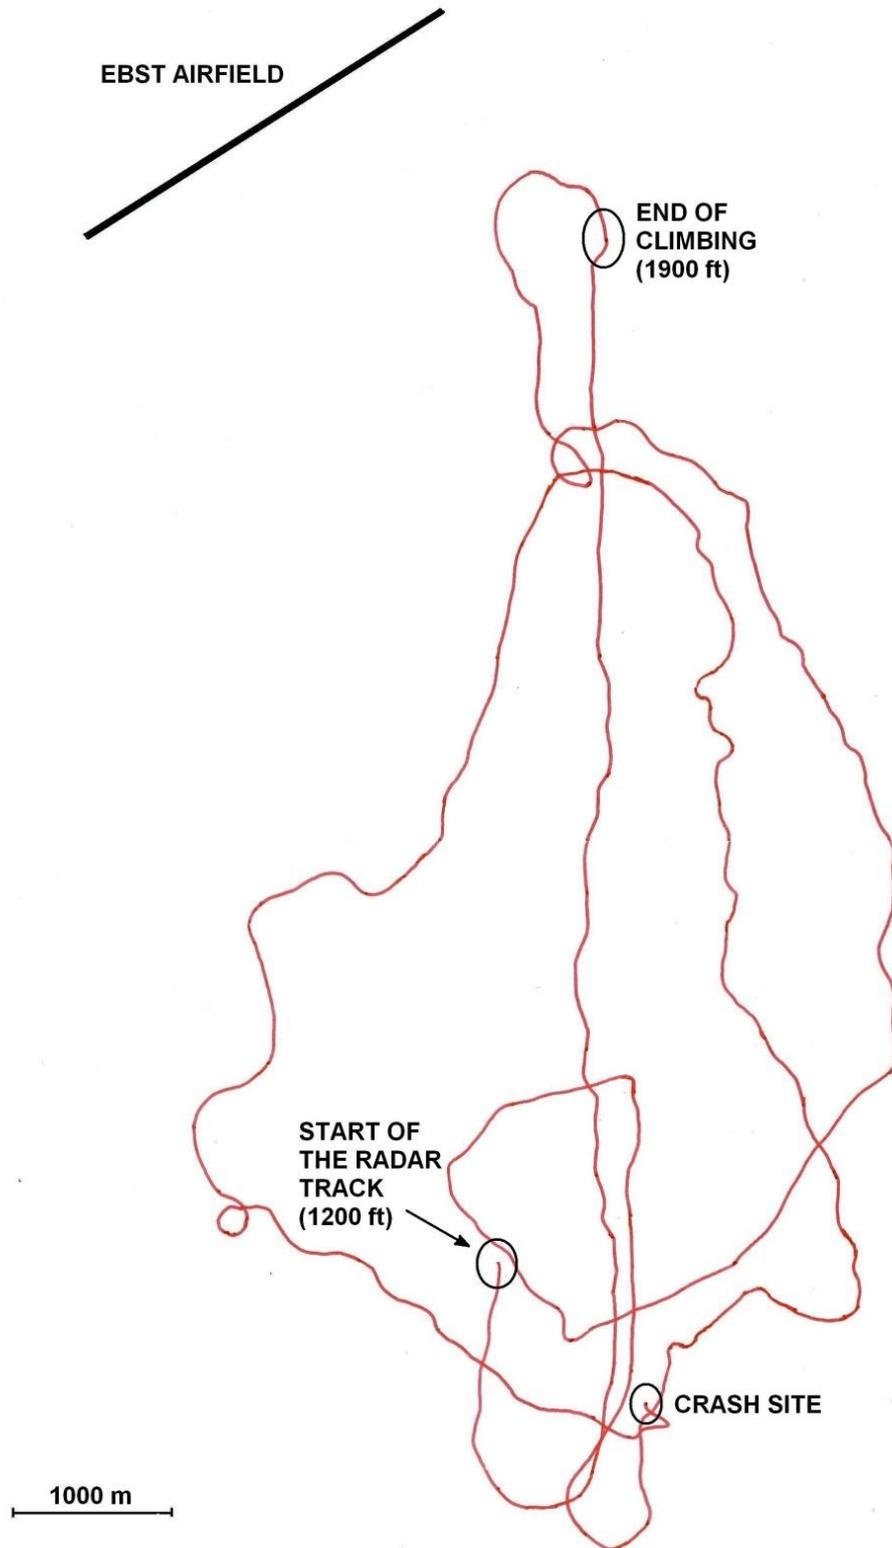
Figure 2

From 30 seconds to 15 seconds before the crash the speed decreases drastically.

The 3 last echoes (During about 15 seconds) do not give any value of speed and the two last plots don't give any value of altitude.
