# **FINAL REPORT ON THE ACCIDENT TO HM 293 REGISTERED 59CKF AT EBCF ON 25 APRIL 2011**

<b>Date and hour of the accident:</b>	25 April 2011 at 9:00 UTC
<b>Aircraft:</b>	ULM : “Henri Mignet” HM 293
<b>Accident location:</b>	EBCF Airfield
<b>Aircraft owner:</b>	The pilot was the owner
<b>Type of flight:</b>	Local flight
<b>Persons on board:</b>	1

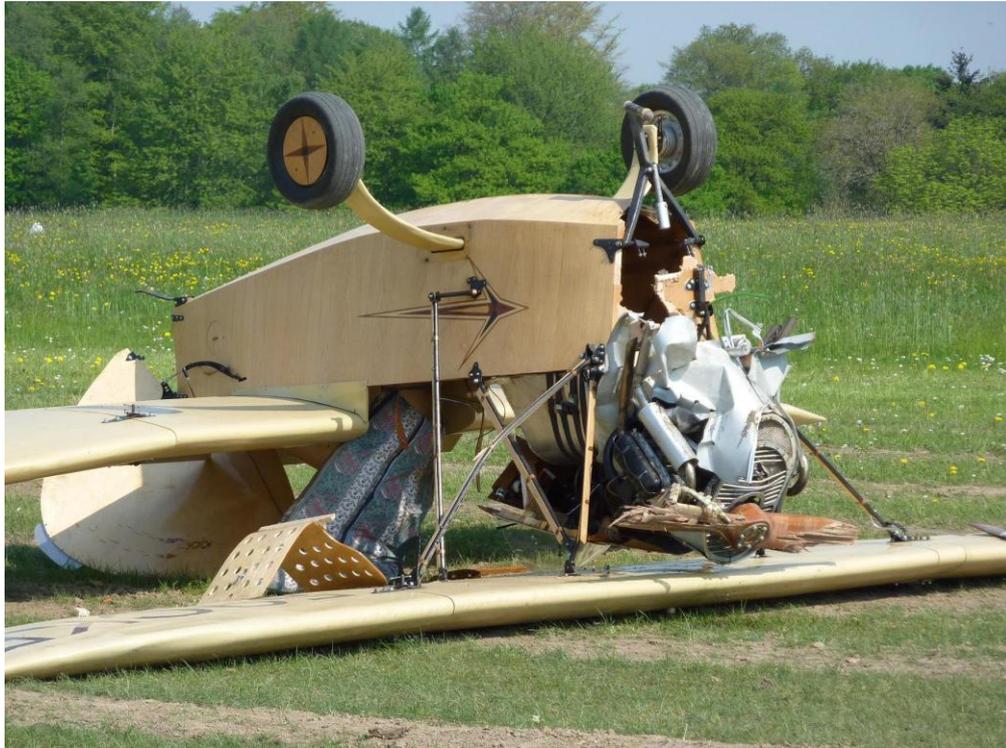
The propeller was destroyed, the engine was seriously damaged and the engine mount was completely crushed.

The front fuselage frame was completely destroyed and the fuel tank was pierced by the impact.

The front wings and the rudder were damaged during the flip over movement.

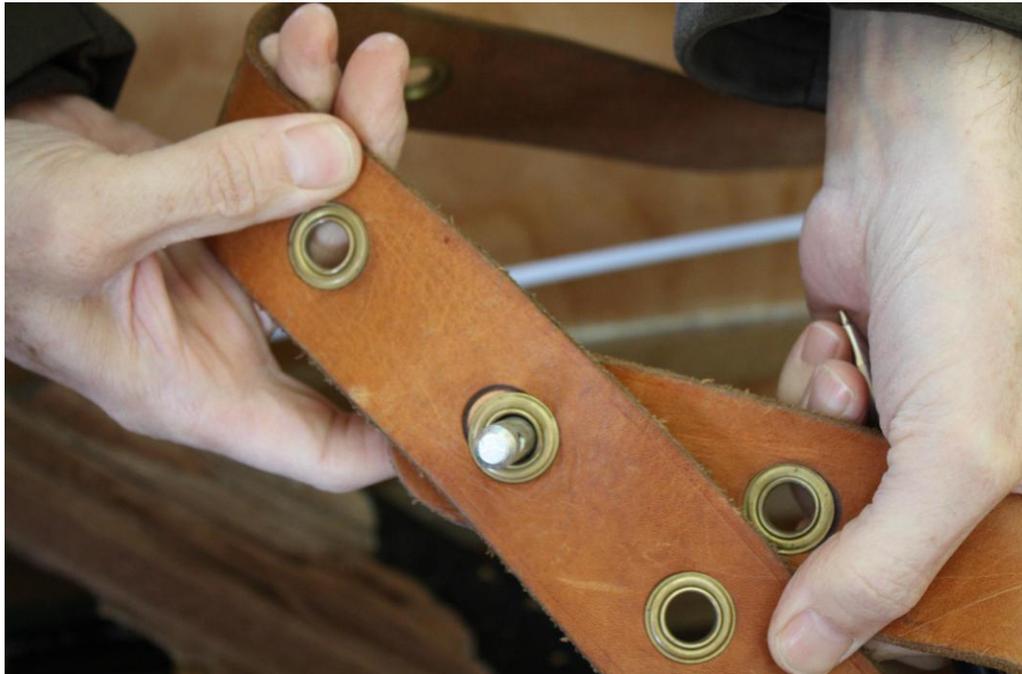
The safety belts were made by the aircraft manufacturer using leather belts that the owner got from a non aviation nor automotive source.

One of the two ventral straps was provided with a fixed pin while the other ventral strap was pierced with a few holes to allow the pilot to adjust the length of the straps.

The shoulder straps were also pierced with a few holes for the same reason as above.

The holes in the leather straps were reinforced by brass eyelets.

- To built or repair their ULM using only material or parts that meet the specifications of the designer.
- To verify the quality and the specification of the material or parts they acquire (*“Trust, but verify” - Ronald Reagan*).
- To install only high quality safety belts assemblies.

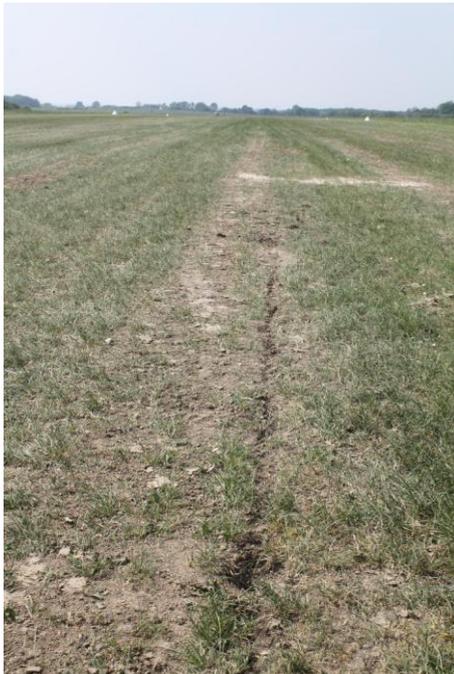
The airplane nose landing gear leg left a 5 meter long groove in the ground.

Then the propeller and the engine hit the ground and the airplane flipped over.

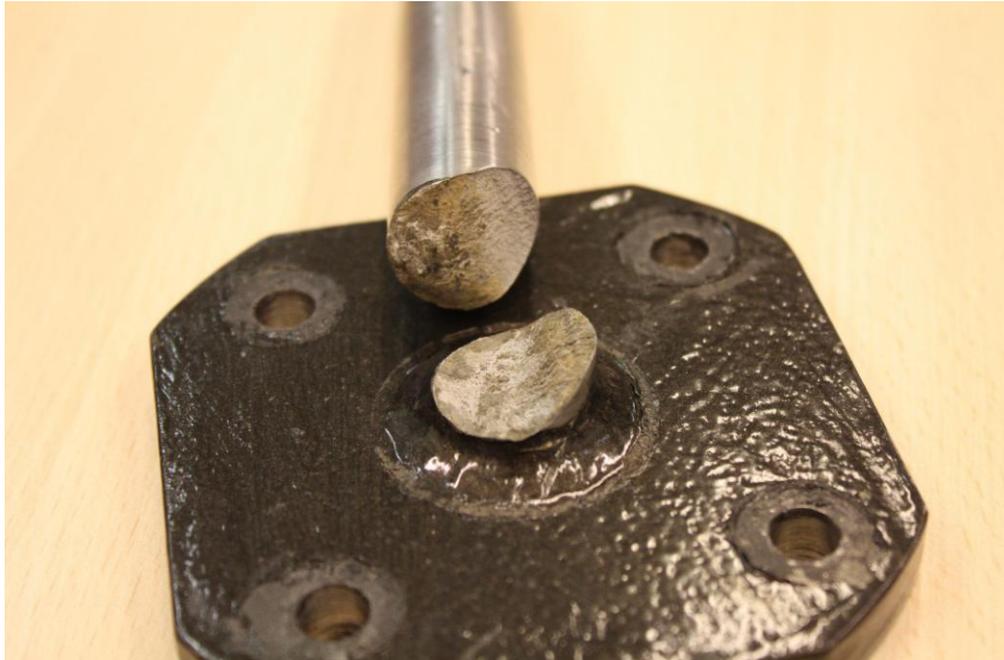
The axle of the nose landing gear fork was found broken at the junction of the square base.

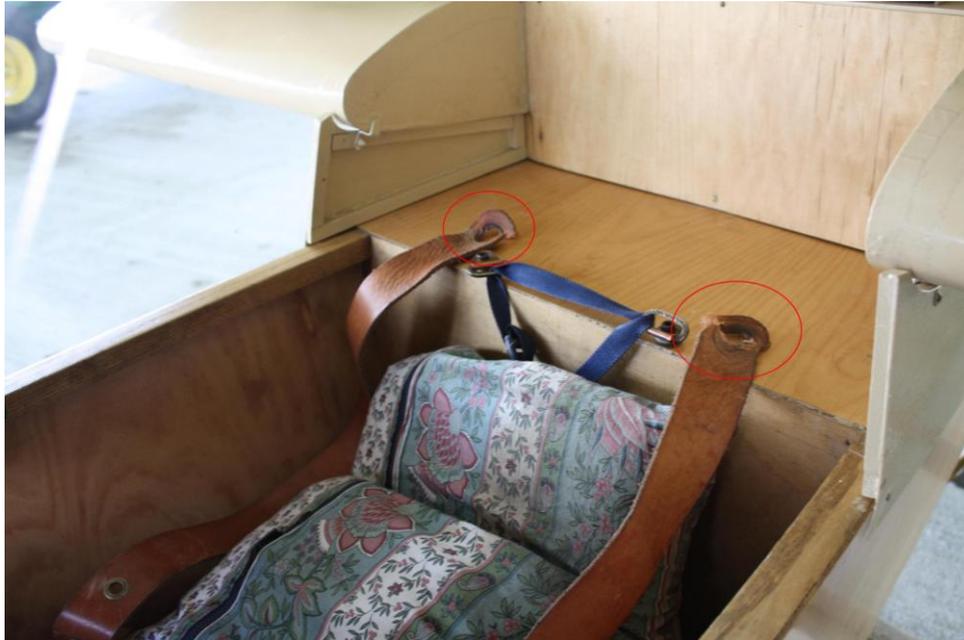
The two leather shoulder harnesses broke upon impact at the fixing to the fuselage.

As consequence the pilot was injured during the crash when his head hit the instrument panel and the windshield.

The pilot wore his safety belts and shoulder harnesses.  
The shoulder harnesses straps did not resist the pilot upper body inertia and broke upon impact at their fixation to the fuselage structure.

On the other hand, both the attaching points of the airplane fuselage structure and the ventral straps withstood the forces without any apparent damage.

The owner/manufacture of the airplane did not find it necessary to install approved safety belts and did not calculate or test the resistance of the assembly.

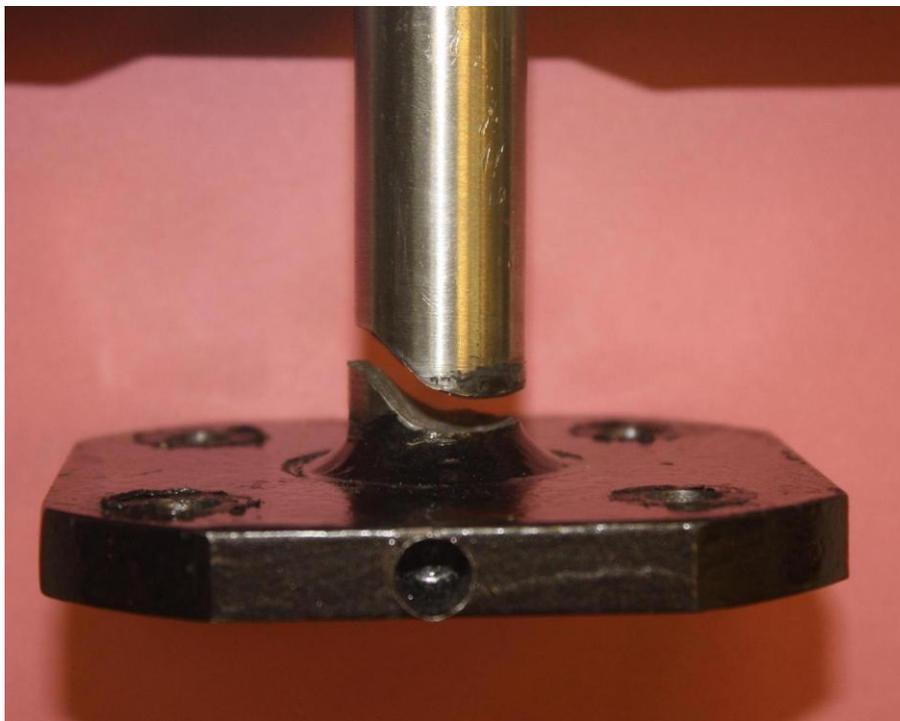
The nose wheel and fork assembly was retrieved forward of the wreckage and was broken close to the welding with the square base fixture of the fork.

Obviously the “stub steel” that the owner used to manufacture a new nose wheel and fork assembly was not equivalent to either the 25CD4S or 4130 specification and did not fit for this type of assembly by welding.

Moreover the information contained in the shop catalog clearly mentions “Very bad welding”.

The cause of the accident is the failure of the nose wheel fork.

The failure occurred because of the use of a material that did not meet the landing gear designer specifications.
