**FINAL REPORT ON THE ACCIDENT
TO THE HOT AIR BALLOON KUBICEK
SPOL. S.R.O. – BB37N
REGISTERED OO-BHA IN OUDENBURG ON
22 APRIL 2011**

Ref. AAIU-2011-09
Issue date: 3 November 2011
Status: FINAL

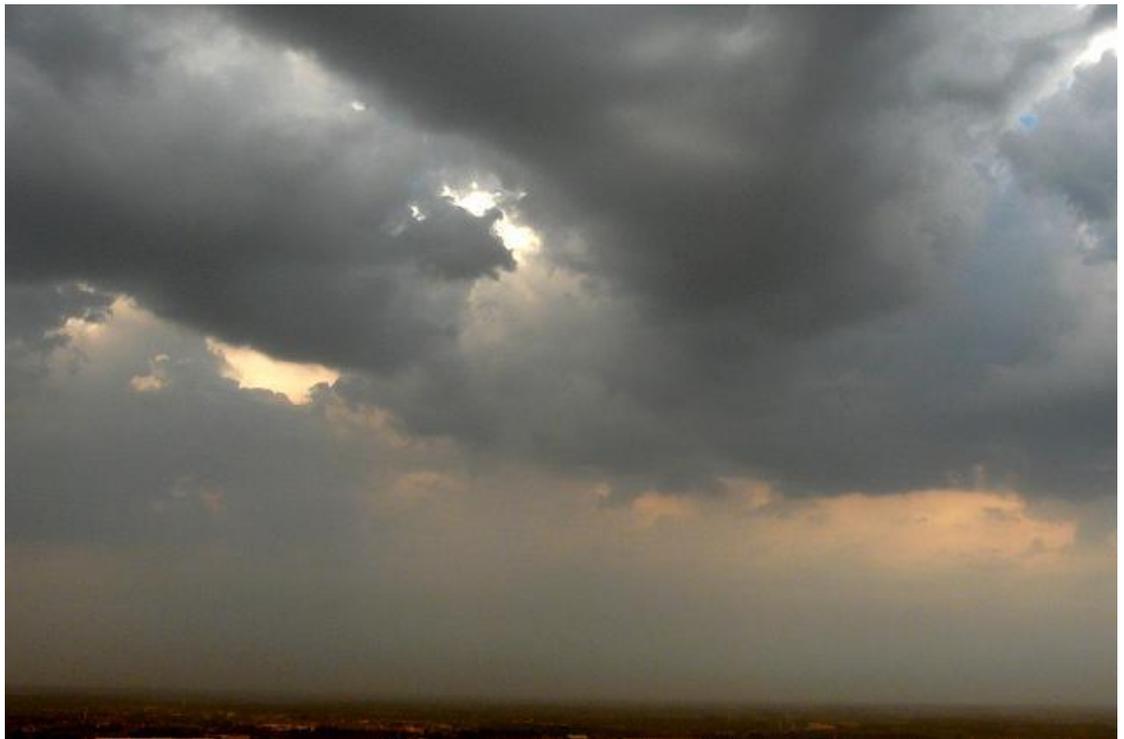
A passenger took a picture of the sky. The weather was becoming increasingly menacing.

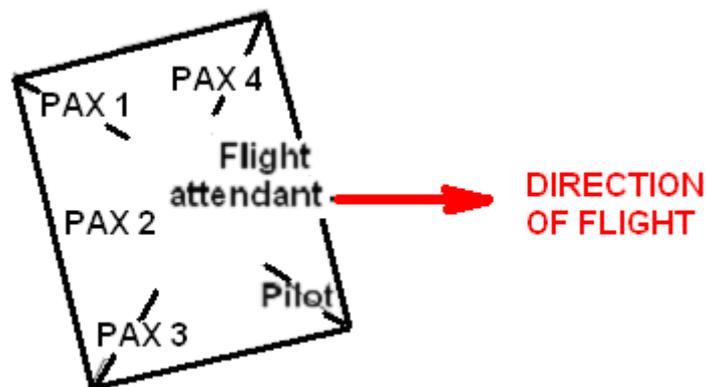
Passengers reported that the standing configuration inside the basket was as follows:

Passengers holding onto the burner support rods tend to have their center of gravity higher than those holding onto the handle; This would have contributed to the first passenger to be drawn outside the basket, when the basket swivelled upon impact.

Also, holding onto the burner support rod implies that passengers have their arms outside the basket, and when the basket skidded on the ground, one passenger got her arms caught between basket and ground.

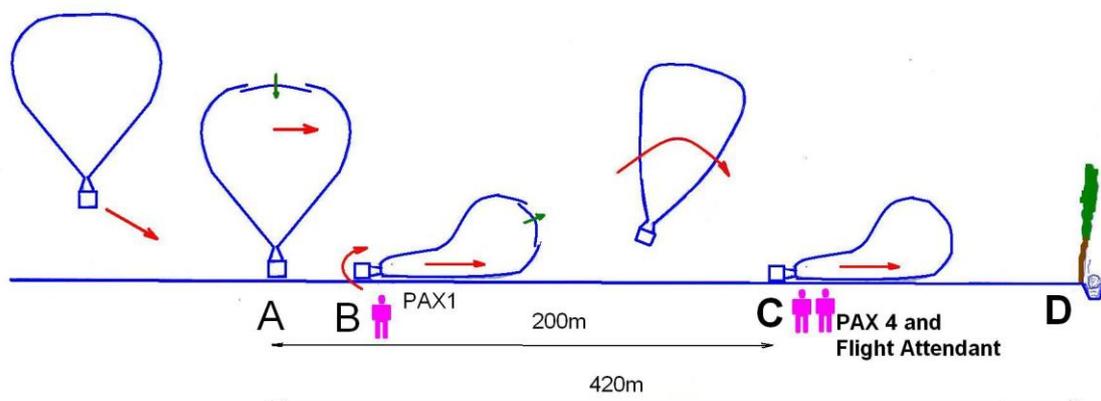
Fig 1. Impact sequences

The ground crew member reported seeing the balloon coming low, in a controlled descend, although the wind condition would have made the landing a rough one. He saw the basket touching down.

A wind gust close to the ground increased the ground speed to 43 km/h, increasing the impact forces upon touch down. As the basket could not be positioned perfectly with respect to the ground, the touchdown caused the basket to swivel round one of the corner.

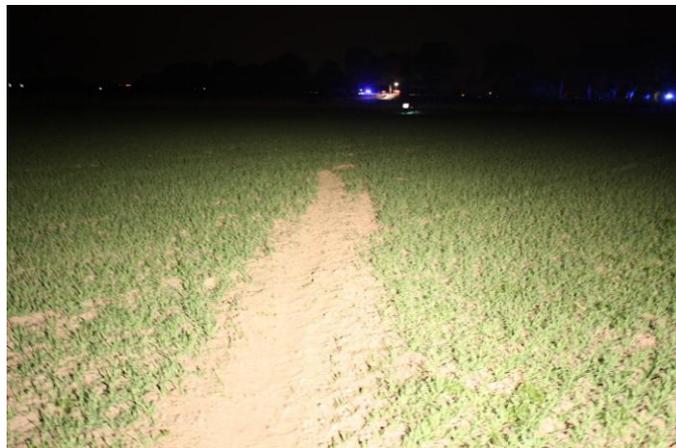
Ground trace between A and B

The basket was dragged on the ground for 50m.

PAX 1 was still hanging out the basket, caught between ground and the basket skidding on the ground. She asked to PAX 4 what to do, and he said her to let go. She did it, and escaped the basket breaking her hip in the process.

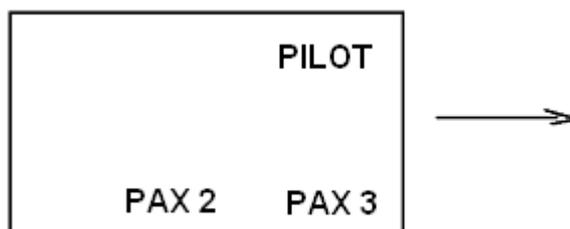
During this time, PAX 3, standing next to the pilot was not anymore clenching one mount of the burner, but had got her arms dragged under the basket. She got one wrist (LH) broken, with the flesh of the arms burned due to the friction.

The other remaining passenger, PAX 2, still holding the rope handle, recalled shouting to the other passenger to keep her head up, and both recalled seeing the pilot laying face down, the arms also caught between basket and the ground, his head banging violently to the ground each time the basket bounced.

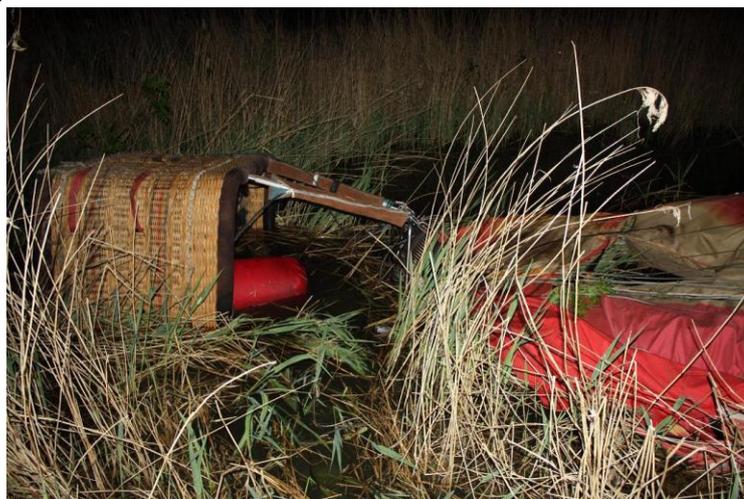
Final Resting place (D)

The balloon reached the tree line, and the basket went into the ditch, before stopping.

One passenger had her leg blocked by a gas bottle, but managed to climb out of the water-filled basket, along with the other passenger.

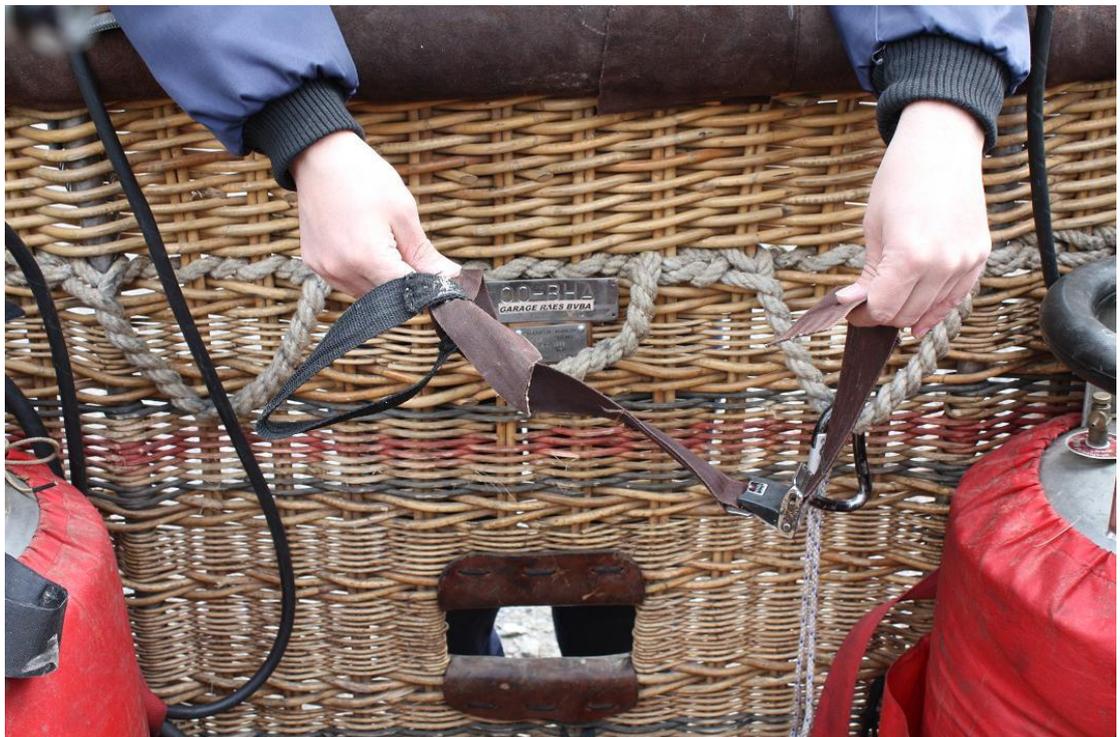
The pilot was using a restraint system to secure himself inside of the basket; a loop was passed on a waist belt on one side, and was fastened to a basket's handle with a D-Ring. The waist belt was cut when extracting the pilot.

Although both systems were not designed to restrain the pilot in the vertical axis, the system used by the pilot would provide more limited efficiency in the vertical axis, with the potential risk of hitting the burner structure with the head.

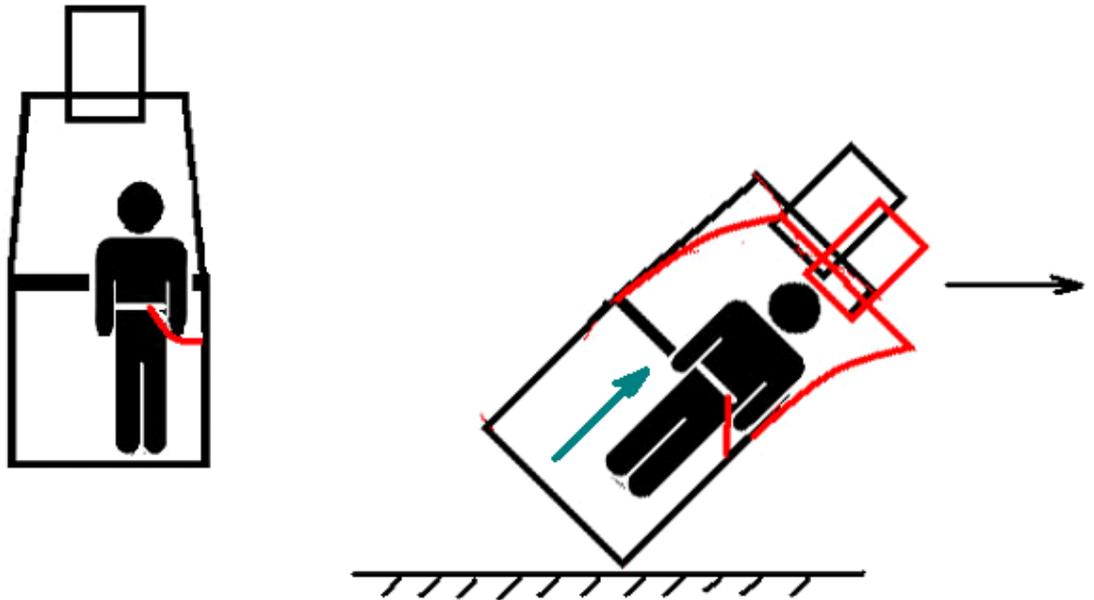
1. Collision with the burner structure.

Since he was standing, he took the full blow of the impact, and it is reasonable to think he banged his head to the burner frame; the restraint system allowing a (limited) vertical movement.
