Safety Investigation Report

ACCIDENT TO AN EUROCOPTER EC120 IN SOUMAGNE ON 18 OCTOBER 2011

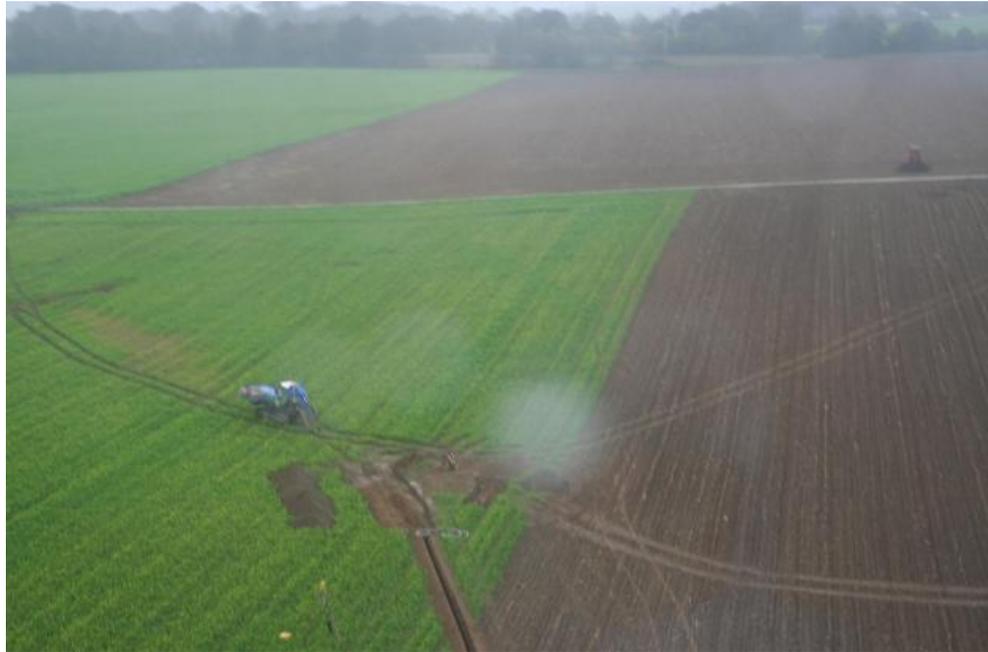
Fig. 2. Last picture taken in the helicopter

The passenger used the camera to record the activities in the vicinity of the pipe-line. The last picture shows degrading weather, and rain.

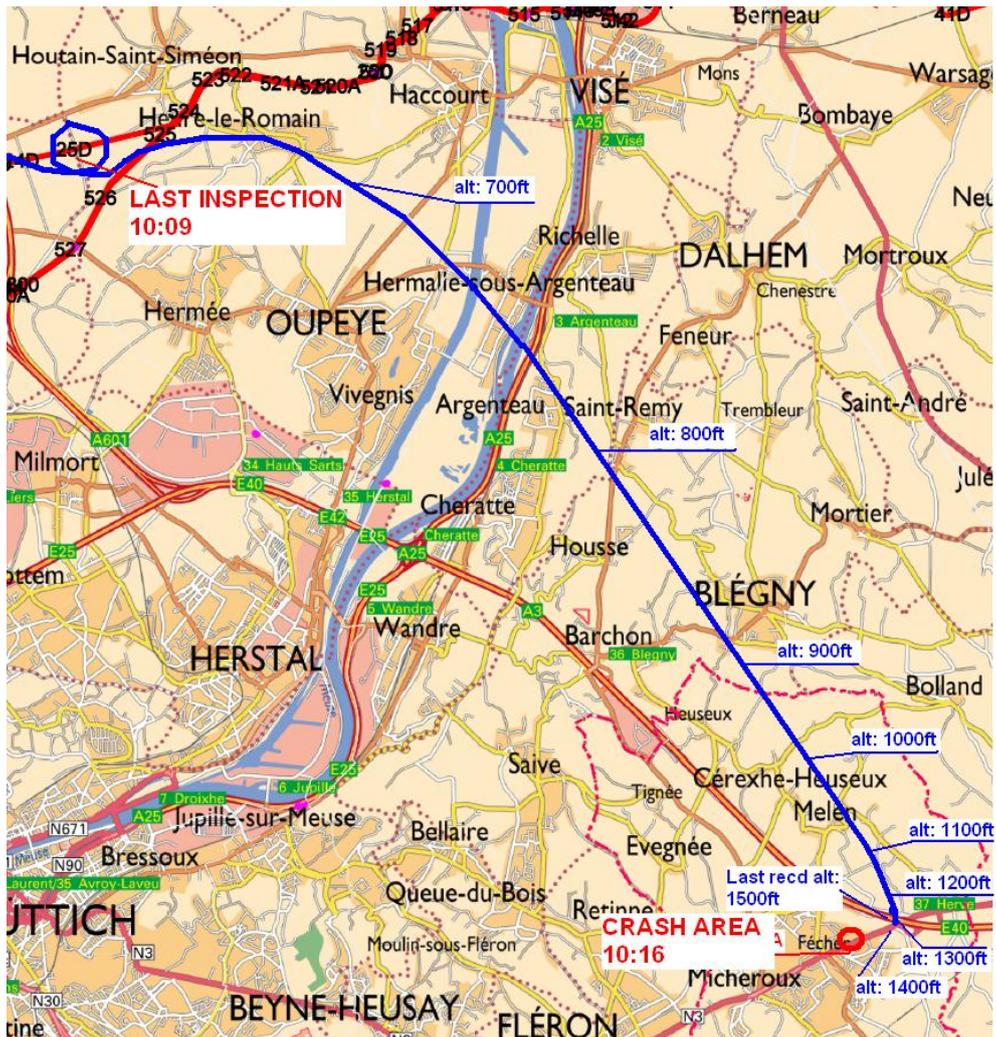
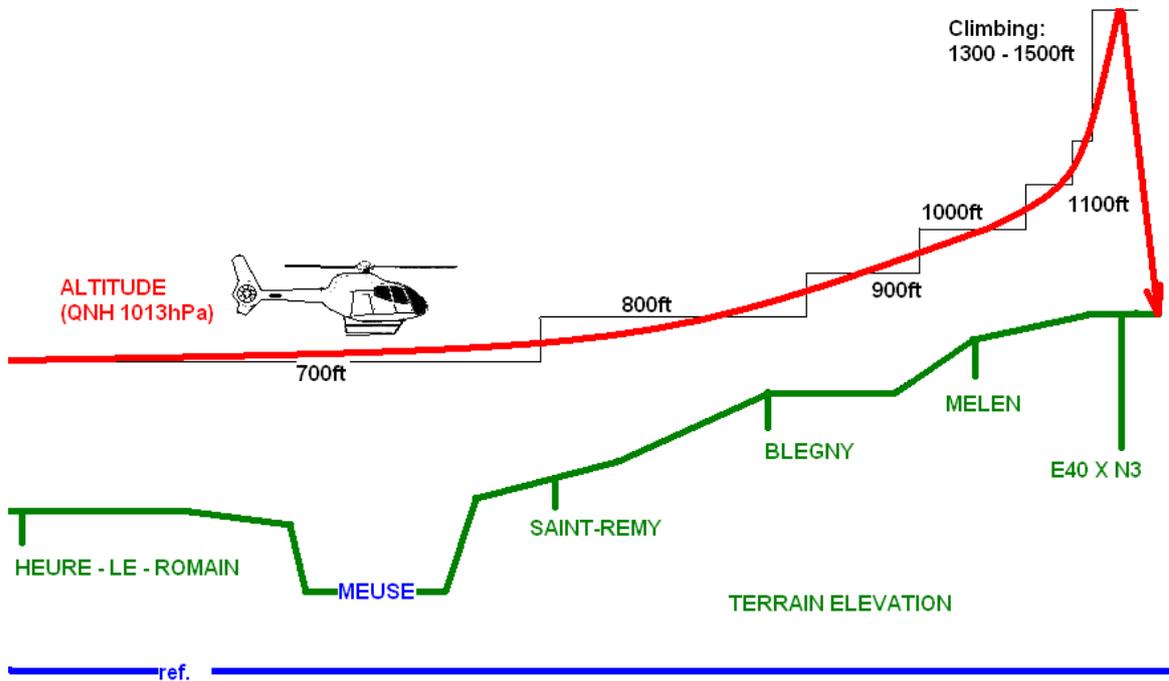
Fig 7. Return flight (radar trace)

The radar trace shows the helicopter flying in a South Easterly direction, with the Highway E40 at its right hand side, at normal speed.

When reaching the area of Blegny, the helicopter climbs gradually to 1100 ft. Upon reaching the intersection with E40 and N3, the helicopter climbs up to 1500ft, and the horizontal speed drops. The direction of flight fluctuates in a clockwise direction. The helicopter then disappears from the scope at 10:16.

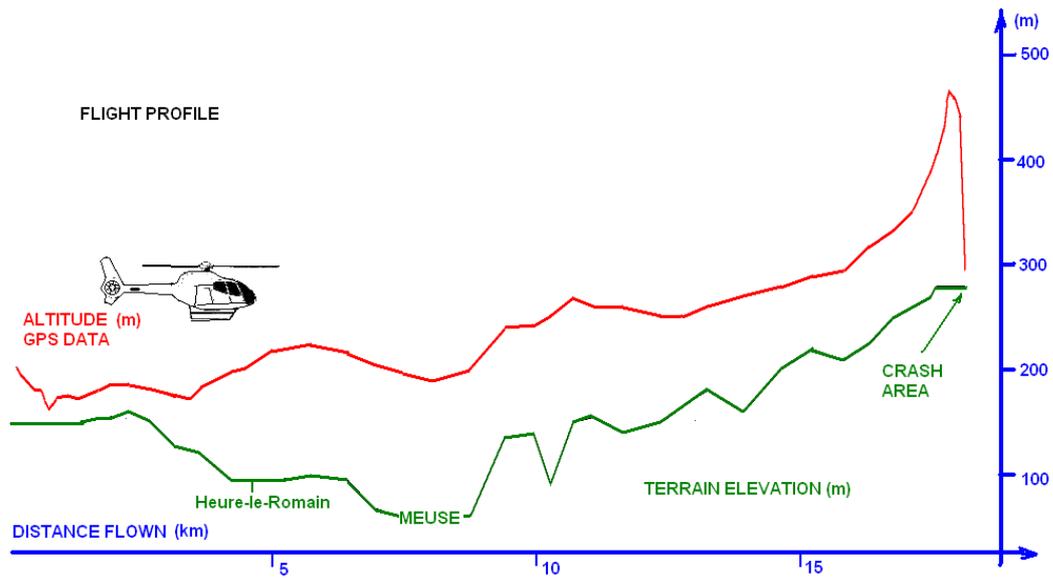
Fig. 9 – Flight profile (GPS data)

Among others, the GPS data confirms the helicopter altitude; the average cruise speed is around 170 km/h.

The GPS gives information of the flight of the helicopter during the last minute: (Fig 9). The speed value are computed from the distance between position and the elapsed time.

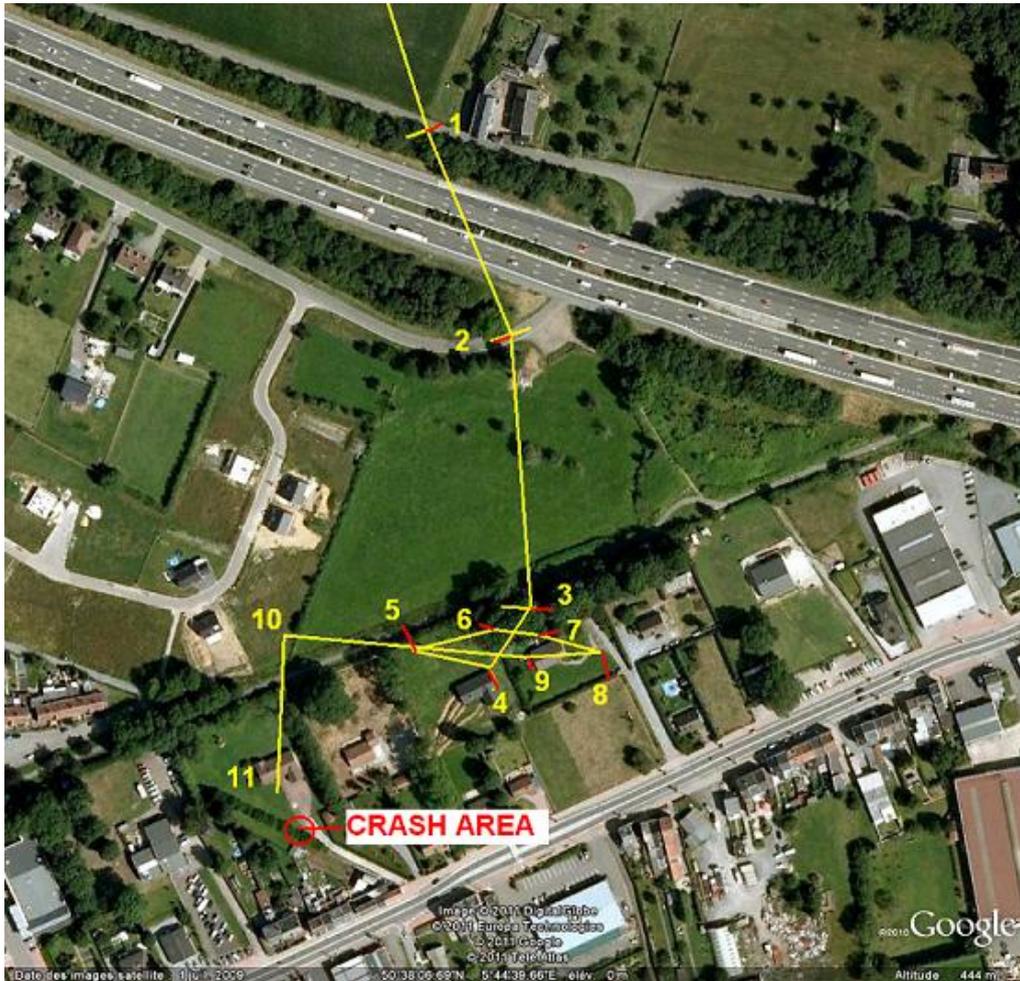
Fig 10. Last 30 seconds

Pos.	Time UTC (hh:min:sec)	Altitude (m)	Speed (km/h)
1	10:15:21	389	152
2	10:15:24	405	129
3	10:15:29	429	101
4	10:15:31	436	67
5	10:15:37	455	27
6	10:15:42	466	31
7	10:15:44	464	40
8	10:15:49	462	24
9	10:15:53	459	34
10	10:15:57	441	110
11	10:15:59	296	297

The helicopter kept turning, as seen on the GPS recording, and the pilot lost control. It is believed that the turning rate in IMC caused the spatial disorientation of the pilot. When the helicopter came lower, still turning, it was too late for the pilot to regain control of the helicopter.

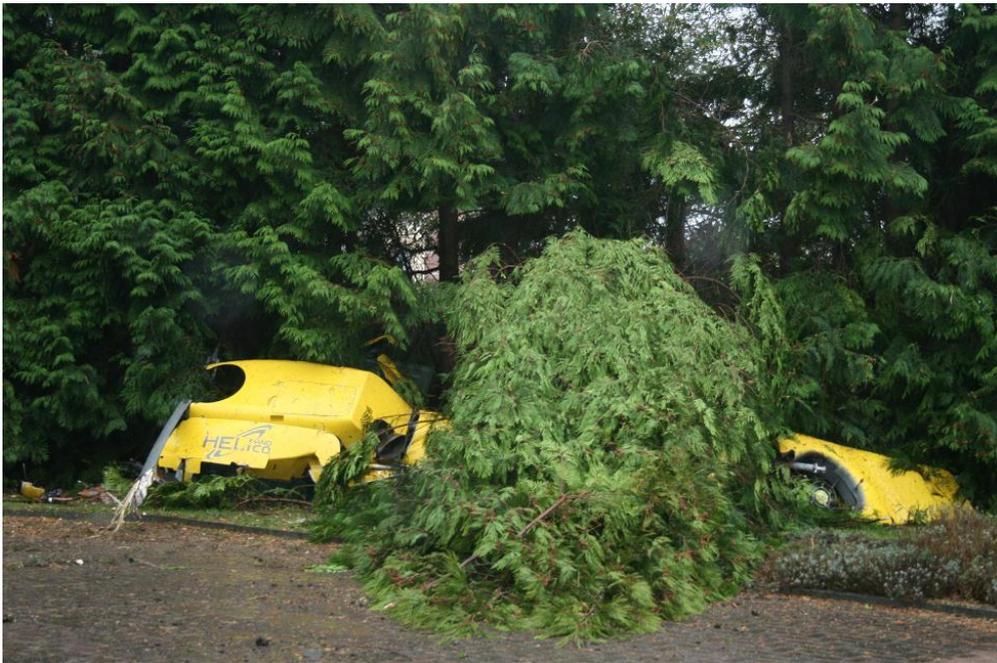
Fig 13. Main body of the helicopter as found by the emergency services

The wreckage lies in the garden of a house close to the N3 road, at 300m from the E40 highway (Liege – Verviers). Small parts of the helicopter were found in the gardens in the vicinity.

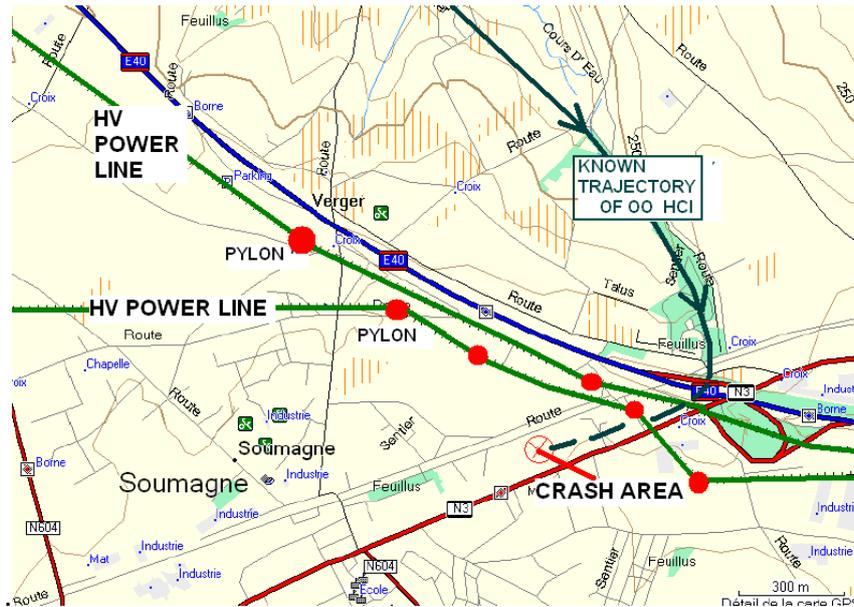
Fig.14 Location of Power lines

Coming from the NW, when reaching the crash area, the helicopter had to cross 2 electrical High Voltage Power Line, one bordering the highway; the other joining the first, 400m from the crash area.

As reported by Heli and Co, the helicopter would need to be at 1200 ft QNH to pass the line with safety.

When reaching the highway, the helicopter had to climb to avoid the high voltage lines; the GPS and the radar data show the helicopter climbing 300ft. At this height, flying at 152 km/h, it went suddenly in IMC condition.

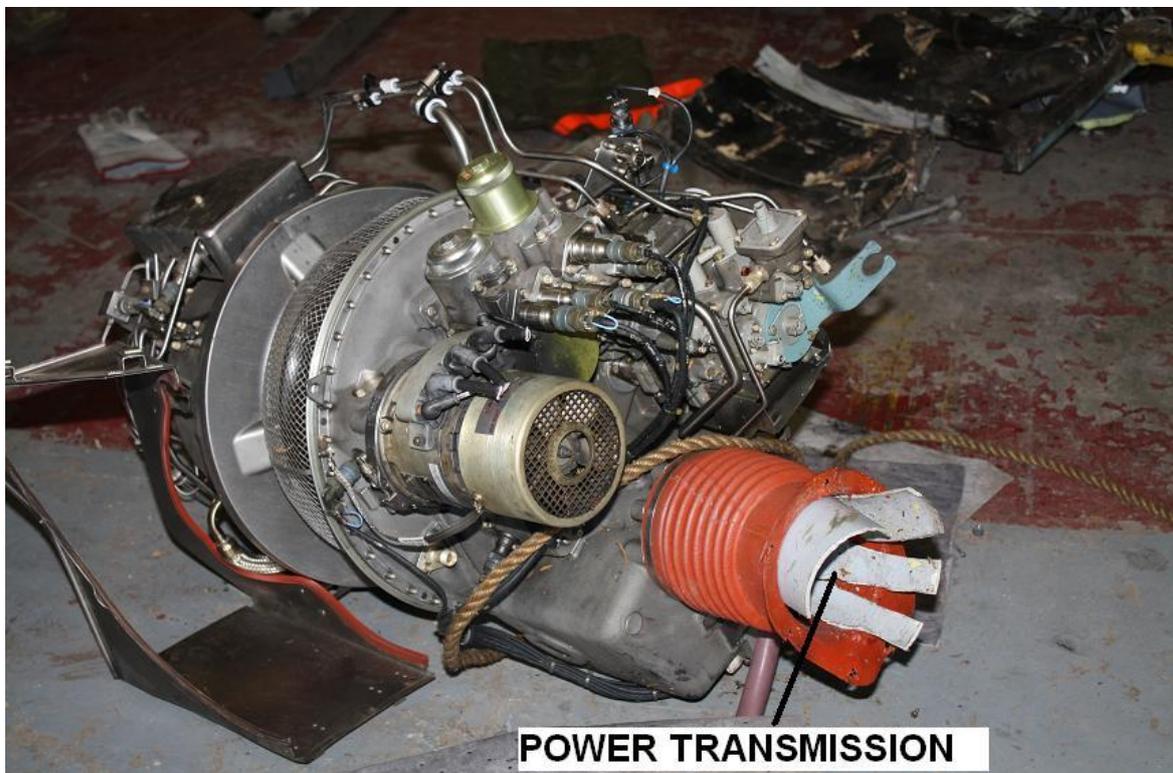
Fig 16: Engine

The engine was removed from the helicopter structure. The damage to the transmission showed the engine delivered power at impact. The free turbine rotated freely, as did the gas turbine. The compressor and turbine blades, as the combustion chamber showed the presence of white particles, coming from the deterioration of the inner labyrinth seals (damage consecutive to a internal movement of the gas turbine, further to the impact). The fuel filter clogging visual indicator, as well as the oil filter were found in the normal (not popped-out) position. The magnetic chip detector did not show any presence of particles

The engine was in good mechanical condition, and the detailed examination determined that it was delivering significant power at the moment of impact;

- There were traces of beat on the splines of the transmission shaft sleeve and on the muff coupling (Main Gear Box) indicating that the engine was running at the moment of the disengagement of the coupling shaft.

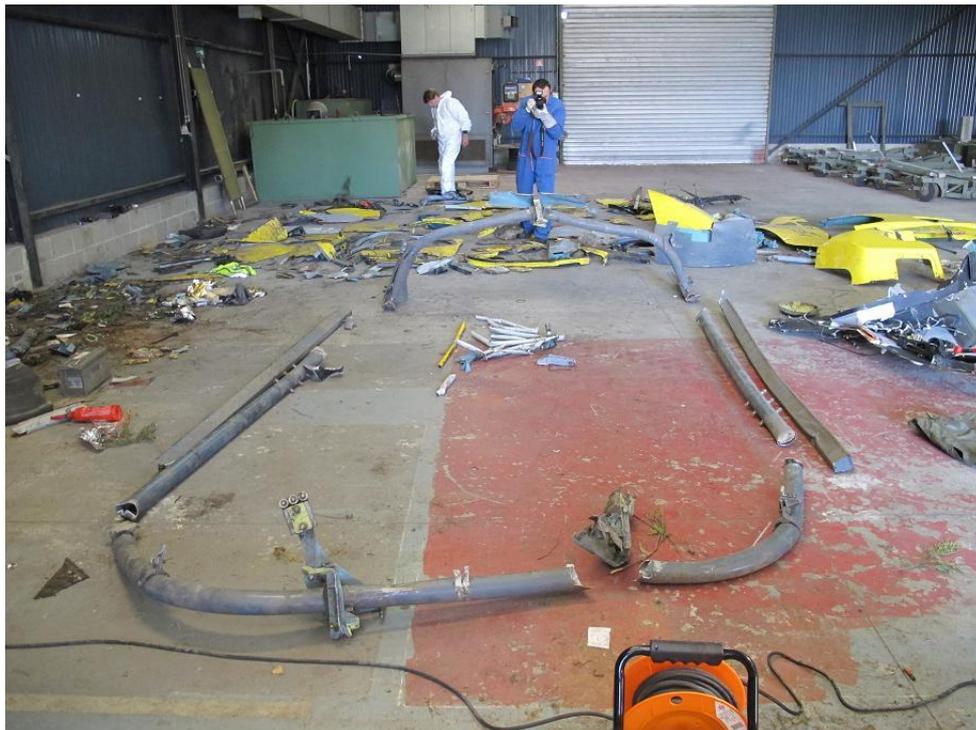
Fig 17: The skids

The structure of the helicopter shows only static fractures, and mostly vertical efforts.

The skids show deformation to the rear.

The cabin floor forward side is deformed upward.

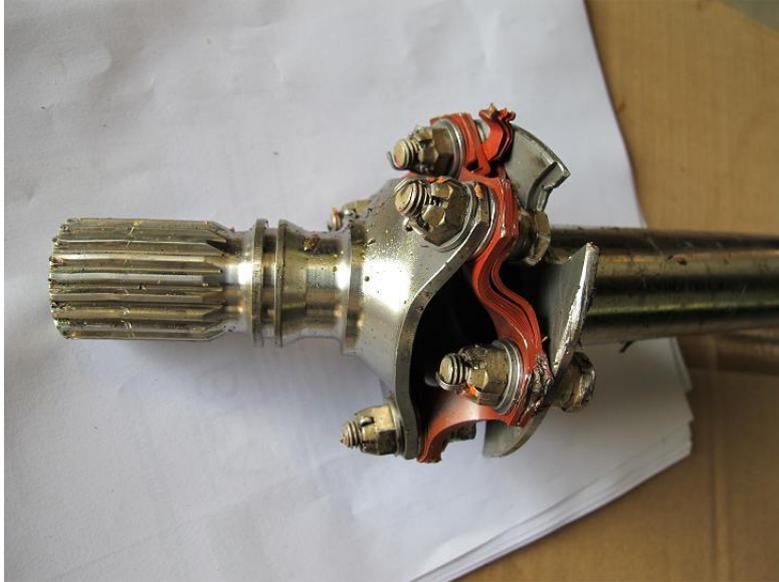
Fig. 18: Power transmission

The power transmission shows breakage and deformation under power. The connection grooves show damage made during rotation.

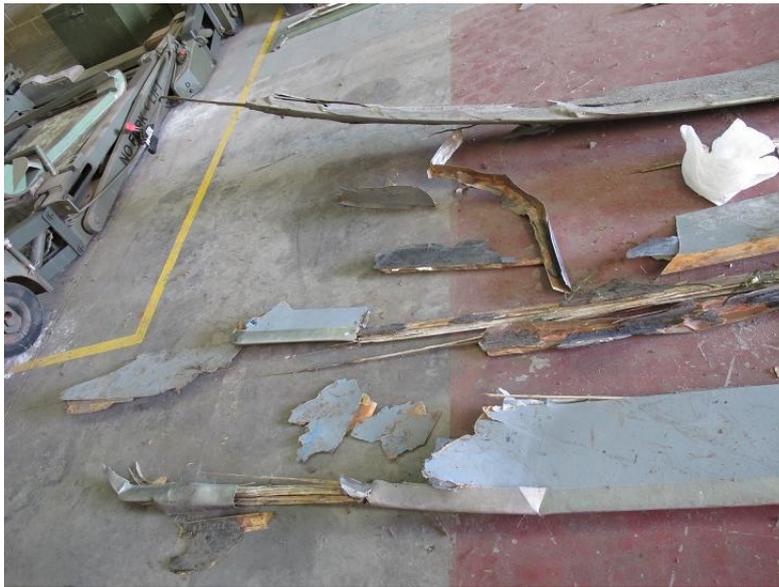
Fig 20: blade tips

The blades show impact damage with a fixed structure (tree).

The yellow blade shows less deformation, but the deformation of the main rotor showed the rotor hub had a tendency to continue the rotation while the main rotor blades were stopped.

Only one blade tip was found (it was found 213 m away from the main wreckage).

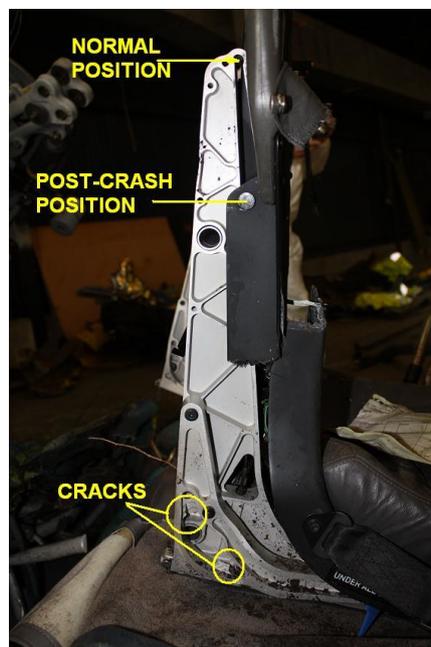
Fig.21: Seat

RH Seat: - LH absorber: 12.5 cm
 - RH absorber: 12.5 cm

In addition the lower structure of the seat are broken.

Note: a book (flight manual) was inserted under the pilot's seat; this might have had a negative effect on the ability of the seat to mitigate impact forces.
