FINAL REPORT ON THE INCIDENT TO AVRO RJ85 REGISTERED OO-DJK ON FRIDAY 11 FEBRUARY 2011

Ref: AAIU-2011-02-Marseille-OO-DJK

Issue date: 14 October, 2011

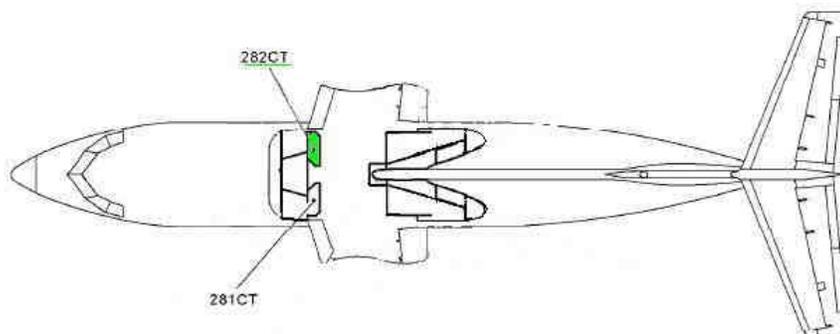
During climb at approx 10.000 ft, a bang has been heard by the crew. There was some slight vibration but all parameters remained unchanged. Aircraft continued his flight to BRU and landed uneventfully. In BRU it was found that the composite top wing leading edge fairing panel (identification number 282CT) above the centertank was lost. In this case this only caused secondary damage on the auxiliary attachment structure.

Figure 1: Location of the detached panel 282CT

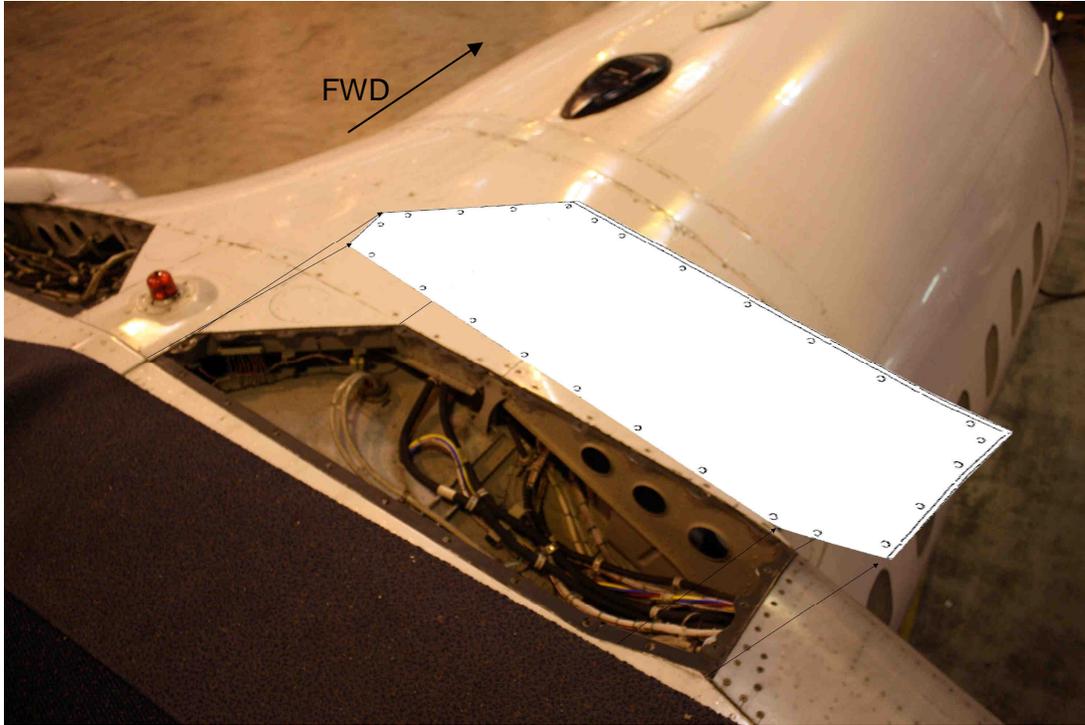
Loss of fairing panel and damage on the auxiliary attachment structure: cracked angles and broken grommets holding the bolts. The bolts were all still located on the aircraft. No secondary damage on the fuselage or flight controls.

Figure 2: Schematic view of the detached panel

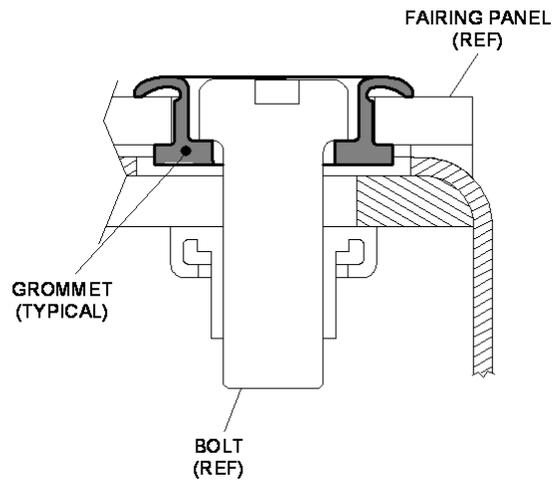
Figure 7: Cross section view of SL5183 installation

Comparing Figure 7 and Figure 9 it is obvious that there's a change of design and the new grommets have a larger and thicker collar.

The SL5183 standard of grommet is also vulnerable because the radius formed by peening over the head provided only a small area at the top of that radius. Only a small amount of material needs to be removed to compromise the structural integrity of the grommet (See Figure 11).

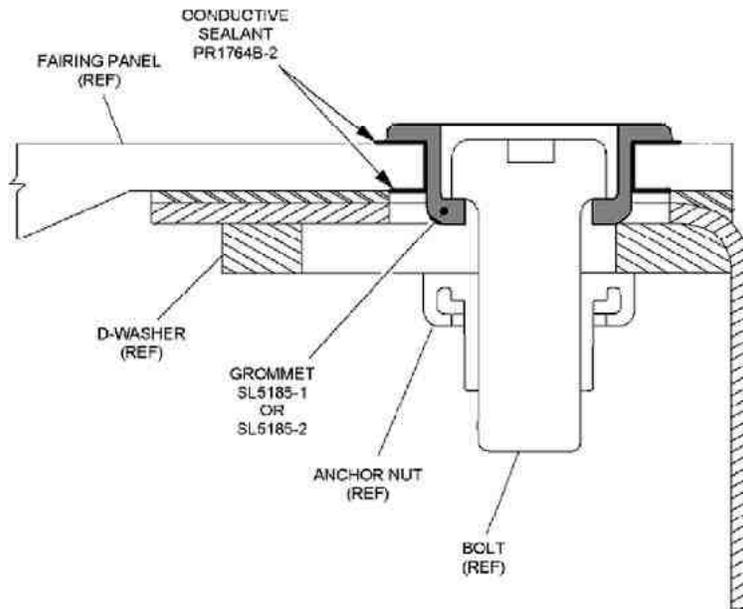
Figure 9: Cross section view of SL5185 installation

The new SL5185 grommets are inserted from the external side, eliminating the need to form the flange with a peening tool.

found, the grommet has to be replaced by a redesigned grommet (PN SL5185) which has to be inserted into the panel from the external side. See Figure 9.

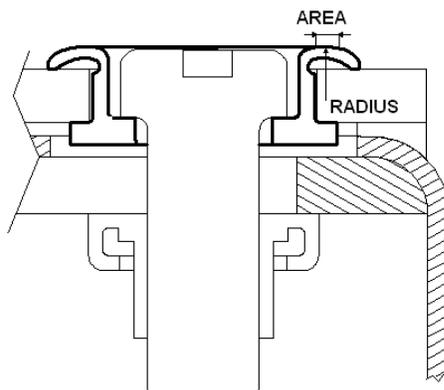
Figure 11: Illustration of vulnerability

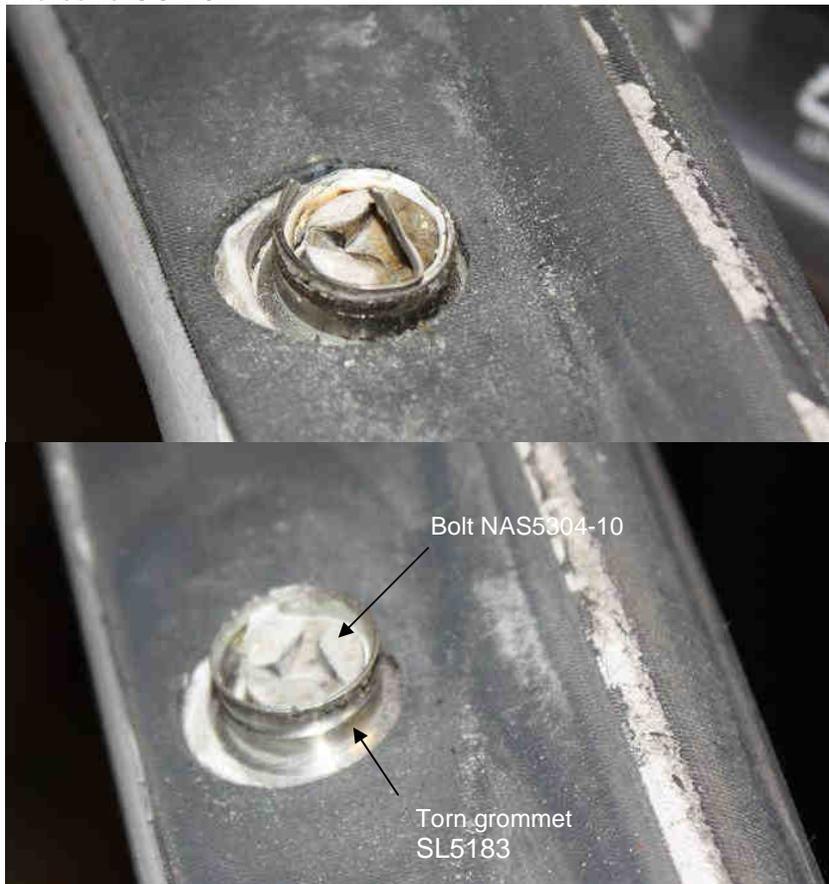
When looking to the structure at the location where the panel was detached, the collars of grommets at the FWD side of the panel were found broken off. Some grommets at the AFT side still were intact. So we can conclude that the panel first detached at the FWD side allowing the air to enter under the panel. Due to the total air pressure the panel was pulled through the aft grommets and completely detached.

Figure 12 : Pictures of the torn grommets

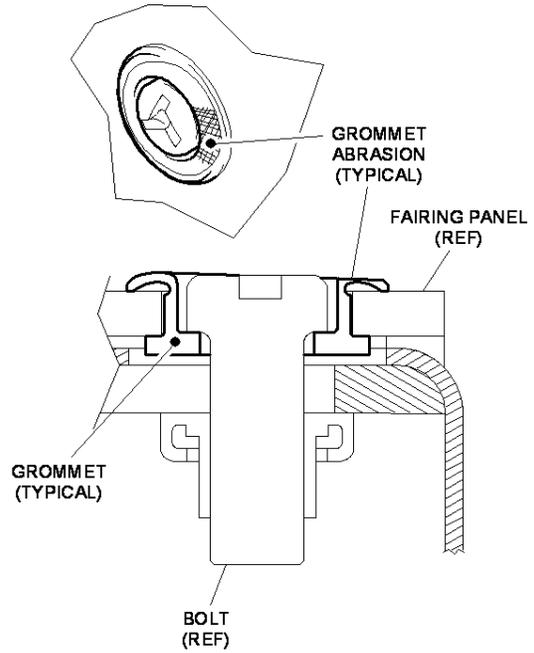
ABRADED GROMMET IN-SITU

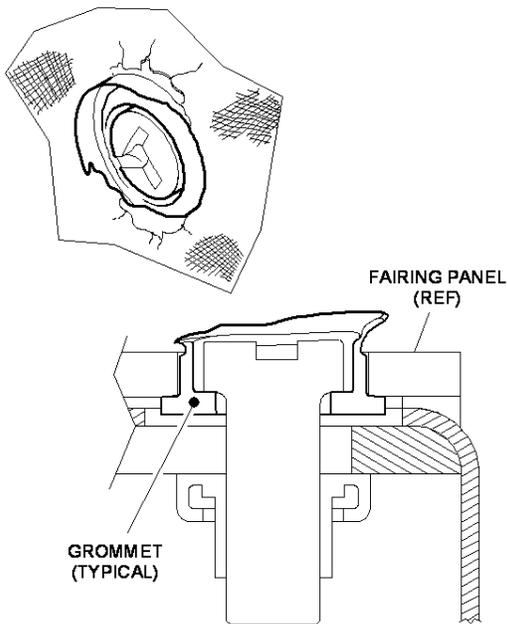
GROMMET WITH 'RING-PULL' FAILURE

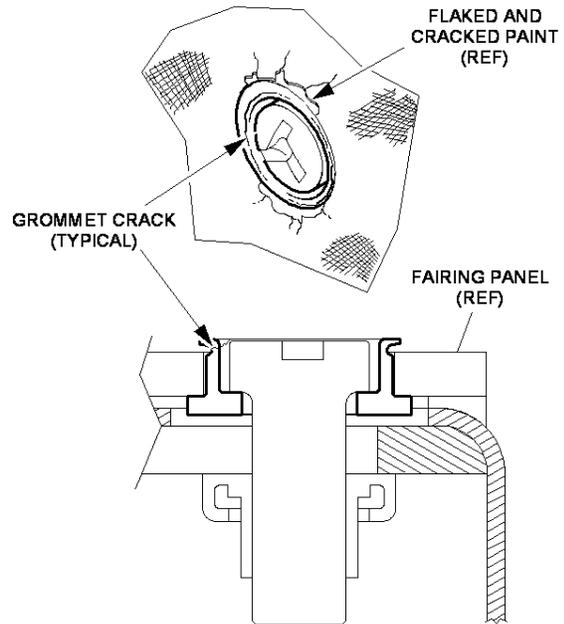
DAMAGED GROMMET IN-SITU
