**FINAL REPORT ON THE ACCIDENT
TO THE ULM ICP MXP740 Savannah
REGISTERED 59-CBE AT
COMBLAIN-AU-PONT ON
10 JULY 2011**

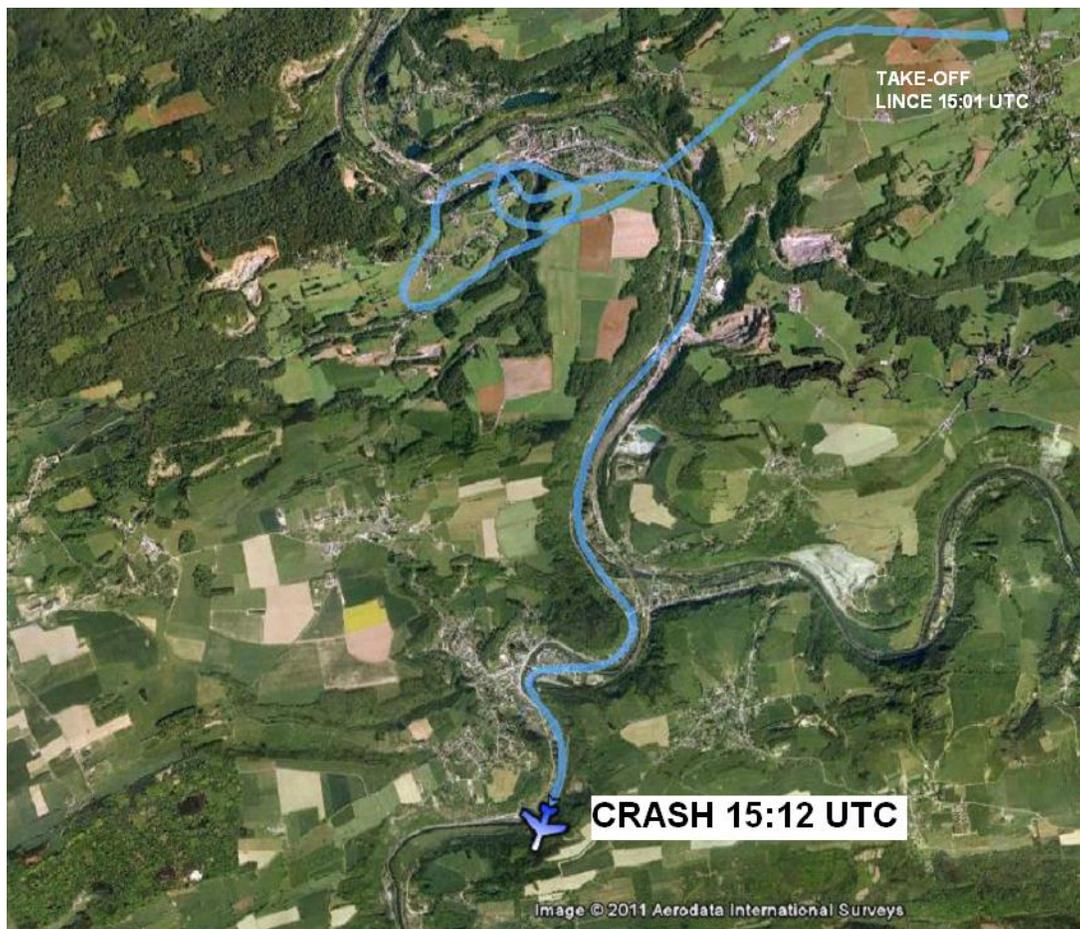
The pilot decided to fly above the Ourthe valley, at 15:12 UTC he was flying at 166 km/h at an altitude of 550 ft (180m) amsl inside the Ourthe valley, at the height of the village of Comblain-au-Pont.

Fig. 1: The flight

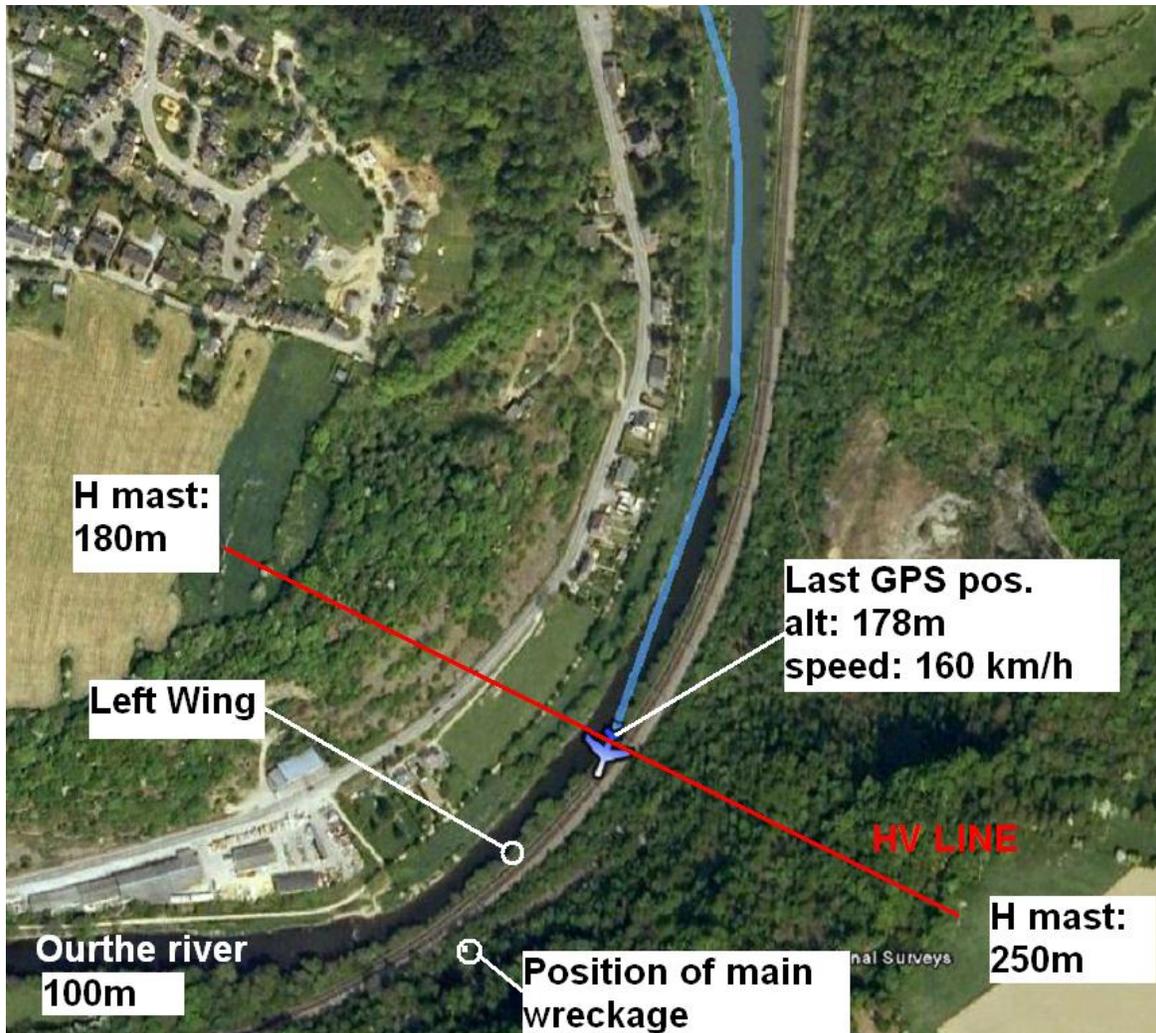
The airplane hit a high voltage line (70kV Goreux – Comblain). The left wing was severed, and the airplane fell down, crashing on the banks of the Ourthe Valley.

Fig.2: Crash area

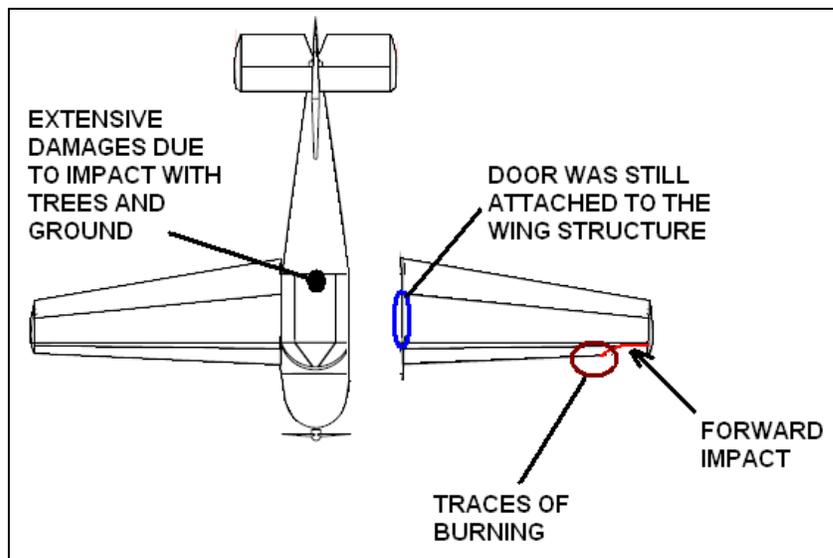
The airplane fell on the steep side of the hill bordering the Ourthe river.

The left wing was severed at the root during the initial shock with the HV power line. It shows signs of burning at the leading edge due to arcing further to the contact with the cable. It rested below the railroad embankment.

The wreckage of the airplane rested in a wood on the other side of the railroad tracks, further away from the Ourthe river. The RH wing shows impact traces of trees. The fuselage is crushed by impact.

Fig. 3: Damage location

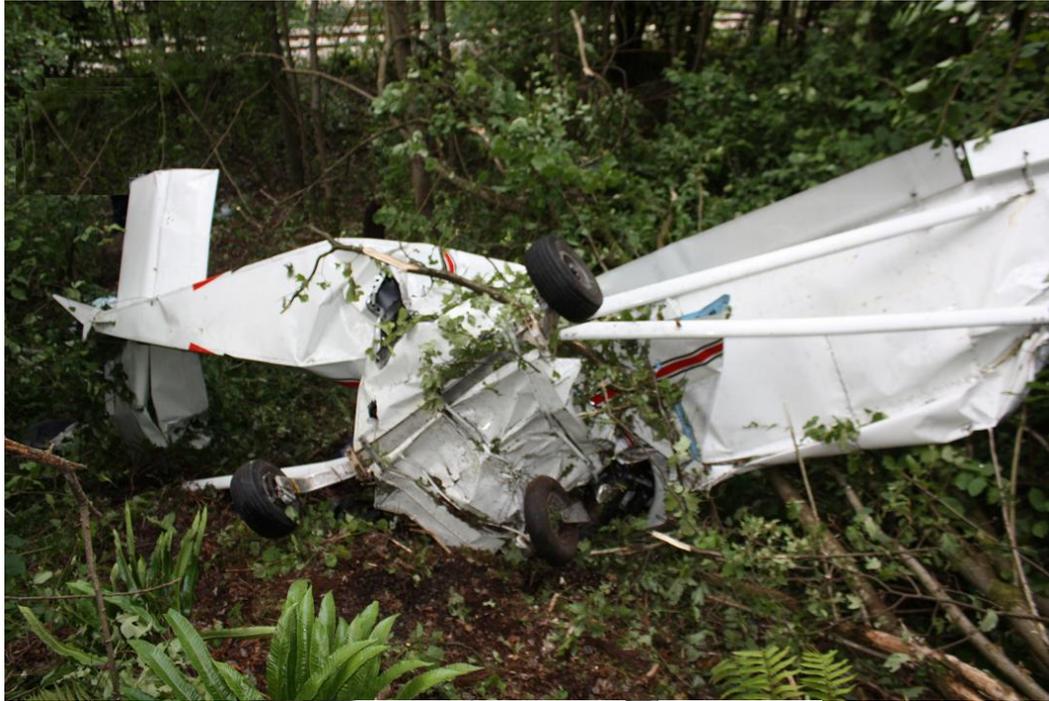
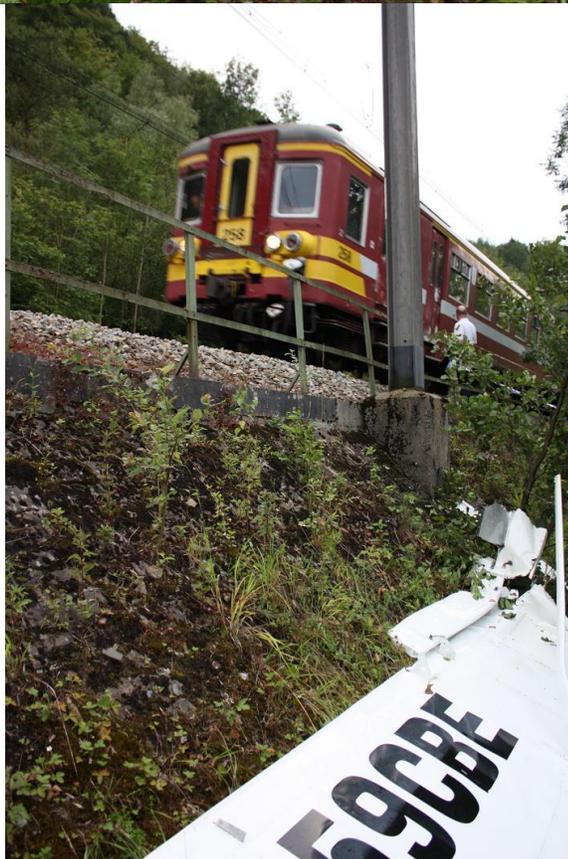
Fig 4 and 5.: Airplane damage

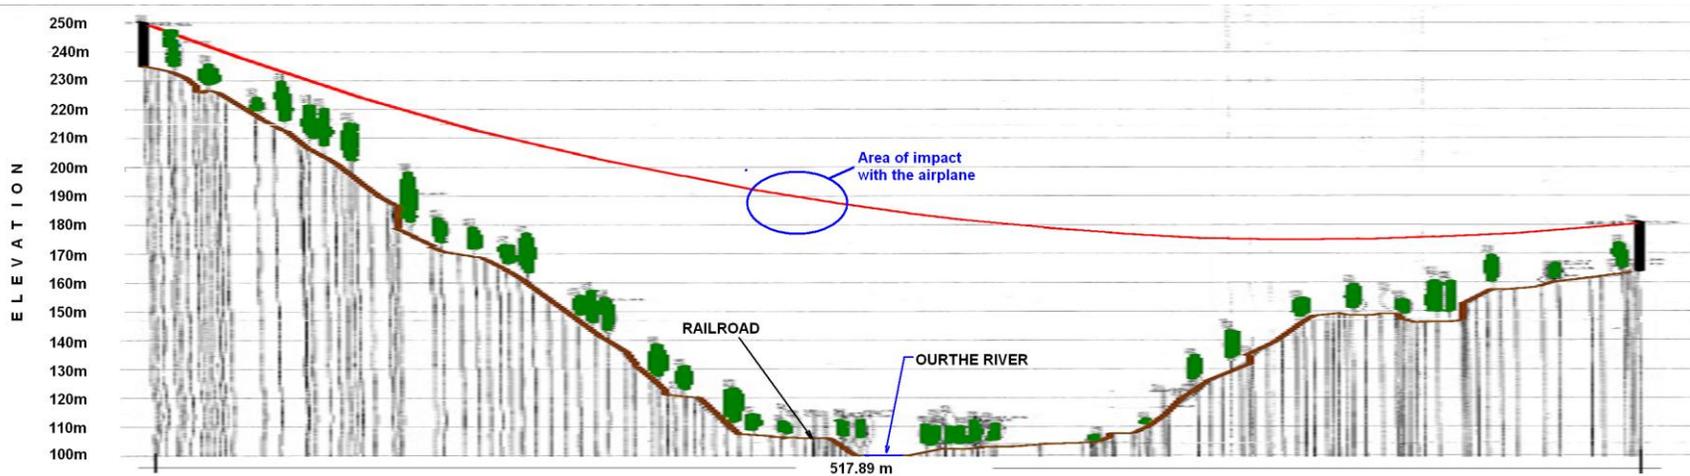
The cutaway view hereunder is based upon an anamorphic drawing made by Elia. The actual position of the line (red colour) depends from the ambient temperature, the electrical current. The actual position of the cable may vary greatly from the standard position depicted on the drawing.

The power line was not provided with markers to signal its presence, such as lighting or warning balls.

Fig 8: Cutaway view of the Ourthe valley where the HV Power line crosses the valley (facing South West)

AAIU(Be) recommends BCAA to mandate an aeronautical study to determine whether obstacles like wires and cables crossing the Ourthe river such as the 70 kV Power line Heid de Goreux – Comblain, constitute a hazard to aircraft navigation.

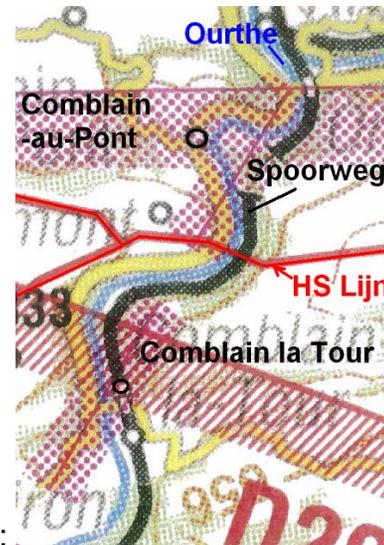
The presence of the line is identified on the aeronautical charts (Low-Air M534 Ed 20).

Fig. 9: Detail of the Low-Air chart :

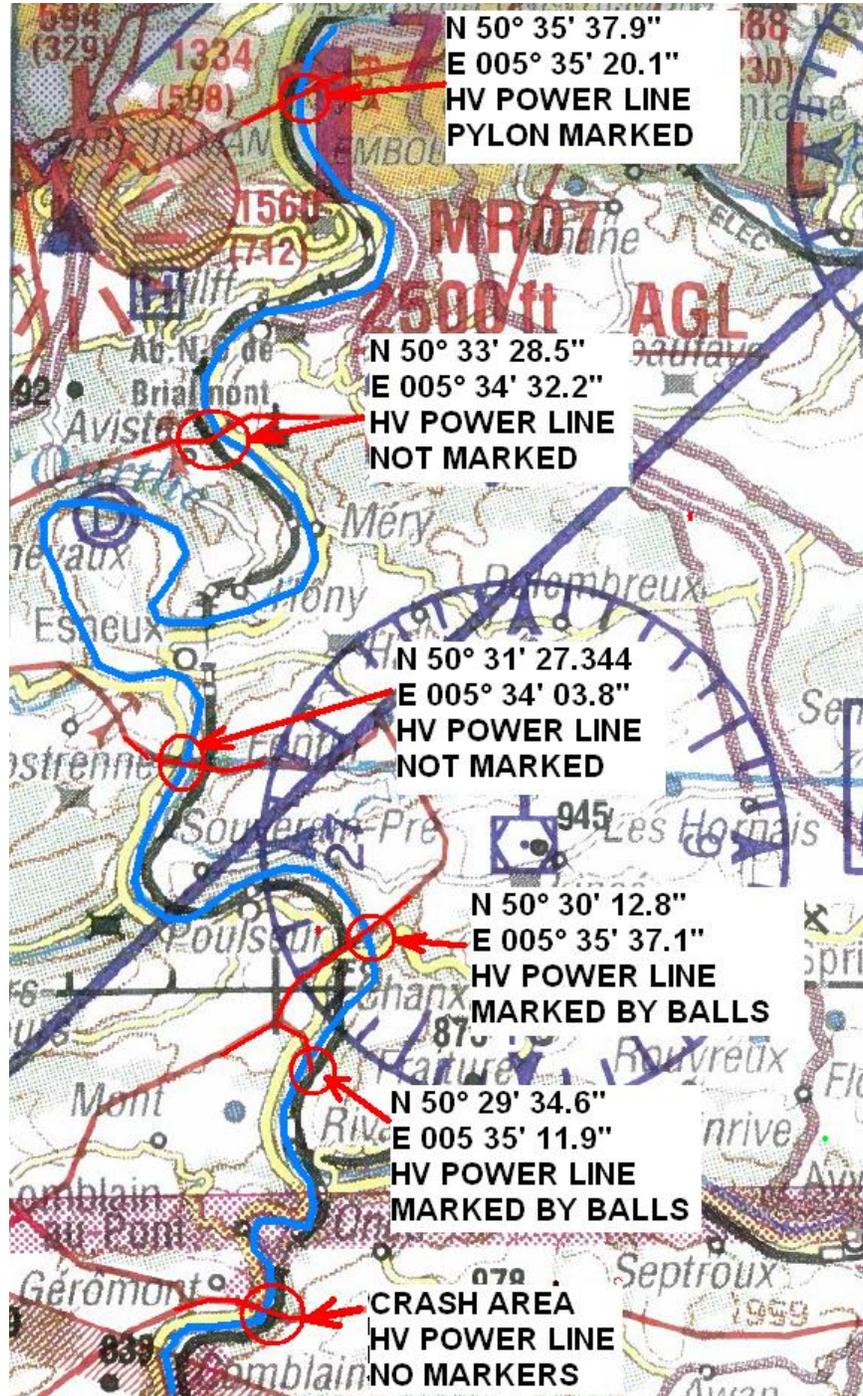
Fig.10 High Voltage Line across the Ourthe River from Comblain-au-Pont down to Embourg.

The High Voltage Line in Comblain-au-Pont is not the only one crossing the Ourthe Valley. From the crash area up to Angleur, there are 7 crossing lines.

The two lines located North of Comblain-au-Pont, that the airplane encountered before the crash, are marked by balls, while the lines North and South of Esneux are not marked. The line crossing the Ourthe in Embourg features marked pylons. The last line in Angleur (not shown on fig.10) is marked.

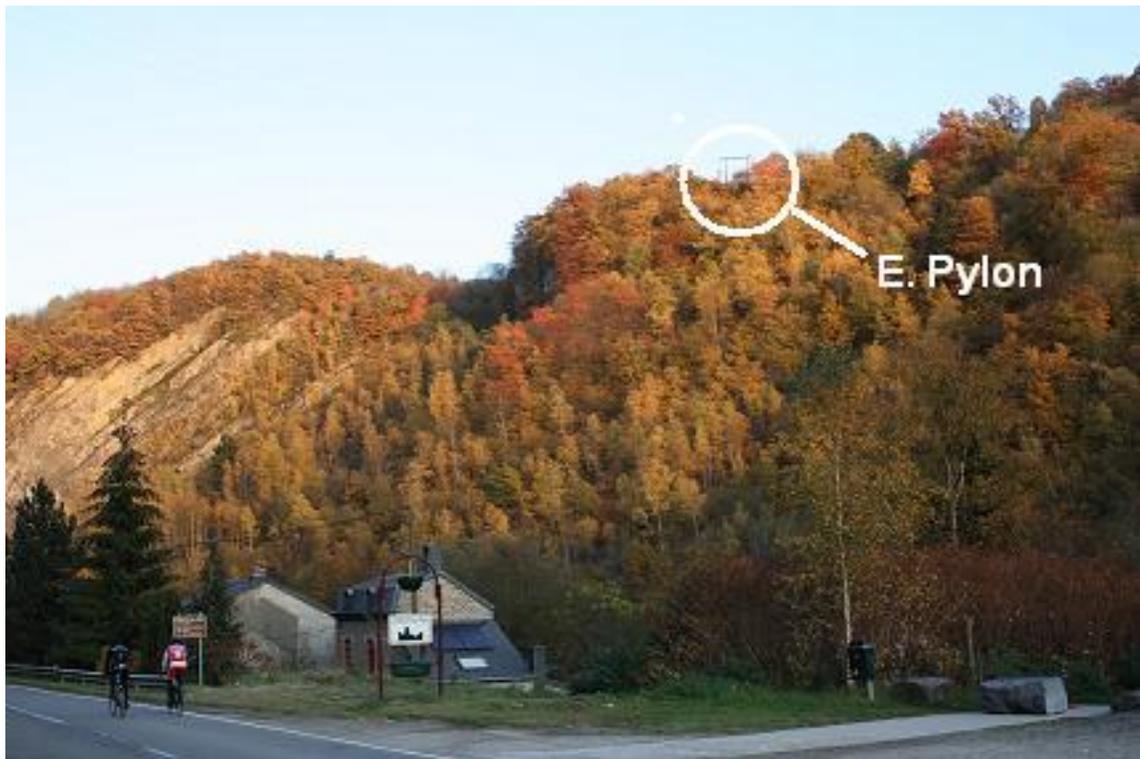
The pylons in Comblain-au-Pont are not quite visible on both sides of the Ourthe river; see Fig 11.

Fig. 11. HV Power line in Comblain-au-Pont.
