Safety Investigation Report

Ref. AAIU-2012-18

Aircraft: Cessna P210N, U.S. registered

Accident location: EBAW, Antwerp Airport

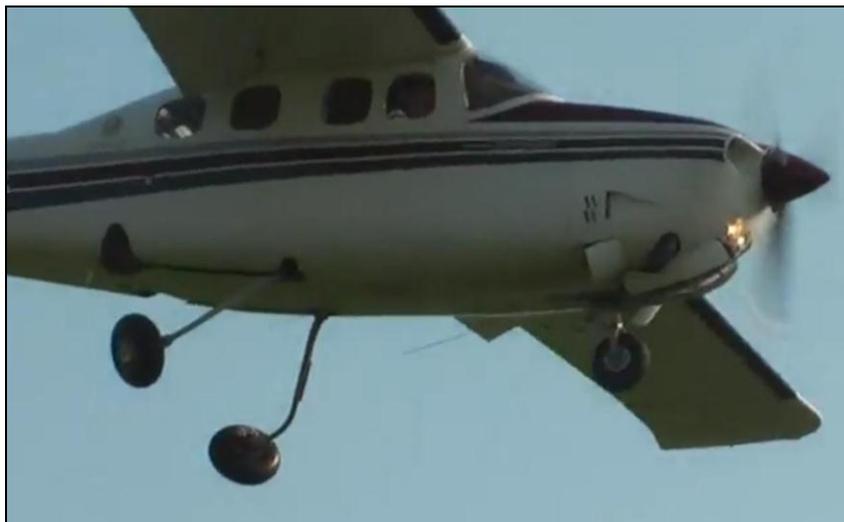
Figure 1: Image from the video showing that main landing gear was not fully extended

The belly was chafed and the RH horizontal stabilizer suffered substantial structural damage. There was minor visible damage to both main gear tires and the fuselage skin in the main gear wheel well caused by the brutal retraction of the main gear during impact. .

After these tests the landing gear extension with the gear pump circuit breaker popped out was simulated. In this configuration, both the nose and the main landing gear went down but it is only the nose gear that locked down while the main gear obviously remained unlocked showing both legs hanging under the fuselage. Then the hand emergency pump was used to fully extend and lock the main gear. This operation was satisfactory.

When the lever is selected down, the pressure in the actuator falls causing the landing gear to drop only due to gravity. However in case of lack of hydraulic pressure, the main gear will not be moved further in the full extended position.

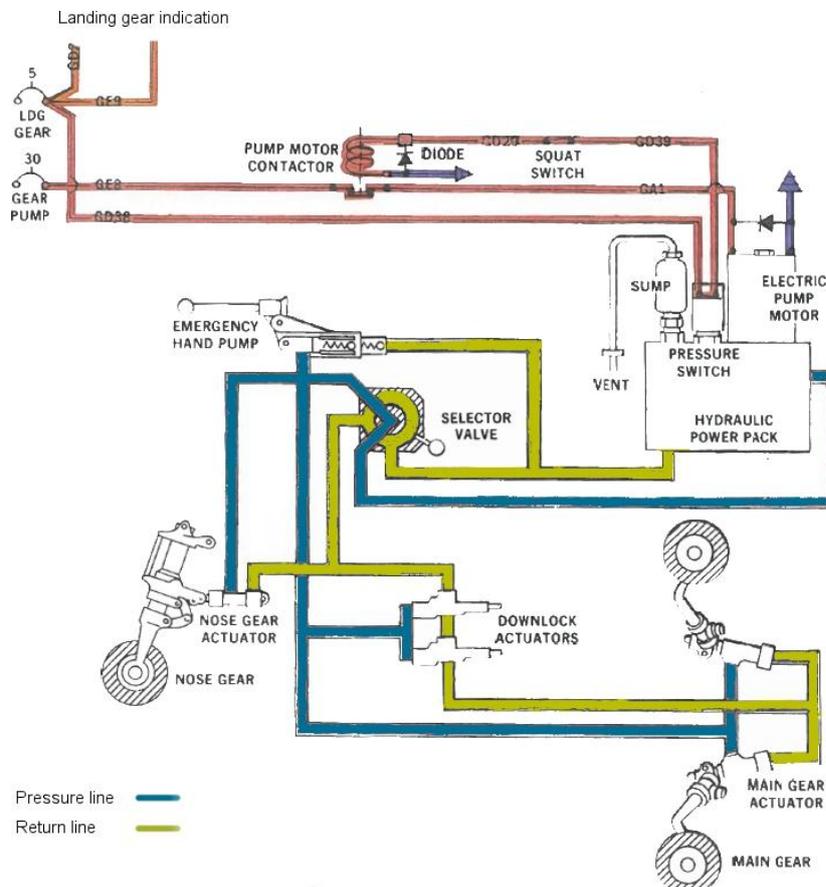
Figure 2: Landing gear system when selector valve is selected down

Each leg of the landing gear is raised and lowered by hydraulic actuators. When the landing gear selector valve in the cockpit is selected in either the up or the down position this will reverse the pressure transfer in the hydraulic lines causing the gear actuators to move in the opposite direction. From either position, the lever must be pulled out to clear a detent before it can be repositioned. When the gear is selected up, both the nose and the main gear are held in the retracted position by hydraulic pressure, there are no uplocks. When the gear is selected down, the main landing gear will be extended forward by the 2 gear actuators and kept in position by 2 downlock actuators. The nose gear extends backwards, its downlock is incorporated in its gear actuator. The hydraulic pressure in the system is generated by an electrically-driven hydraulic power pack which supplies hydraulic pressure by means of a pump. The pump motor is activated by a pressure switch which closes (and starts the pump) when the pressure falls to 1000 psi and opens (and stops the pump) when the pressure reaches 1500 psi.

An emergency extension system hand pump, which is located between the two front seats, provides the back-up of the power pack. Stroking this hand pump will only cause pressure to increase in the extend side of the system. The gear can't be retracted back without the use of the hydraulic power pack.
