Safety Investigation Report

Ref. AAIU-2012-13

Aircraft: Aquila A210 MSN: 183
The aircraft is registered in France and held a valid Airworthiness Review Certificate (ARC)

Type of engine: One Rotax 912S (BRP-Powertrain) S/N: 4.923.554

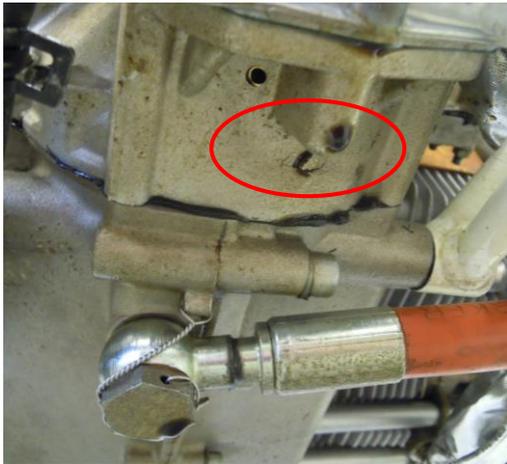
The cause of the incident was a loose washer in the engine causing a hole in the ignition housing and a subsequent oil leak.

The engine was sent to Franz Aircraft Engines Vertrieb GmbH, Germany for an investigation. A hole was found in the ignition housing under the water pump. When removing this housing, a damaged thrust washer of the idle/intermediate gear fell out. A tooth of the camshaft gear was missing and the water pump gear was also damaged. A metal part was found in the range of the circlip on the sprag clutch housing. Besides this, there was also damage on the pistons and the inlet valves.

Figure 1: hole in ignition housing

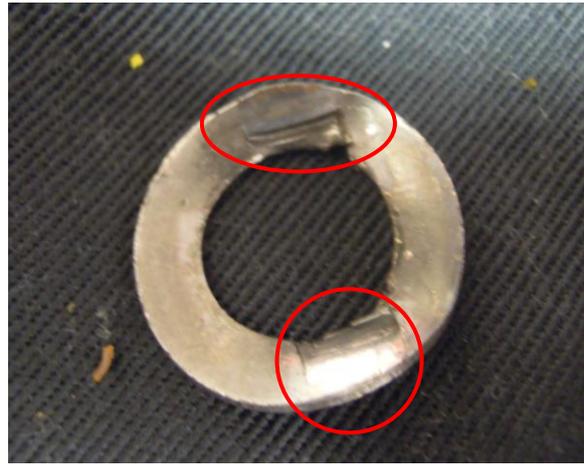
Figure 2: damaged thrust washer showing impact of gear teeth

It is obvious that if the thrust washer would have been on its place during the re-assembly it never could have fallen and been damaged like it was.

The hypothesis is that while removing the ignition housing to perform the repair, the gear shaft (see figure 4 and 5) moved together with the housing, allowing the aft thrust washer to become loose and to shift down. Subsequently, the washer got between the different gears causing amongst others a tooth of the camshaft gear to break. Finally this broken tooth came down below the water pump gear which pushed it through the housing with the oil leak as result.

AAIU(Be) recommends that BRP-Powertrain adds a note in the Maintenance Manual that warns the users that a failure to check the presence of both thrust washers of the intermediate gear before re-installation of the ignition housing could led to heavy damage of the engine.

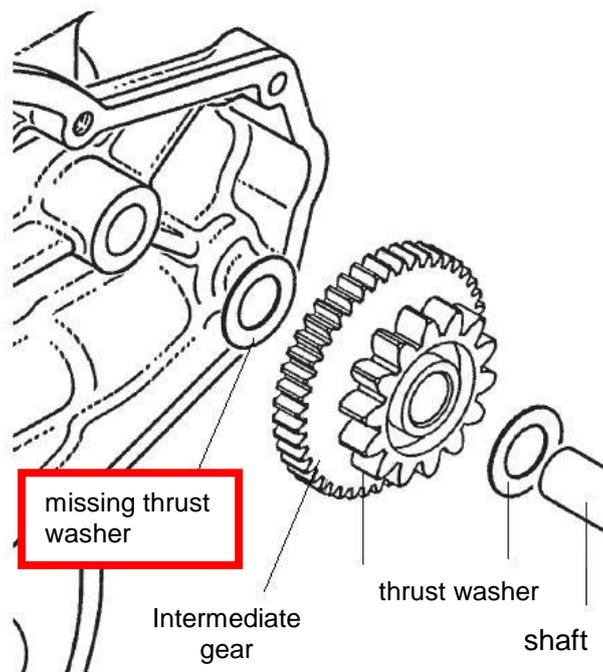
Figure 3: Assembly of the idle/intermediate gear

Pull out the intermediate gear shaft and remove the intermediate starter gear with the thrust washers on both sides of the intermediate gear.

The thrust washer of the intermediate starter gear may be stuck on the rear side if the ignition housing.
