Safety Investigation Report

ACCIDENT TO DPM MICROBEL EQUIPPED WITH ORYX WING AT ISIERES ON 7 SEPTEMBER 2013

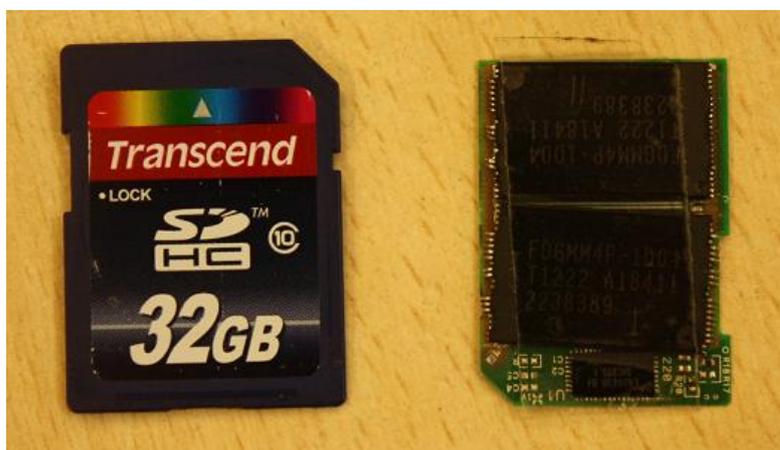
Figure 6: SD card retrieved from the wreckage

The memory card was retrieved after the crash. It suffered internal damage consecutive to the shock.

The SD card was sent to the laboratory of BEA-France that made a thorough inspection of the internal circuit. A read-out of the memory, however, was not possible. However, there are still, at the date of the publication of this report, discussions in progress with a specialized company for another attempt to recover the data.

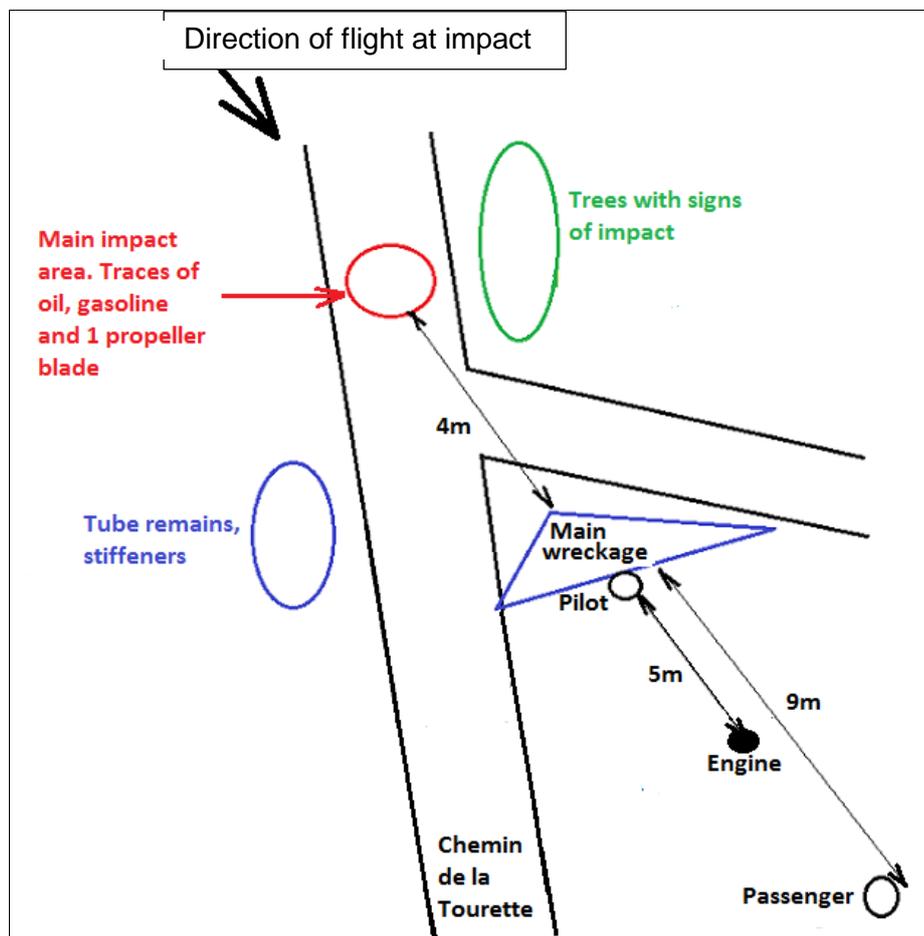
Figure 9: Sketch of the crash site

The aircraft hit the ground at a steep flight path angle and left a trace on the pavement. The aircraft bounced and came to a halt four meters further. The first impact area shows damage to the trees, including remnants of the wing cover and traces of oil and gasoline on the pavement.

The wing itself, with the trike still attached, was resting 4 meters away showing multiple fractures to the structure.

The pilot was found within the remains of the trike. The engine and the propeller with two ruptured blades was lying 5 m behind. The passenger was found 9 meters beyond the main wreckage, in the same orientation as the engine.

Smaller parts were found on the other side of the Chemin de la Tourette, such as fractured tubes and stiffeners.

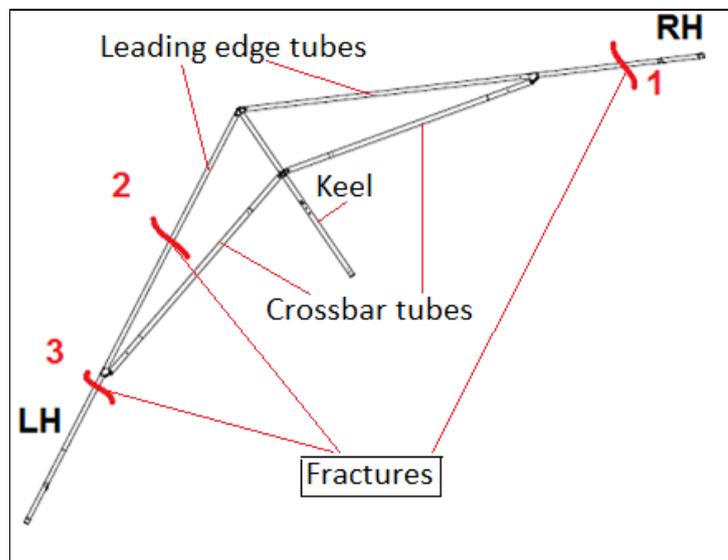
Figure 10: Wing structure – location of the fractures

The sail fabric showed minimal damage. The sail structure showed several fractures, mainly in its LH part. The Leading edge tubes showed 3 fractures; 2 on the LH side (N°2 and 3); one on the RH side (N°1); all fractures are static. The LH tube and the interior of the wing, on its left side showed presence of foliage and dirt. The RH leading edge tube showed a series of dents. The keel structure was intact. The nose plate showed no damage, nor presence of dirt.

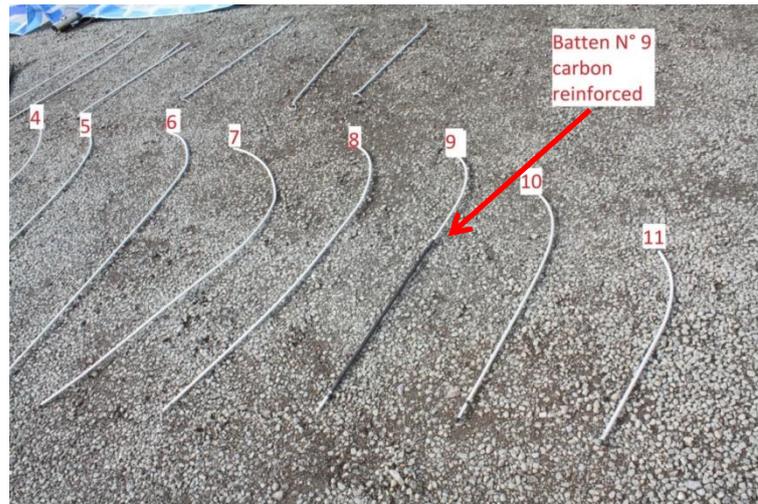
Figure 14: Battens of LH Wing.

The LH wing showed one fractured batten. This batten is mirroring the fracture N°2 of the leading edge tube. Additionally, some other battens were showing deformations.

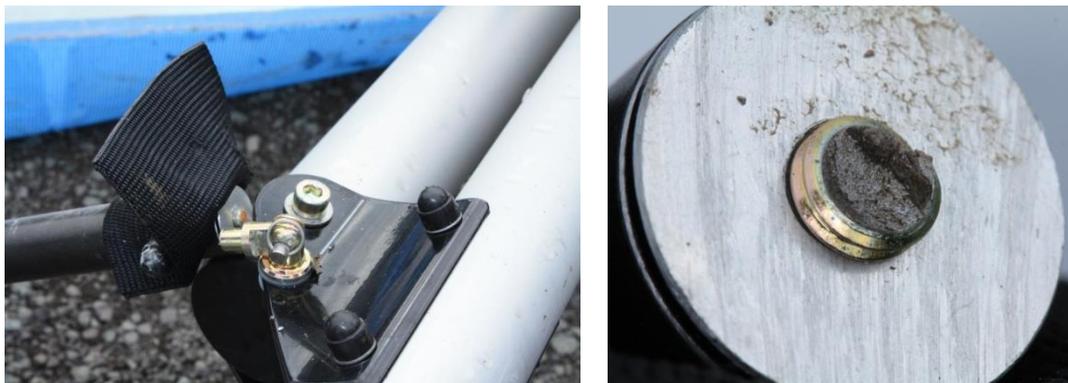
Figure 15: Internal sprog attachment area.

Internal sprog fracture: The connection of the spar attachment to the internal sprog is severed, on both LH and RH sides. Both fractures are static.

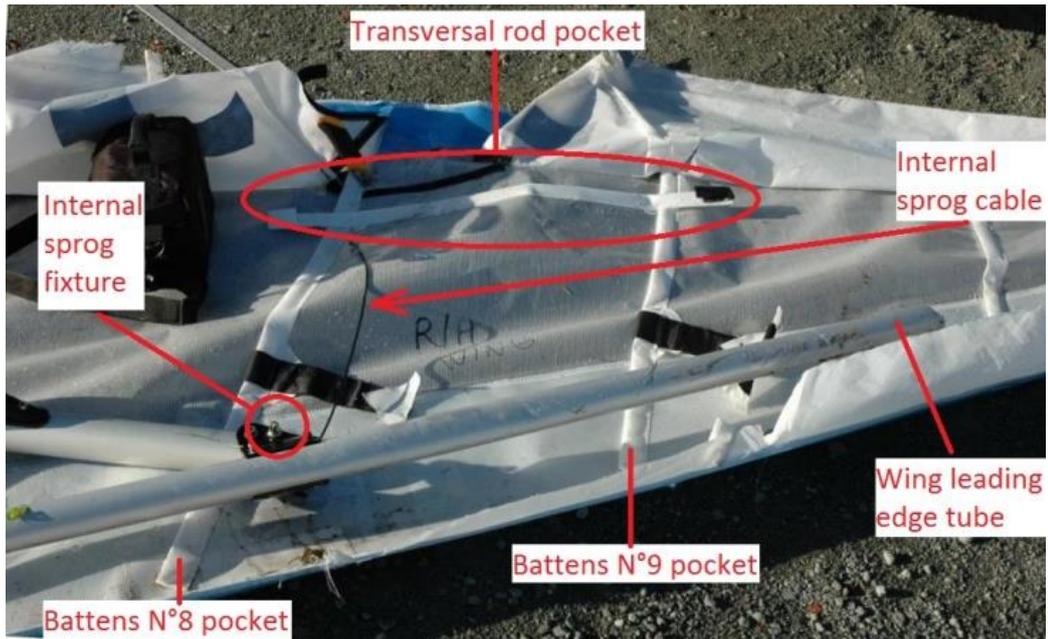
Figure 16: Empty transversal rod pocket

The transversal rods, part of the reflex system (see § 1.6 Aircraft Information), were not found in the wreckage. The transversal rod pocket was found empty. The transversal rods were found later, stored in the pilot's closet in the aero club building.

Removing the transversal rods would have a small impact by decreasing the overall drag of the wing and also by improving the wing responsiveness to the pilot's commands, but at the same time it would degrade the reflex system.

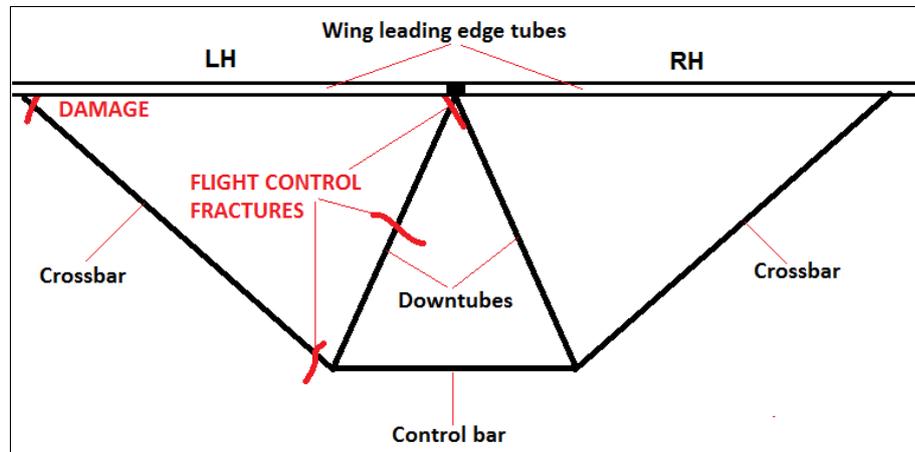
Figure 18: Flight controls: damages

The control bar was almost intact, showing little deformation. The LH down tube was broken near the upper connection and in the middle. The LH side strut was severed just aft the connection with the control bar and damaged near the connection with the Leading edge tube. The tensioning cables were undamaged and still attached to the wing keel.

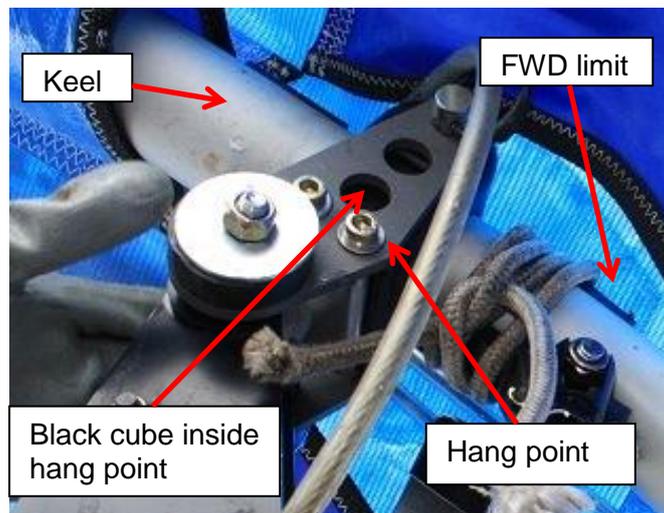
Figure 20: Hang point

- The fixation bolt was not secured (the safety pin was not engaged) but the bolt and its nut were properly screwed.
- The black “cube” connecting the mast of the trike with the wing keel was not limited in its longitudinal movement by a bolt or by any other fixed device as foreseen by the trike manufacturer. A rope strapped around the keel worked as a provisional forward stop, reducing somewhat the black cube forward movement. However, a movement of a few centimeters forward and backward was still possible between the rope and the rear stop.

A closer inspection revealed distinctive 8cm long black traces on the keel. Other black traces were also visible on the entire length between the forward and the back stops.

In normal conditions, the position of the trike with respect to the wing is defined as part of the wing/trike marriage process. The ideal position is determined during the test flights in order to achieve the best compromise between the different characteristics (Stability, speed ...). The assembly wing/trike is then fixed by installing two stops on the keel beam, allowing at the same time the rotation of the black cube and avoiding any longitudinal movement of the connection.

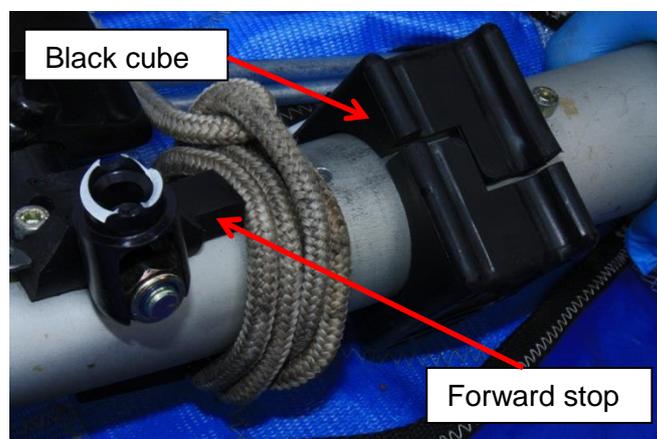
Figure 21: Black cube is more visible after removal of the hang point.

After removal of the black cube and moving the cord, old traces made by friction with a black cube were visible on the keel. These traces are supposed to represent the position of the hang point of the previous trike.

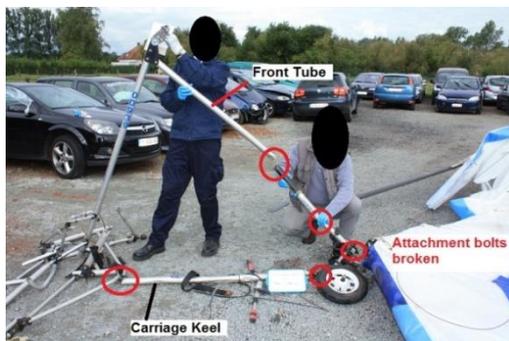
Figure 22: Reconstitution of the front tube and carriage keel

The front tube was severed in 2 points, as well as the attachment bolts to the carriage keel.

The carriage keel was severed at the Main Landing Gear drag strut attachment and aft of the nose landing gear.

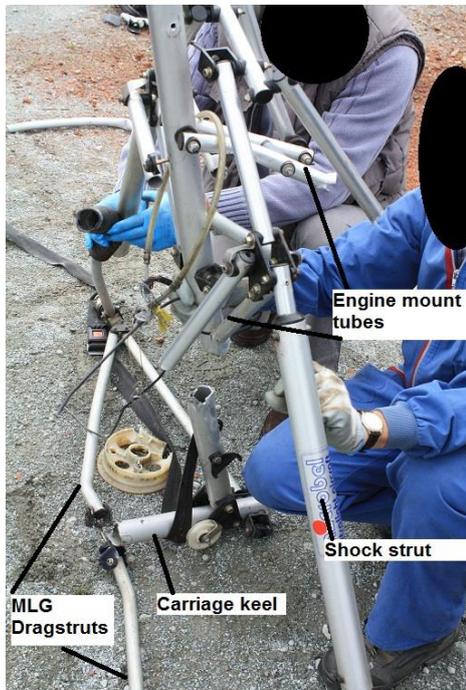
Figure 23: Reconstitution of the front tube and carriage keel

Both feet rests of the pilot were broken in the middle (attachment to the carriage keel).

The Nose landing gear showed less damage than the main landing gear, and the damage at the MLG were concentrated on the LH side.

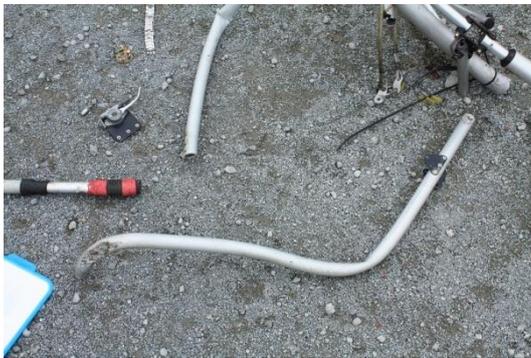
Figure 24: Remains of the safety frame of the seats.

The safety belts attachments were broken (originally tested at 15 G).

The seat (safety) frame showed vertical deformations and scraping.

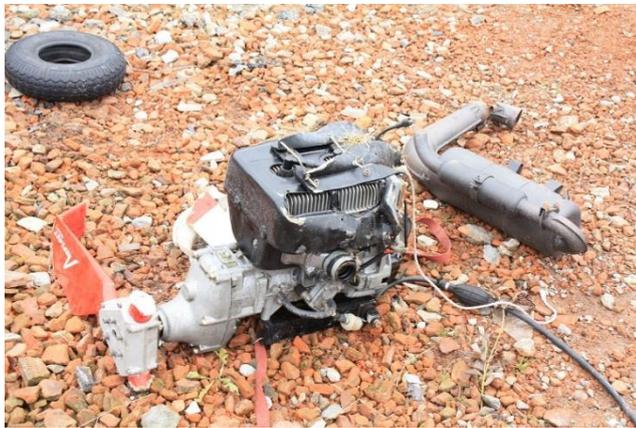
The engine case was fractured.

The 3-blade propeller has two blades severed at the root, and the third with damage at mid-length.

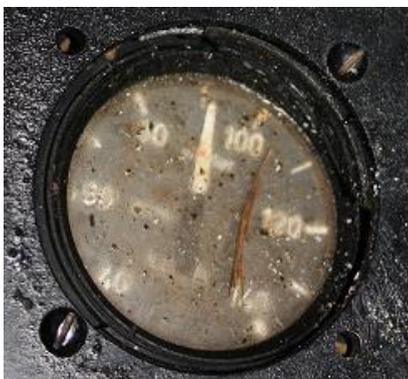
Fig. 26: Speed indicator

The speed indicator needle was found stuck at 91 km/h.
