Safety Investigation Report

ACCIDENT B&F TECHNIK FK12 COMET AT EBAV AIRFIELD ON 29 AUGUST 2013

Ref. AAIU-2013-AII-07
Issue date: 17 March 2015
Status: Final

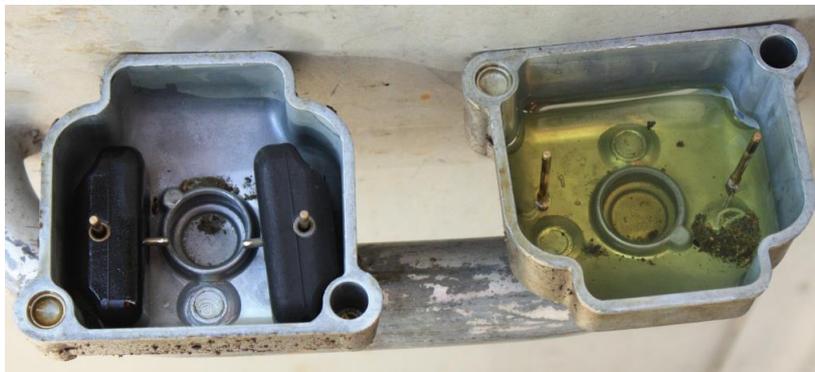
- Inspection of the spark plugs: no anomaly.
- Inspection of both carburettors. The bottom side of both carburettors' float bowls were found to be contaminated. The L/H carburettor float bowl was empty which is normal as it was found upside down after the accident while the R/H carburettor contained still a certain quantity of fuel. Particular attention was paid to determine a potential nozzle obstruction. No obstruction was found.

Figure 3: carburettors' bowl showing the presence of contaminant.

However, the examination of the engine found a contamination in the carburettors demonstrating that the maintenance was not adequately performed. Notwithstanding that anomaly, no indication was found showing that this contamination prevented the effective functioning of the carburettors. This contamination likely wasn't a contributing factor in the accident.

- Indications have been found in the wreckage showing that the maintenance was not adequately performed (carburettor contamination). However, this issue was determined not likely to be a contributing factor in the accident.

Indications have been found in the wreckage showing that the maintenance of the fuel system was not adequately performed. Poor maintenance will, sooner or later, lead to engine problems or even failure. Therefore:

It is recommended that the Belgian ULM Federation (BULMF) raises the general awareness amongst their members about the danger of insufficient or inadequate maintenance/inspection of the fuel system of their ULM. This is particularly crucial for ULM's not regularly flying during the winter period, back in use after a long period of inactivity.

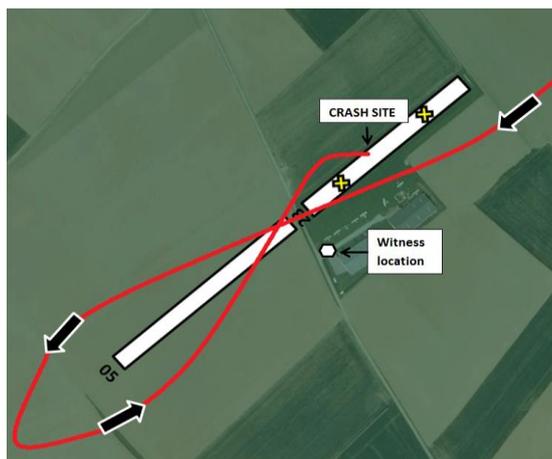
Figure 4: flight path deduced from the witness statement and impact traces.

The flight path was reconstructed based on the statement of a witness sitting in his car close to the country road. However, it has to be noted that the witness was facing opposite to the flight path when the aeroplane flew approximately above the closed runway and impacted the ground.

The easterly direction of the flight just before the impact was determined by the impact traces left in the ground and the repartition of the lost parts found in the neighborhood of the wreckage.

The direction of impact was estimated to be oriented almost 60° to the right of the last witnessed heading.
