Safety Investigation Report

ACCIDENT TO CESSNA P210N AT EBCI ON 9 FEBRUARY 2013

Ref. AAIU-2013-04
Issue date: 27 March 2014
Status: Final

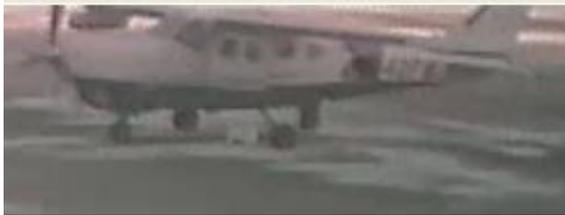
Figure 1: Airplane after the de-icing

The airplane was covered by a few millimetres frost (Estimated between 5 to 10mm) and probably also a thin layer of ice under the frost. The pilot requested an airport worker to provide him a ladder and started to de-ice manually the extrados of the wings at 8:08. As recorded by one of the security cameras of the airport, the pilot used the back of his arm to remove the frost.

This picture of the airplane, taken by a security camera after the de-icing, shows white traces on the ground originating from the frost removed from the airplane.

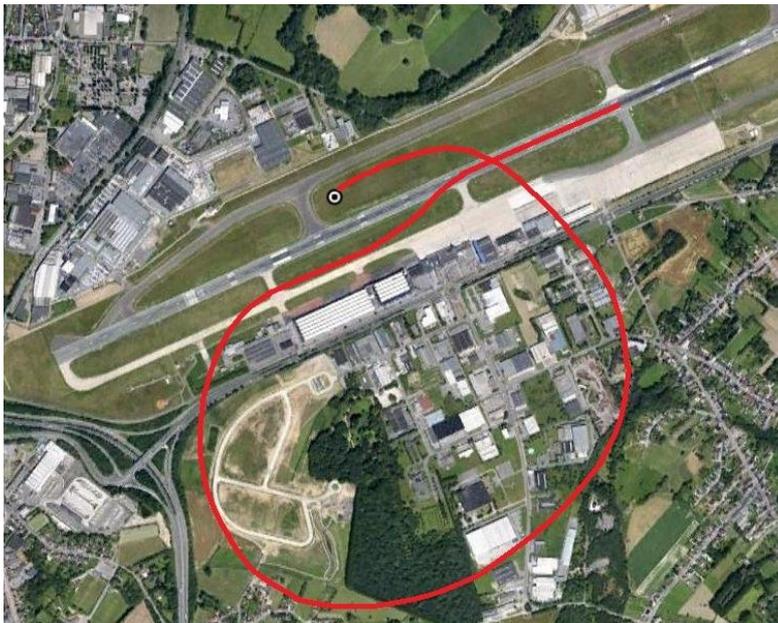
Figure 2: Approximate flight path.

This approximate flight path has been reconstructed based on the witness declarations and on the radar records. Radar records show a part of the flight beginning when the airplane had reached sufficient altitude (800 ft) to be detected. The airplane was flying East when it appeared on the radar screen.

Altitude values sent by the transponder demonstrated the airplane climbed up to around 1100 ft which means more than 400 ft AGL.

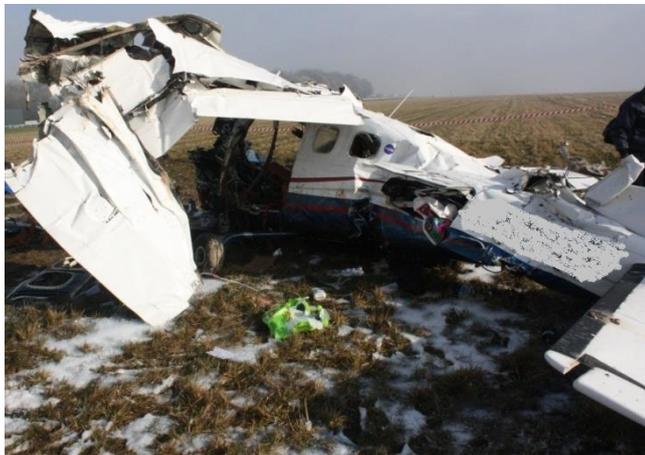
Figure 10: Left view of the wreckage.

The front section of the fuselage, including the engine, was significantly crushed. The left wing was folded aft and was almost separated at approximately wing station 138.00.

The engine remained retained inside the engine mounting support and displayed heavy impact damage.

The propeller was separated from the engine with the prop shaft having fractured just aft of the propeller hub.

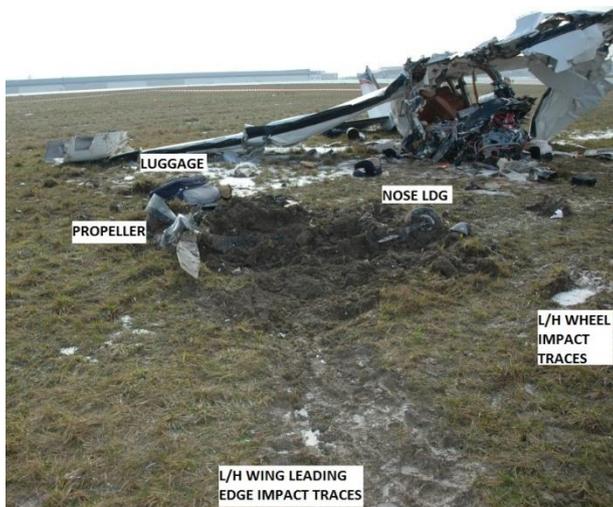
Figure 11: General view of the impacted area.

Both wings sustained leading edge crush damage along their entire length. Orientation of the traces of impact of both wings leading edges in the ground showed the general flight direction of the airplane at impact was 95°.

The wreckage was found resting on the belly at a few meters from the impact traces of the wing leading edges and the nose section. The general heading of the fuselage was 340°.

The nose landing gear and the propeller separated respectively from the engine and from the airplane at impact and remained partially buried close from each other at the impact place.

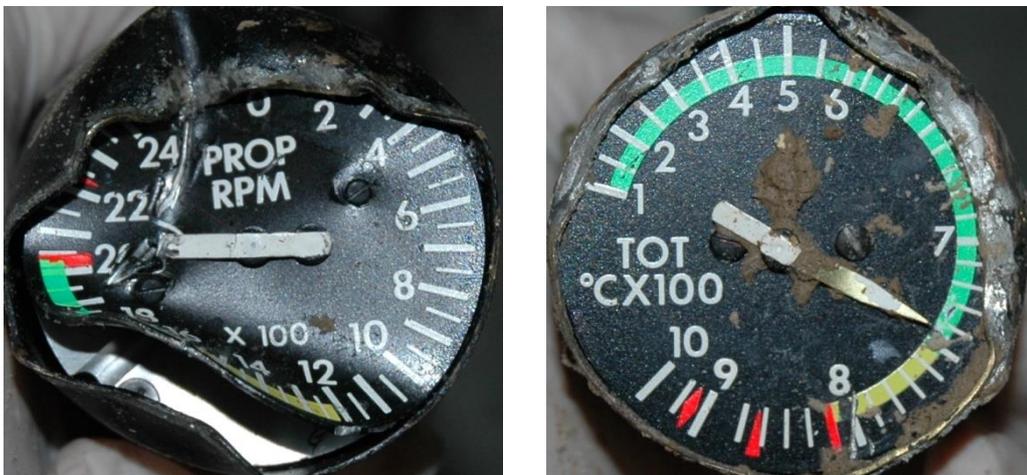
Figure 12: Propeller RPM and Turbine Outlet temperature indicators.

Instruments: Most of the instruments were severely damaged, beyond possible exploitation, however the propeller (Np) RPM and Turbine Outlet Temperature (T.O.T.) needles were blocked around 2050 Prop RPM and 750°C.

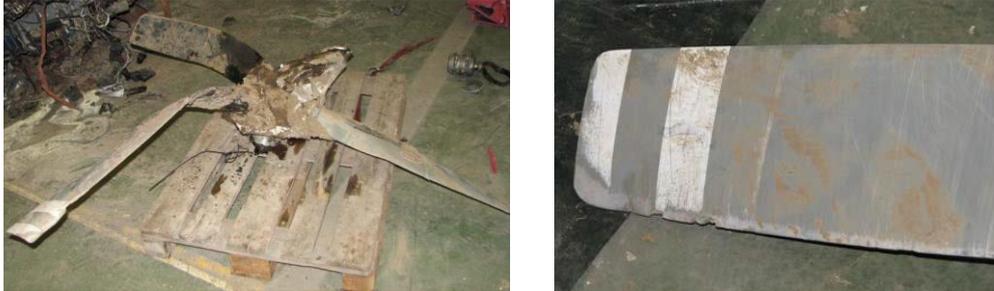
Figure 13: General view of the propeller and detailed view of one blade at tip.

All three propeller blades remained attached to the hub with all three exhibiting leading edge impact damage and bending of the blades opposite the direction of rotation.

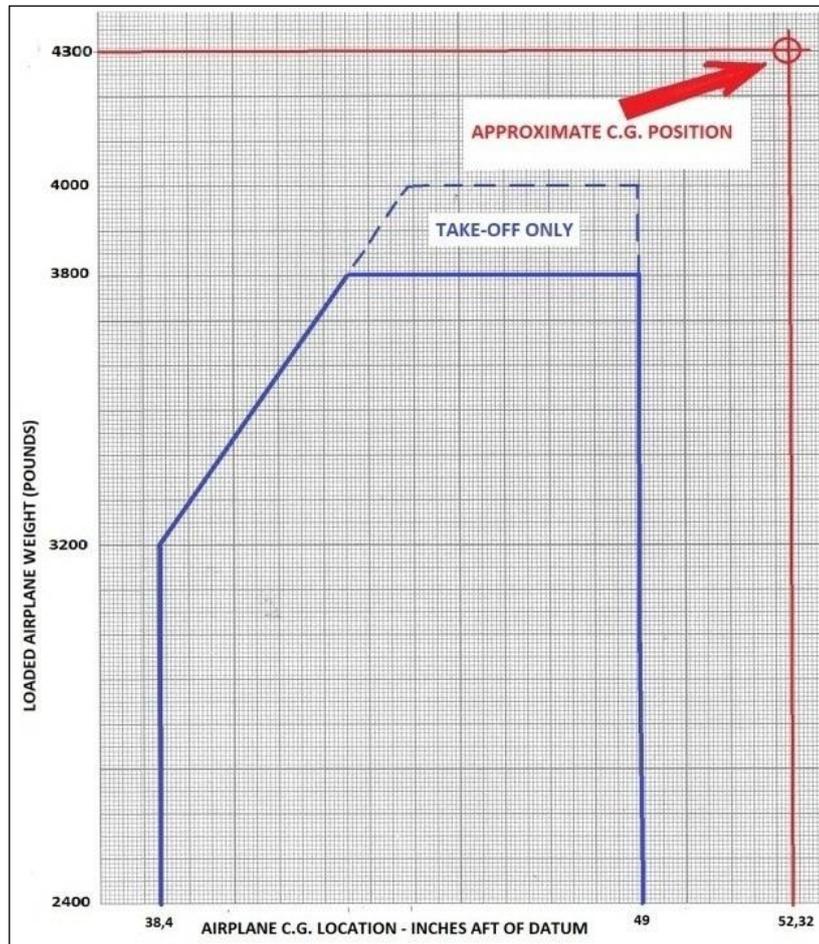
Figure 18: Estimated Weight and Balance position.

As seen on the above computation, the airplane was around 300 lbs in overload for take-off and 500 lbs for landing.

More serious is the fact that despite no object has been simulated on position 115"; the CG position was 3.32" out of the most aft limit of the balance envelope.

Obviously, the great distance to the datum of both the baggage compartment and the rear fuel tank generate, when loaded, a significant moment causing the airplane C.G. to seriously move rearward.

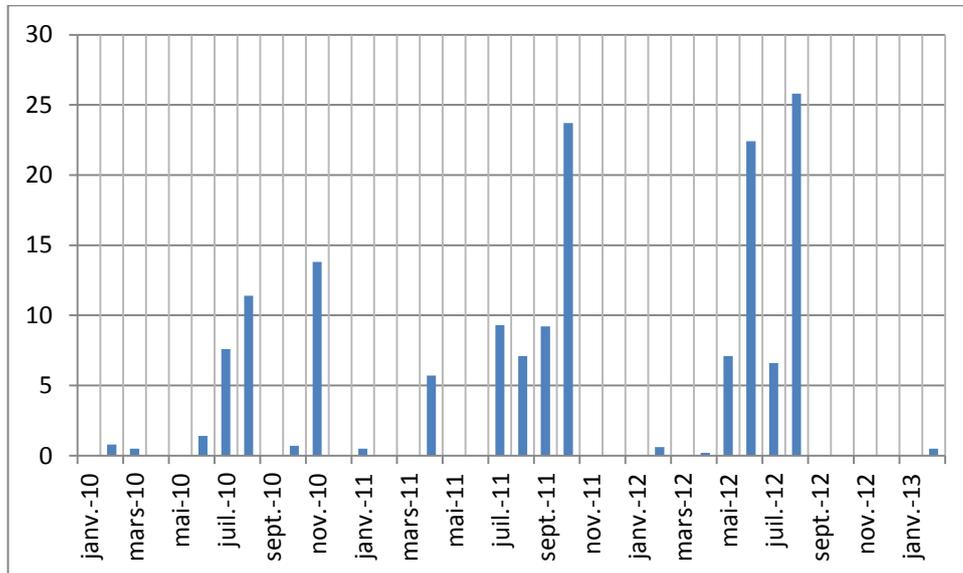
The above graph shows the pilot flight hours performed during the last three years. Total flight hours per year was in:

- 2010: 36,2 hours
- 2011: 55,5 hours
- 2012: 62,7 hours
