Federal Public Service
Mobility and Transport
Air Accident Investigation Unit

Safety Investigation Report

ACCIDENT TO A ROBINSON R-44 IN ROESELARE ON 5 SEPTEMBER 2014

Ref. AAIU-2014-20- Roeselare
Issue date: 15 December 2015
Status: Final

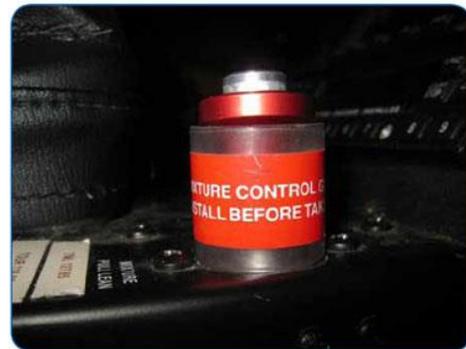
Figure 5: Mixture control (full rich position)

The Robinson Helicopter Safety Notice N°1, first issued in 1981 (in appendix) identifies the risk of inadvertently actuating the mixture control in flight. The knob is specifically shaped, and a small plastic guard is foreseen.

The mixture control knob is located also on the central console, but at the right side. It is surrounded by a small plastic tube (guard) (see figure 5) that needs to be removed to operate the knob, and replaced afterwards, for the next flight. The plastic guard was not found when inspecting the wreckage (although it might have completely destroyed during the fire).

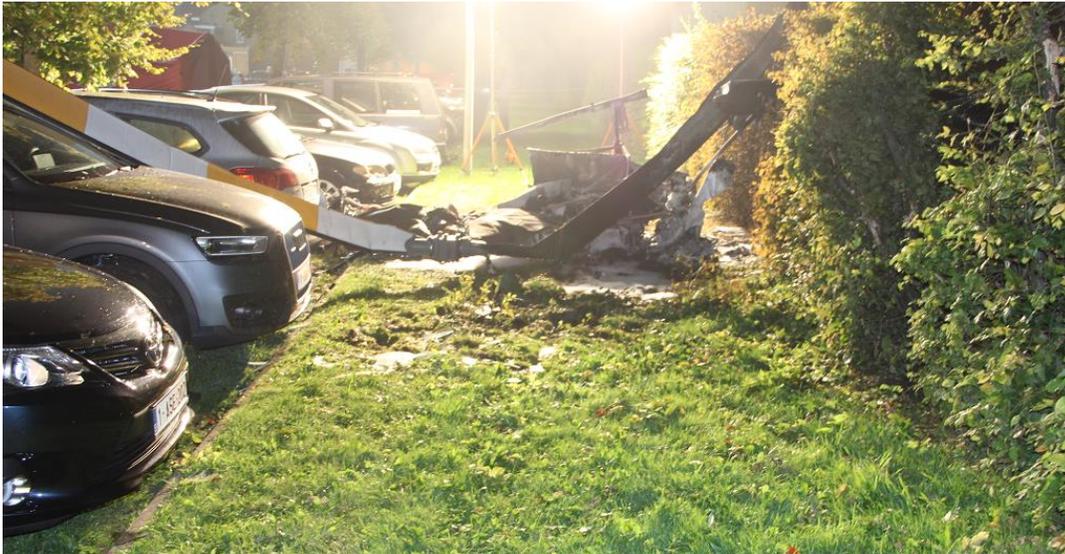
Figure 10: crash area

The helicopter fell on the stroke of grass between the row of parked cars and the parking lot fence. The helicopter did not hit any person or vehicles in its fall.

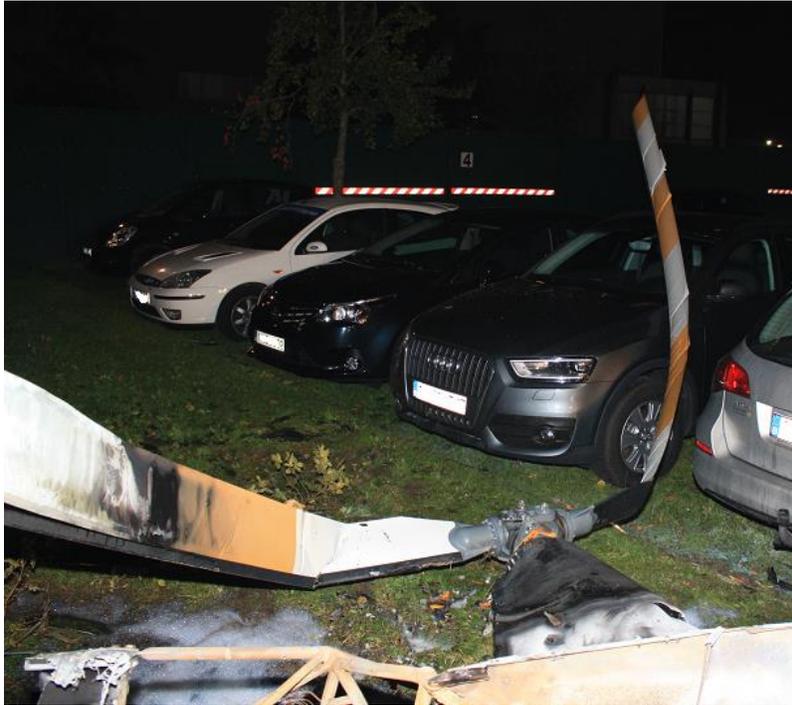
Figure 13: main rotor

The main rotor blades were still attached to the hub, and the leading edges showed little to no rotational movement at impact.

One blade was resting on the, still intact, windscreen of a car

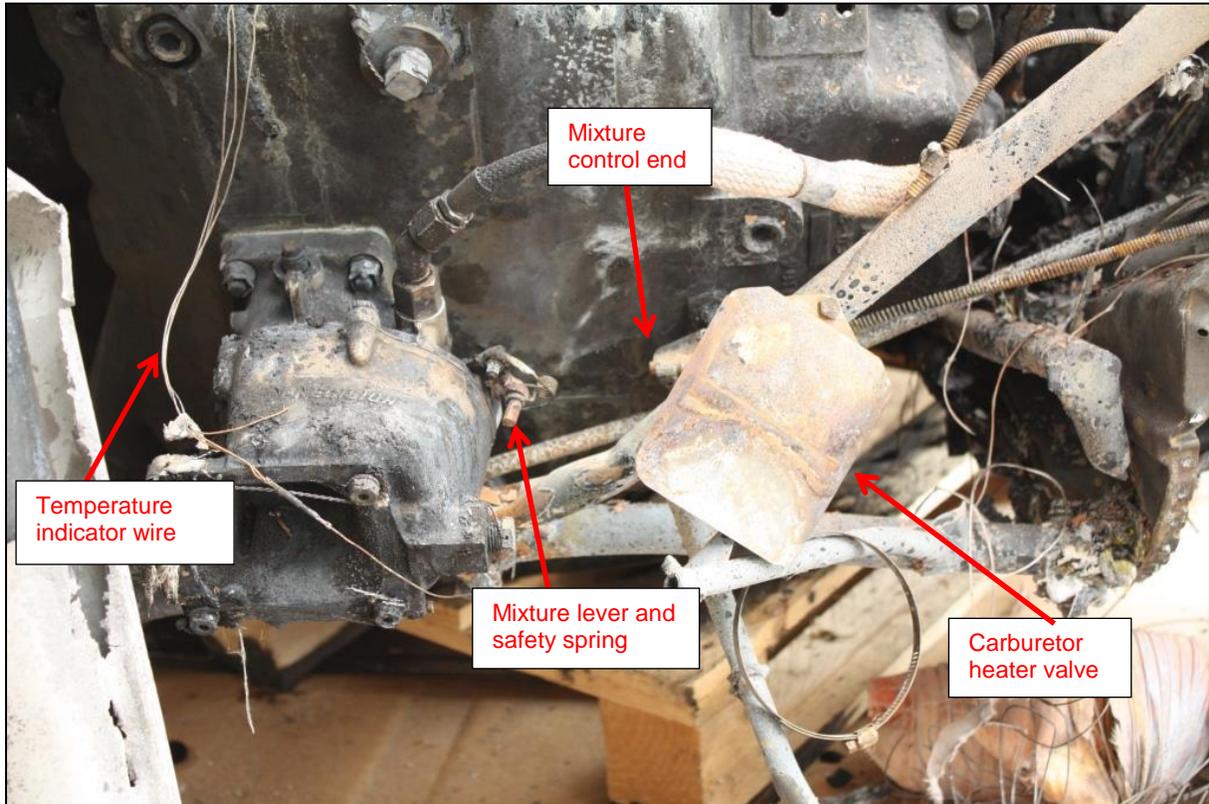
Figure 14: Fuel system components

The mixture lever was positioned on the "R" rich stop under the effect of a security spring.

The carburetor heater valve showed a straight trace in the middle of the valve, corresponding to a medium position.

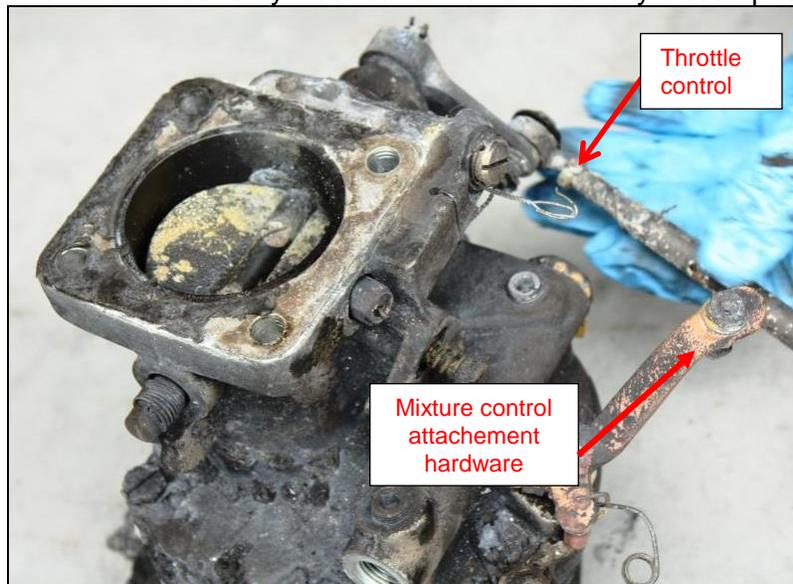
Figure 15: Fuel controls

The throttle control (broken further) was still attached to the throttle valve lever of the carburetor and the butterfly was found in an almost fully closed position.

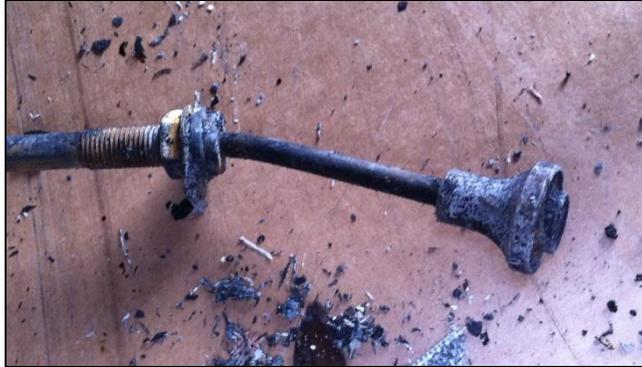
Figure 16: Mixture control

The sheath of the mixture cable is found still attached at its last attaching point on the oil sump. The carburetor end of the steel wire stops exactly at the end of the sheath.

The other end of the mixture control was found fully pulled back meaning it was in cut off position. The sheath of the mixture control shows few signs of elongation.

There was no trace of the plastic mixture guard found on the mixture control or in the wreckage.

It is recommended that Robinson Helicopter Company further improves the guard system of the mixture control on the Robinson R44 I (Raven I) to prevent the unintentional operation of the mixture control leading to a possible engine shutdown in flight.

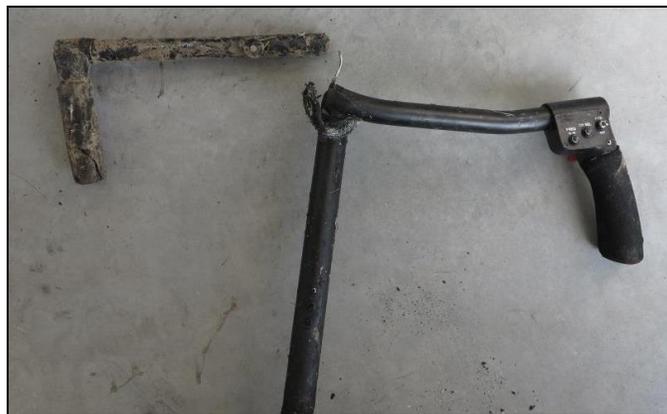
Figure 17: T-bar

The LH cyclic control was found broken at its attachment on the top of the T-Bar, probably caused by a violent contact with a body at impact.

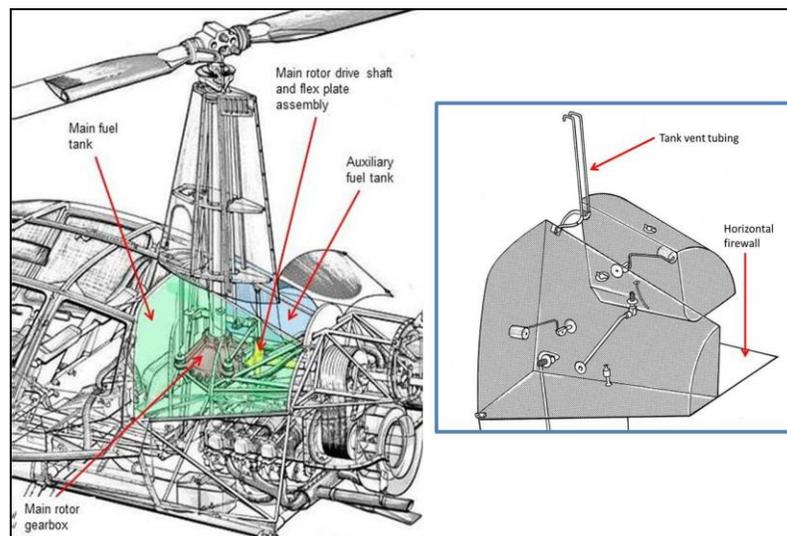
Figure 18: Fuel tanks

Due to the impact, the fuel tanks ruptured and the fuel was ignited by exposed electrical wires or by the fuel leaking on the hot parts of the engine. People in the vicinity had the time to reach the wreckage before the fire started; they reported seeing the occupants wounded and unconscious and noticed fuel leaking.

The helicopter was equipped with the original aluminium tanks located above the engine firewall, either side of the main transmission.

The post-impact fire was caused by the rupture of the fuel tanks and subsequent leaking of fuel on the hot parts of the engine or a damaged electrical component.

It is recommended that the FAA requires owners and operators of existing R44 helicopters to comply with the fuel tank retrofit advised in Robinson Helicopter Company Service Bulletin SB-78B to improve the helicopter's resistance to a post-accident fuel tank leak.

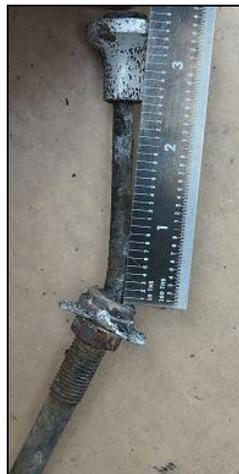
Figure 20: mixture control after accident

The mixture control knob was found bent, indicating the knob was pulled before impact. There were no traces left of the plastic guard (but the area was totally burned)

The position of the mixture control knob upon impact corresponds to the idle cut-off (ICO) position, as compared to another Robinson R44 helicopter.

Pulling the mixture control knob to the idle cut-off position would interrupt the fuel flow to the engine, with the engine stoppage as a result.
