Safety Investigation Report

ACCIDENT SCHEMPP-HIRTH JANUS C AT WEELDE AIRFIELD ON 21 APRIL 2014

Ref.:
AAIU-2014-6

Issue date:
21 April 2017

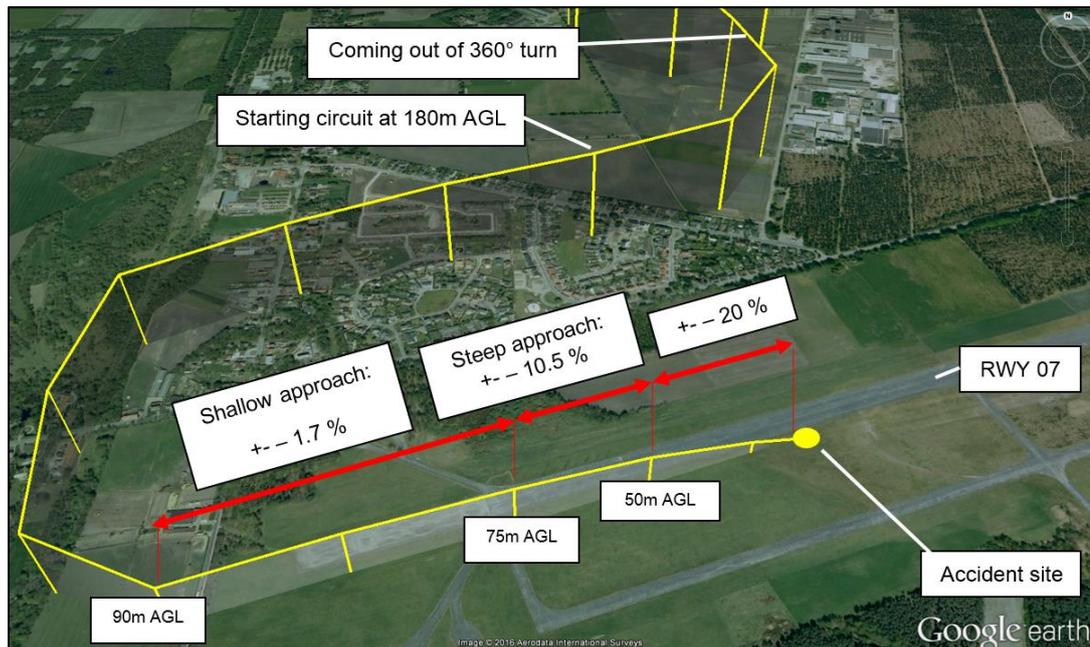
The flight was uneventful up to the approach. When the sailplane was in final for a landing at the grass strip right of runway 07 at a height of approx. 90m above ground level (AGL), the flaps were lowered to the second position (position 'L') and the air brakes were raised. The speed was stabilized to an indicated airspeed of 105km/h (verified with groundspeed of IGC-file¹). According to the PIC, it was at that time that he activated the tail brake chute. However, the parachute did not immediately deploy. The PIC continued the approach up to an approximate height of approx. 50m AGL, when the parachute eventually did deploy. The PIC, having his left hand on the air brake handle and his right hand on the stick, pushed the stick to keep the airspeed. A few seconds later the sailplane violently impacted the ground and almost immediately came to a halt approximately 325m in front of the perpendicular taxiway. Both pilot and passenger had to be removed from the glider by the rescue services using spine supporting stretchers. The rear instrument panel and control column were cut out because the control column was jammed against the passenger's stomach, and the glider fuselage was cut to facilitate further movement. Extracting the pilot was a reasonable straight forward operation, although he suffered major injuries (multiple vertebral fractures). The passengers had only minor injuries.

Figure 1: last part of the flight, retrieved from the IGC-file

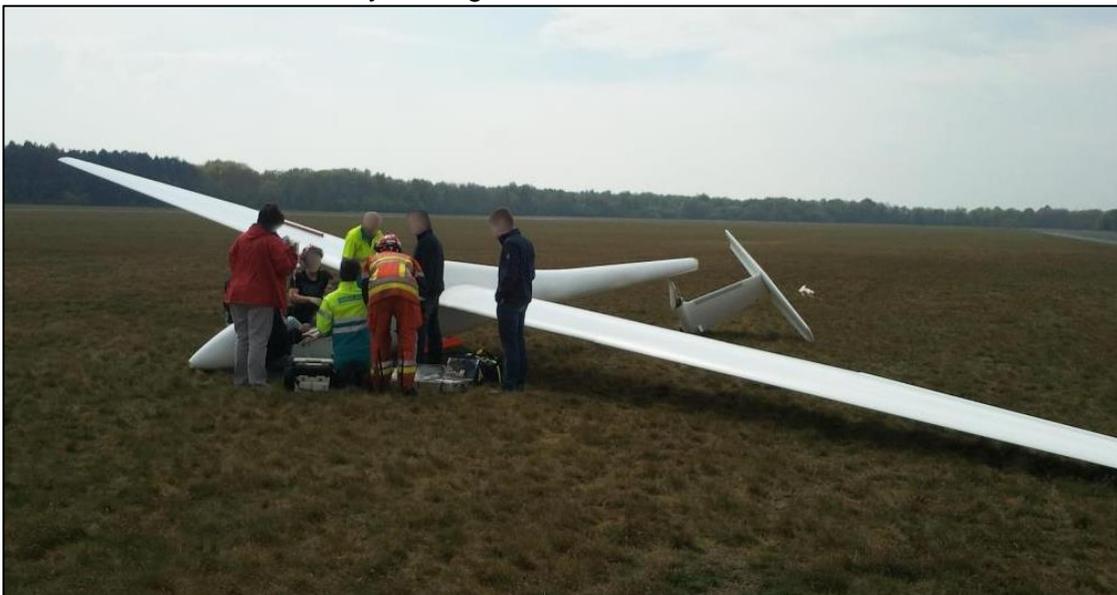
The aircraft was substantially damaged.

Figure 2: The damaged Janus after the accident.

The front belly of the fuselage was cracked but not heavily deformed. Both the nose and main wheel were distorted upwards. The aft tail section was severed at approximately 80cm from the tail end. The L/H wing leading edge was damaged near the wing root. The top skin of the fuselage was cut and removed by the rescue services to facilitate the evacuation of the pilot.

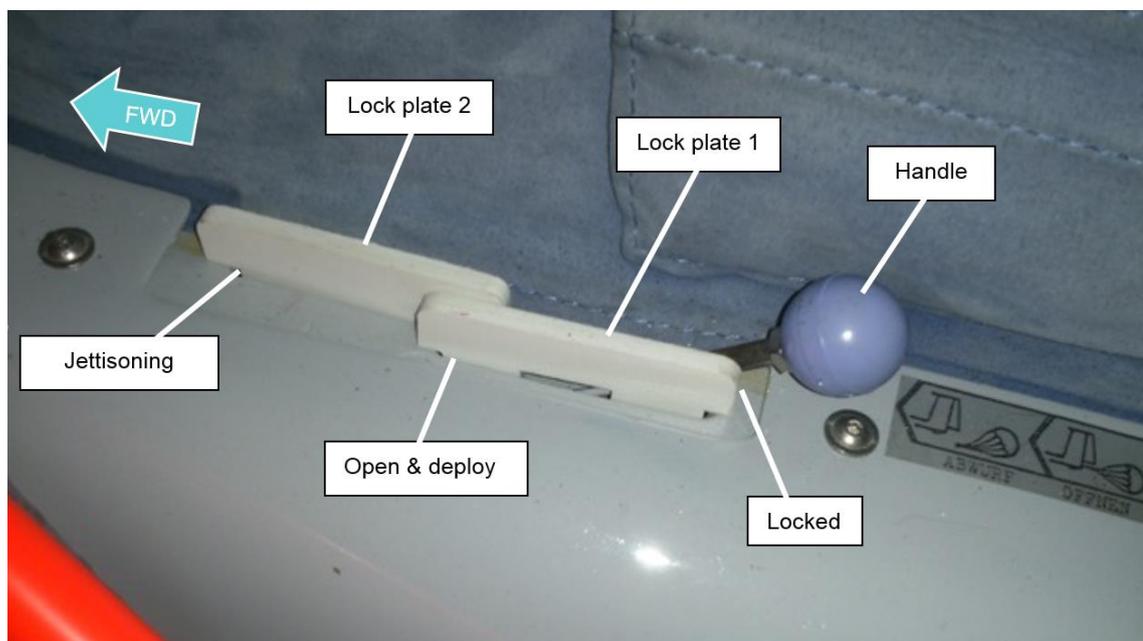
My next reaction was to look if I could eject the parachute. I was wearing a rain-jacket and the pockets covered the side of the seat, including the parachute deployment handle. I moved my jacket out of the way, and realised that the lock plates that we use to prevent unwanted release of the parachute were still in place.

In order to prevent unwanted release of the brake chute during flight, the aero club made 'lock plates'. To slide the handle to the 'open' position, a lock plate has to be manually removed first. For jettisoning the chute, a second lock plate has to be removed. This is a practice that is well known and applied within the glider community but however not based on an approved design.

Figure 5: The forward seat guide slot with operation handle of the brake chute

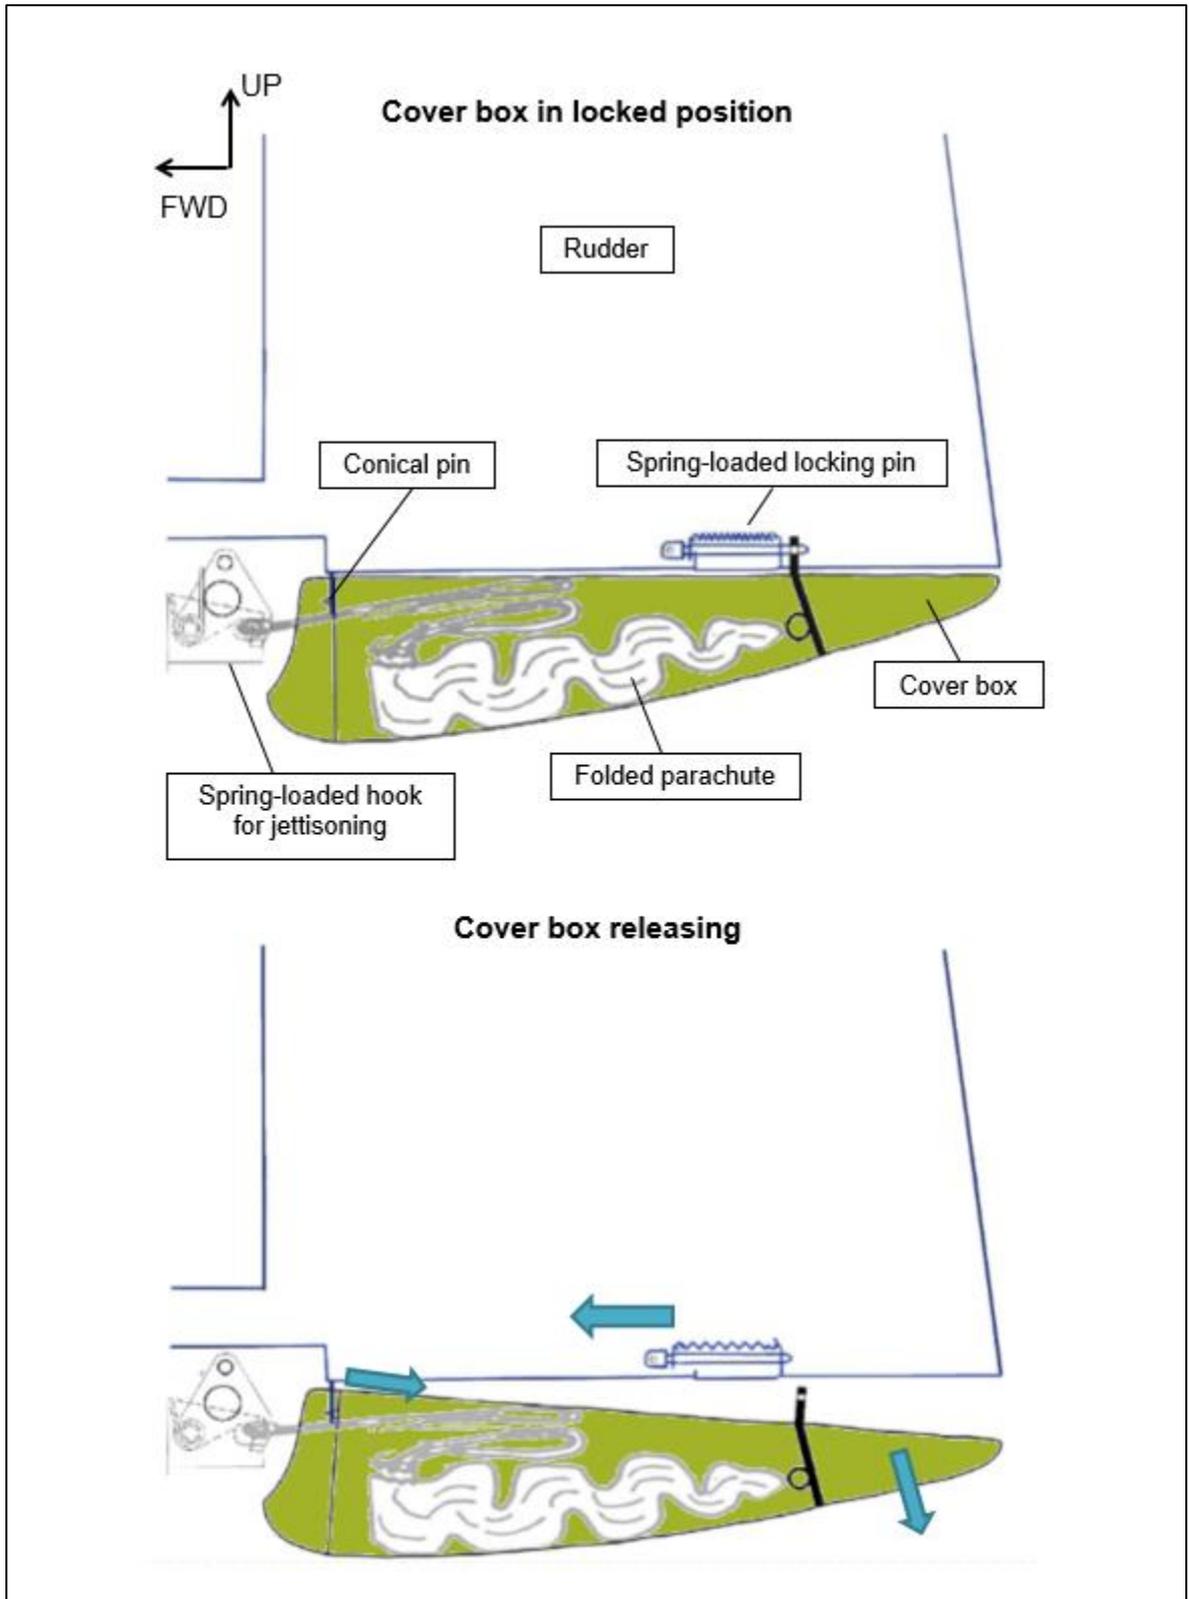
The chords of the parachute are attached to the fuselage structure by a torsion spring-loaded hook and the canopy of the parachute is fixed to its cover box by means of a ring. The cover box is attached to the underside of the rudder by 2 conical pins and a tension spring-loaded lock pin.

Figure 6 : A sketch of the brake chute releasing mechanism (not on scale)

A possible scenario for the malfunction would be that the box did not completely move down upon the activation of the handle and just remained in position due to friction between the locking pin and the locking fitting inside the box.

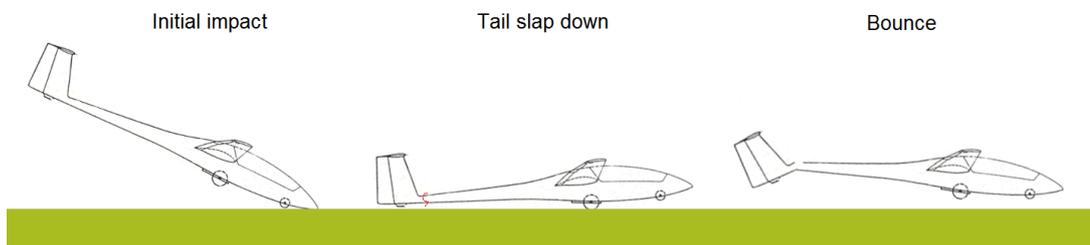
The surface didn't show either sliding marks or impact holes, which is consistent with a steep impact with relatively low energy. The separation of the aft tail section can be declared as the result of the secondary impact, also called the 'tail slap down', in which the aircraft rotates around its center of gravity due to the reaction forces on the nose.

Figure 9 : Sketch of the impact sequence
