# Safety Investigation Report

Ref. AAIU-2015-11  
Issue date: 27 April 2016  
Status: Final

An aircraft part was found in a privately owned garden located near to the airport of Liege, Belgium (EBLG).

The part fell down from a B737 airplane, on approach to EBLG.

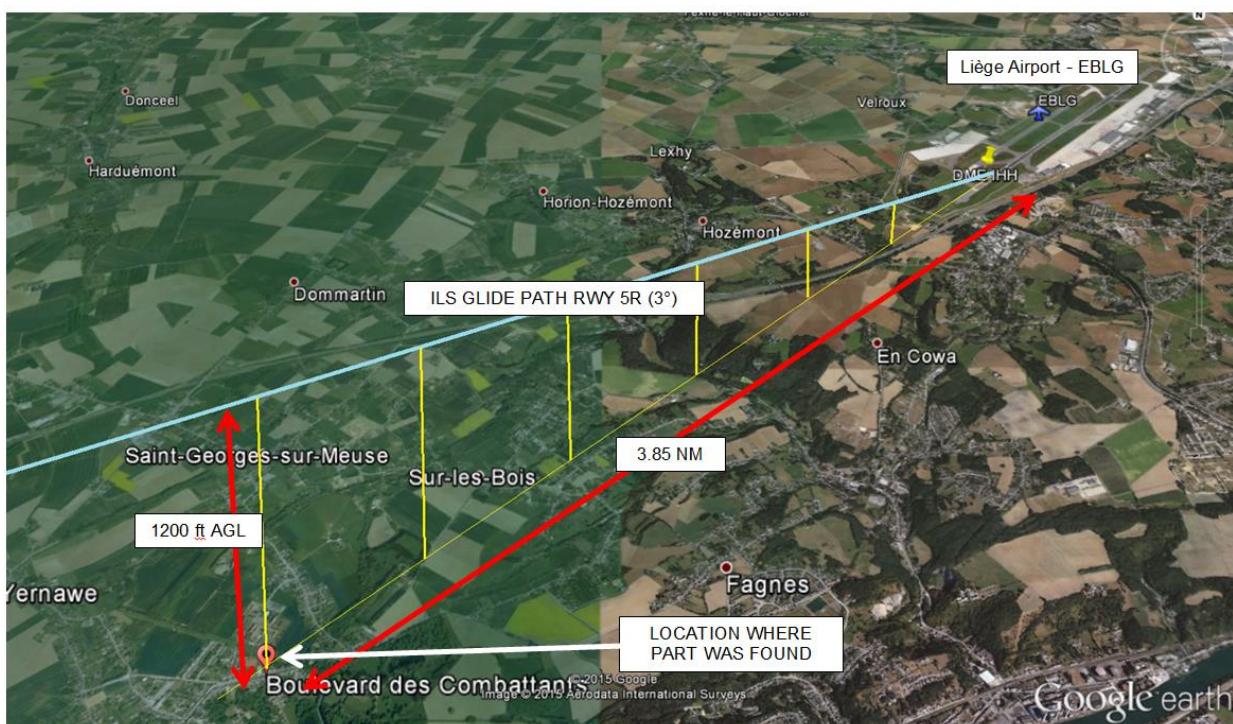
Figure 1: A scheme of the ILS approach glide path of runway 05R showing the location where the part was found

The Boulevard des Combattants is located in the extension of runway 05R of EBLG airport.

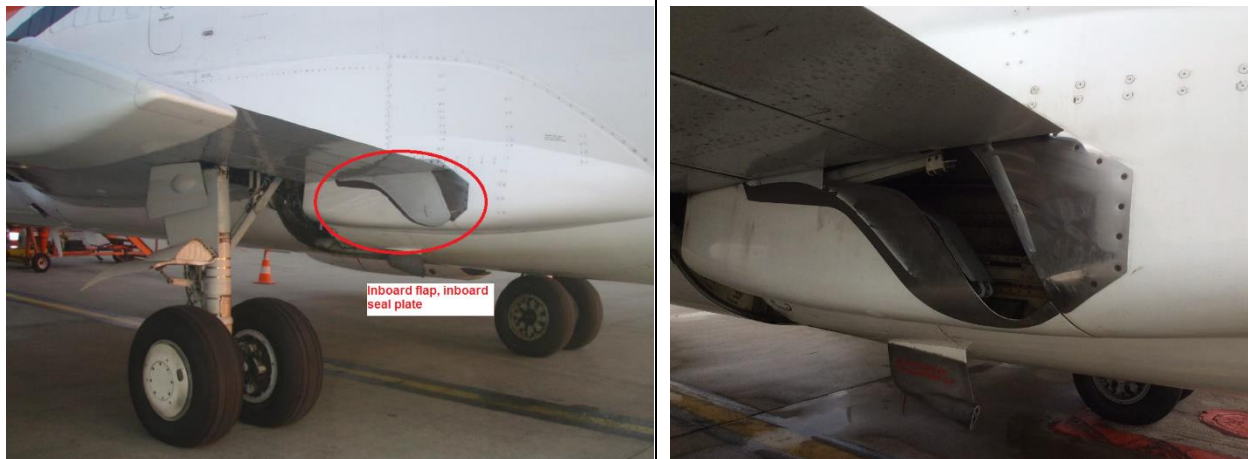
Figure 2

DEFERRED DEFECT	DEFECT DESCRIPTION	REASON FOR DEFERRAL	STAMP (OR APPR NO)	SIGN
4 APRIL 8 ITEM NO. E6734/2 DATE 01082015 STA BAU	LH INBOARD MIDFLAP SEAL PLATE MISSING.	PARTS ORDERED.

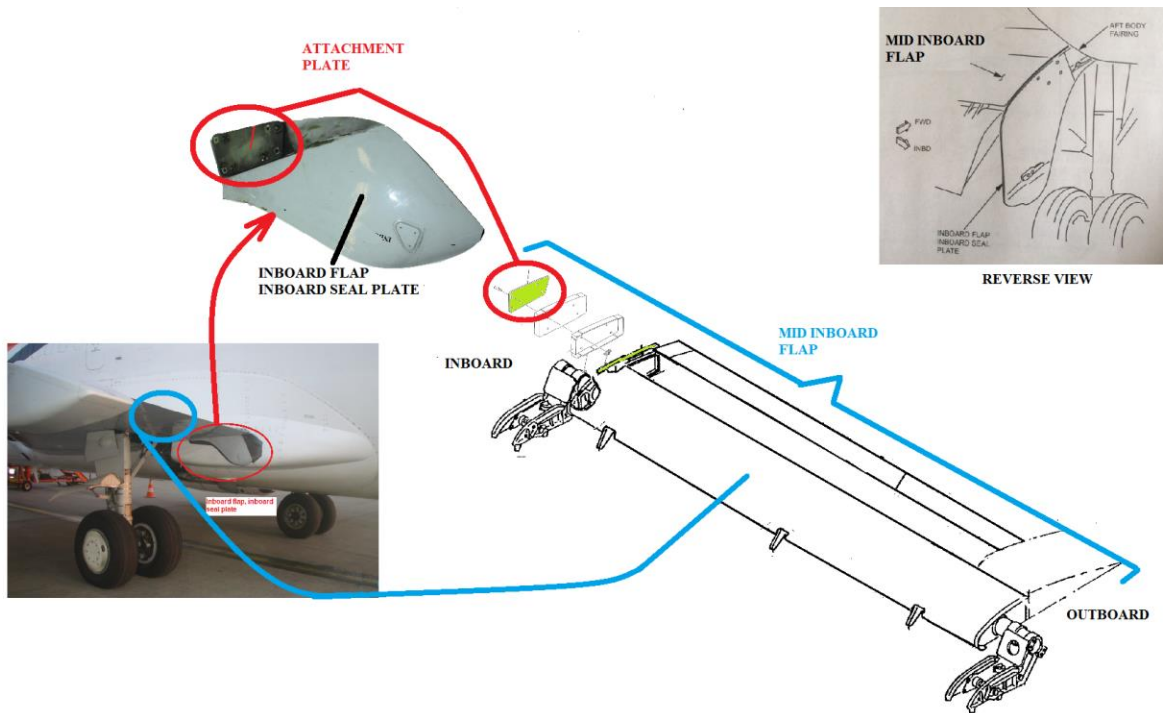
Figure 3

The part recovered is physically very similar to a B737 inboard flap inboard seal plate PNo 65C10543 – although no part number is visible. The part dimension are 79 cm x 40 cm.

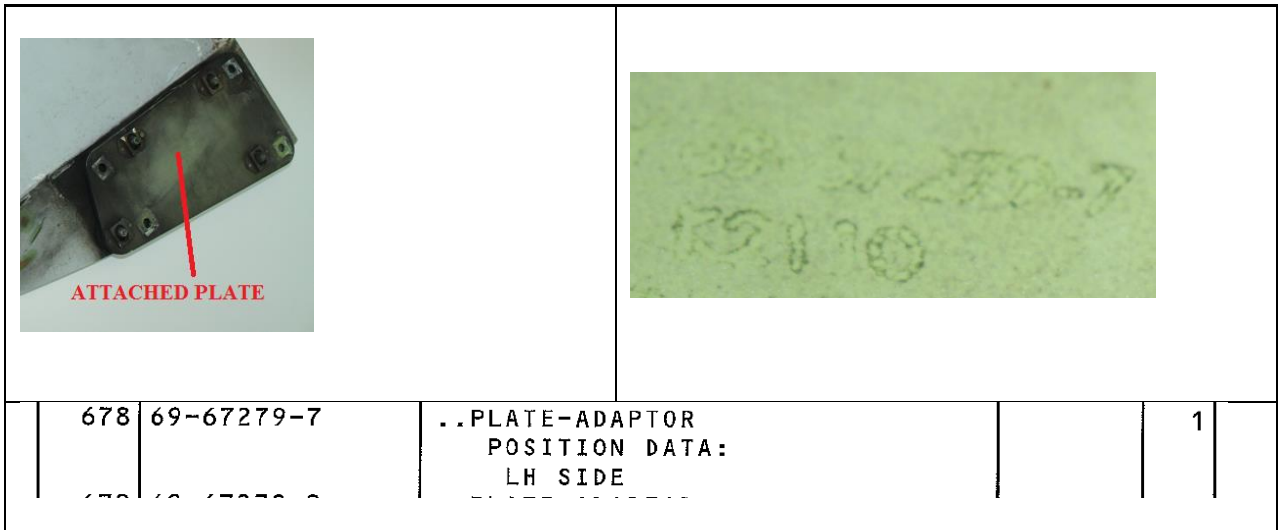
Figure 5

A plate is attached on one of the sides. After cleaning, a part number became visible – pn 69-67279-7. This part number matches the B737 Illustrated Parts Catalogue Chapter 27-51-04-02 fig 2, confirming the assembly is originating from a B737 aircraft.

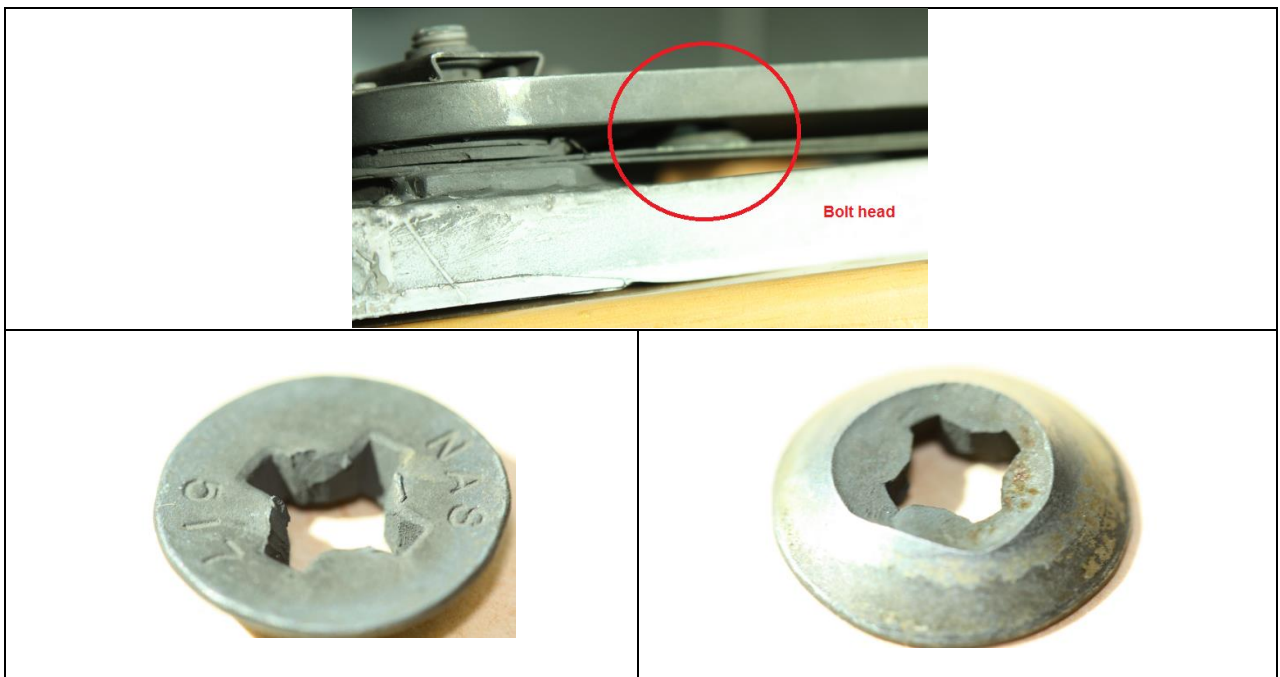
Figure 6

The fasteners are missing, although the remains of one is still lodged between the plate and the main body.

The bolt bears the identification of a NAS 517 bolt, is severed at the head, and shows some discoloration.

AMM 27-51-04-02 Fig 02 indicates that another type of bolt should be used.

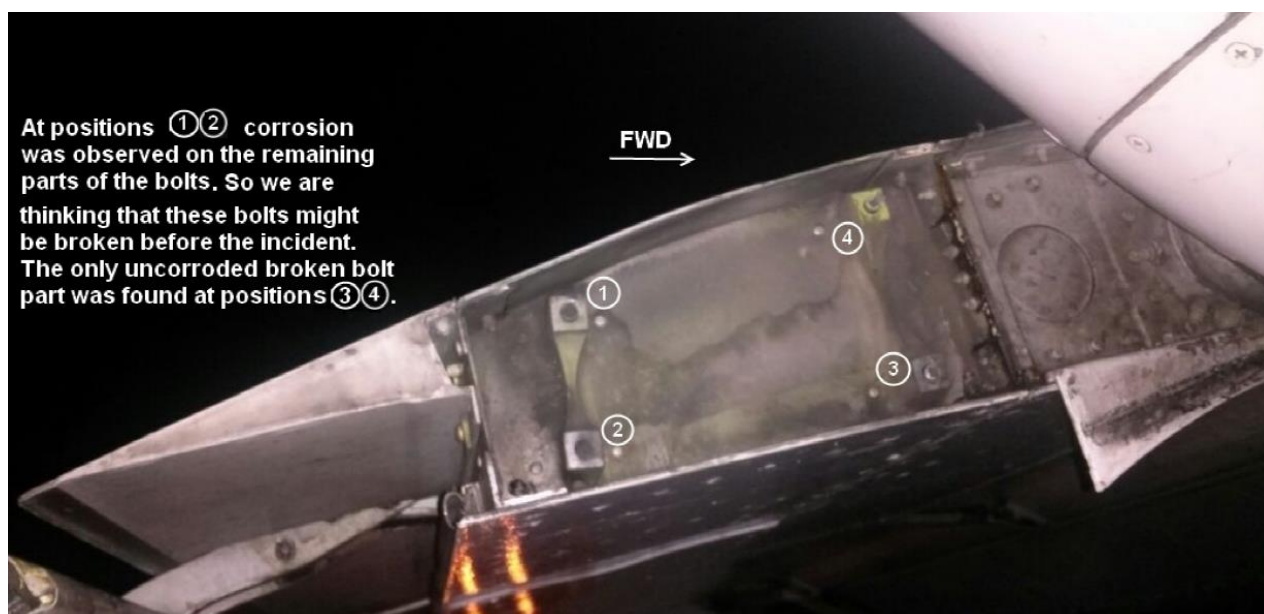
Figure 8

- All 4 fasteners holding the plate-adaptor were found broken at the base of the bolt head. Two of them were found corroded (dark aspect); two others were found not corroded (shiny appearance).
- The RH mid flap seal plate (in position) was found to be fastened with the correct bolts.

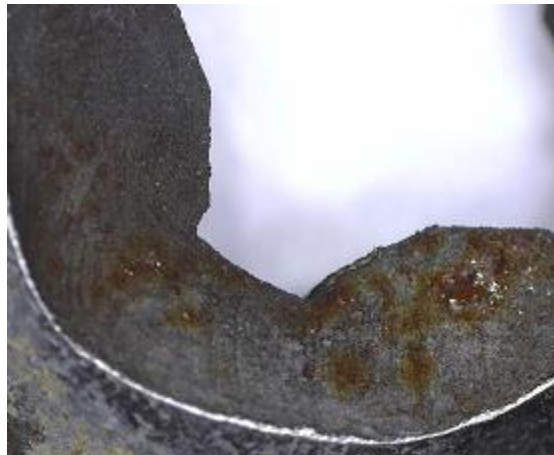
Figure 9

The close examination of the remaining bolt head shows the presence of corrosion and fatigue beach marks.

The maintenance program does not require a systematic removal of the plate adaptor pn 67279-7, and of the inboard flap, inboard seal plate. Therefore, these parts may remain installed for a very long period. Since the fasteners attaching the plate adaptor are hidden under the inboard flap, inboard seal plate, their deterioration can escape detection.

The in-flight and undesired detachment of the LH inboard flap/inboard seal plate was due to the failure of the attachment bolts of the pno 67279-7 plate adaptor. This was caused by the use of NAS 517 bolts instead of the Boeing-prescribed BACB30NN5K23.

AAIU(Be) advises the Belgian Part-147 Maintenance Training Organisations to use the content of this report to highlight the importance of following the IPC prescriptions when selecting fasteners.
