Safety Investigation Report

Ref. AAIU-2015-11
Issue date: 27 April 2016
Status: Final

Classification:	Serious incident
Level of investigation:	Standard
Date and time:	31 July 2015 – 11:30 UTC
Aircraft:	Boeing B737-4Q8, msn 27628
Operator:	Tailwind Airlines
Date of Manufacture:	February 1997
Type of engine:	Two CFM-56-3
Accident location:	At the moment of the incident: Above St Georges sur Meuse, on approach to EBLG airport.
Type of flight:	Commercial
Phase:	Landing
Injuries:	None

Other – Things Falling-Off Aircraft (TFOA)

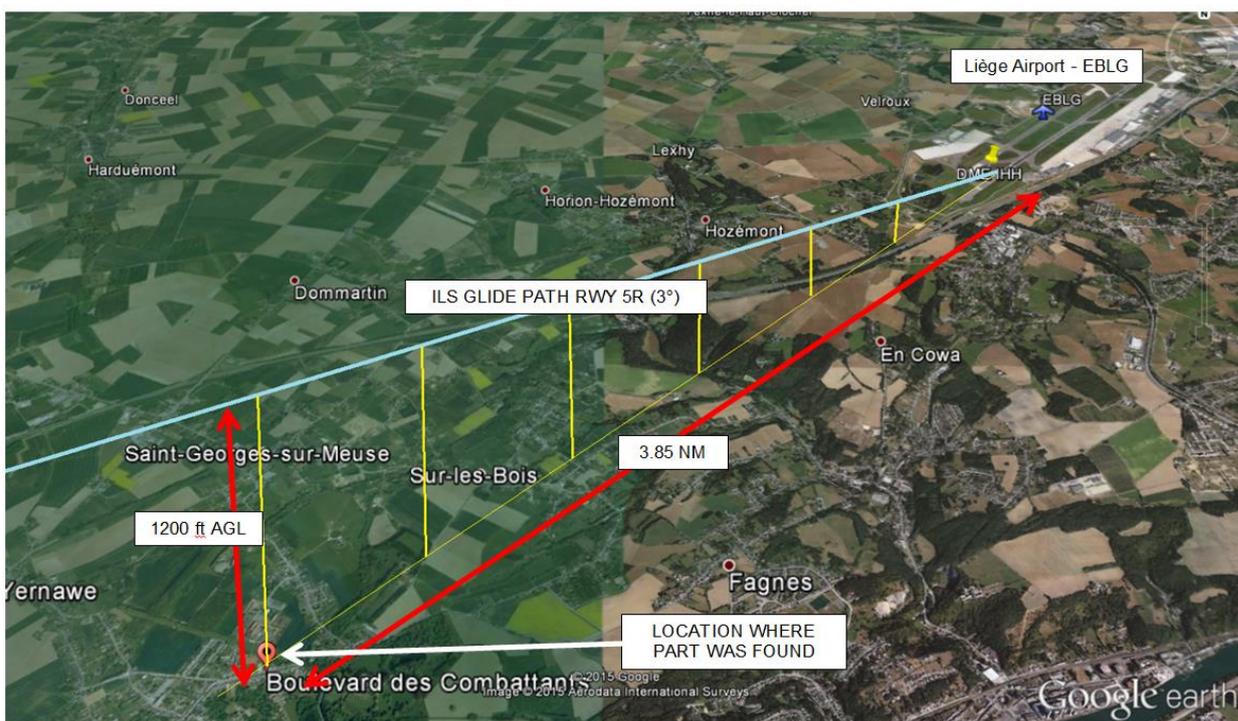
Figure 1: A scheme of the ILS approach glide path of runway 05R showing the location where the part was found

A person living on the Boulevards des Combattants in Saint-Georges sur Meuse was walking in his garden when he noticed the presence of an object, thought to be an aircraft part. The discovery was made around 16.00 LT on the 31st July 2015.

The Boulevard des Combattants is located in the extension of runway 05R of EBLG airport.

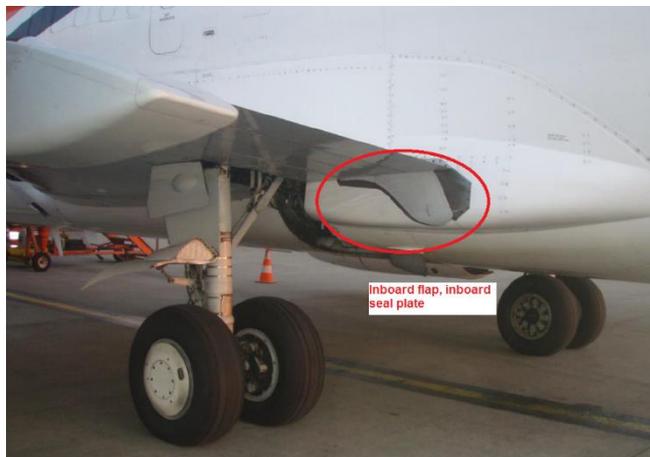
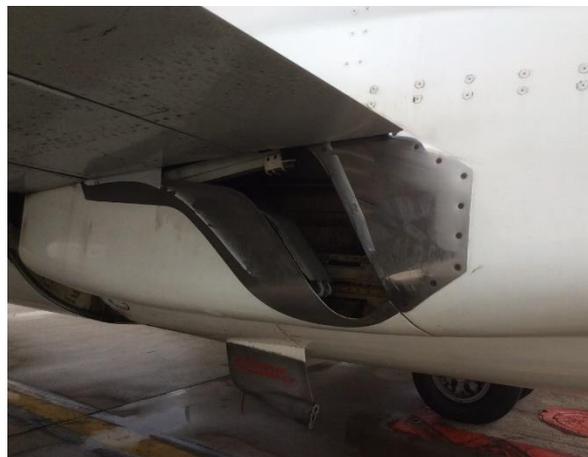
Figure 2

Related or not: 40 minutes after, landing TWI473 Pilot in command calling TWR (0475 775 839) to tell that, after inspection of the they saw it was damaged. A fitting of flaps was missing. Thorough RWY inspection 25R was required. A sudden RWY change ha place.

DEFERRED DEFECT	DEFECT DESCRIPTION	REASON FOR DEFERRAL	STAMP (OR APPR NO)	SIGN
4 APRIL 8 ITEM NO. E6734/2 DATE 01/08/2015 STA BAU	LH INBOARD MIDFLAP SEAL PLATE MISSING.	PARTS ORDERED.

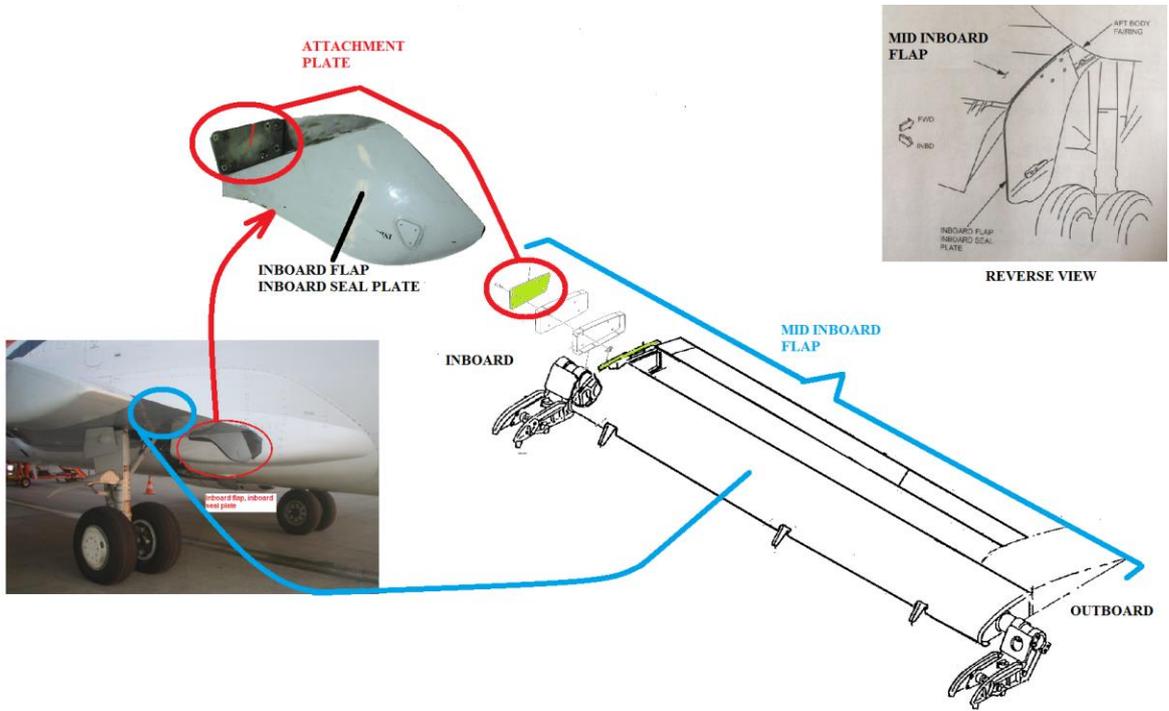
Figure 3

The part recovered is physically very similar to a B737 inboard flap inboard seal plate PNo 65C10543 – although no part number is visible. The part dimension are 79 cm x 40 cm.

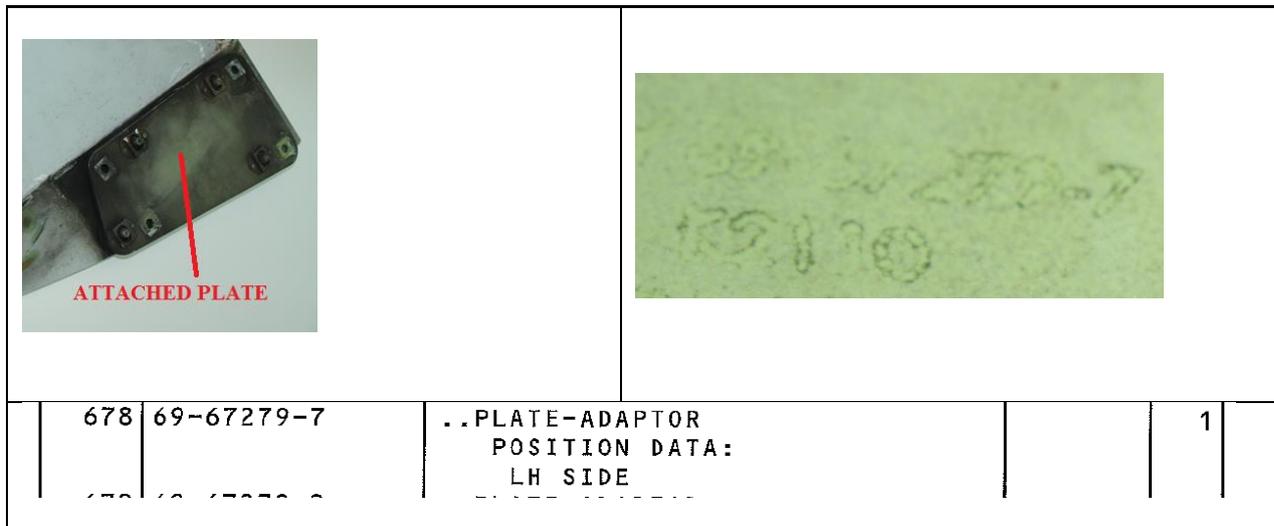
Figure 5

A plate is attached on one of the sides. After cleaning, a part number became visible – pn 69-67279-7. This part number matches the B737 Illustrated Parts Catalogue Chapter 27-51-04-02 fig 2, confirming the assembly is originating from a B737 aircraft.

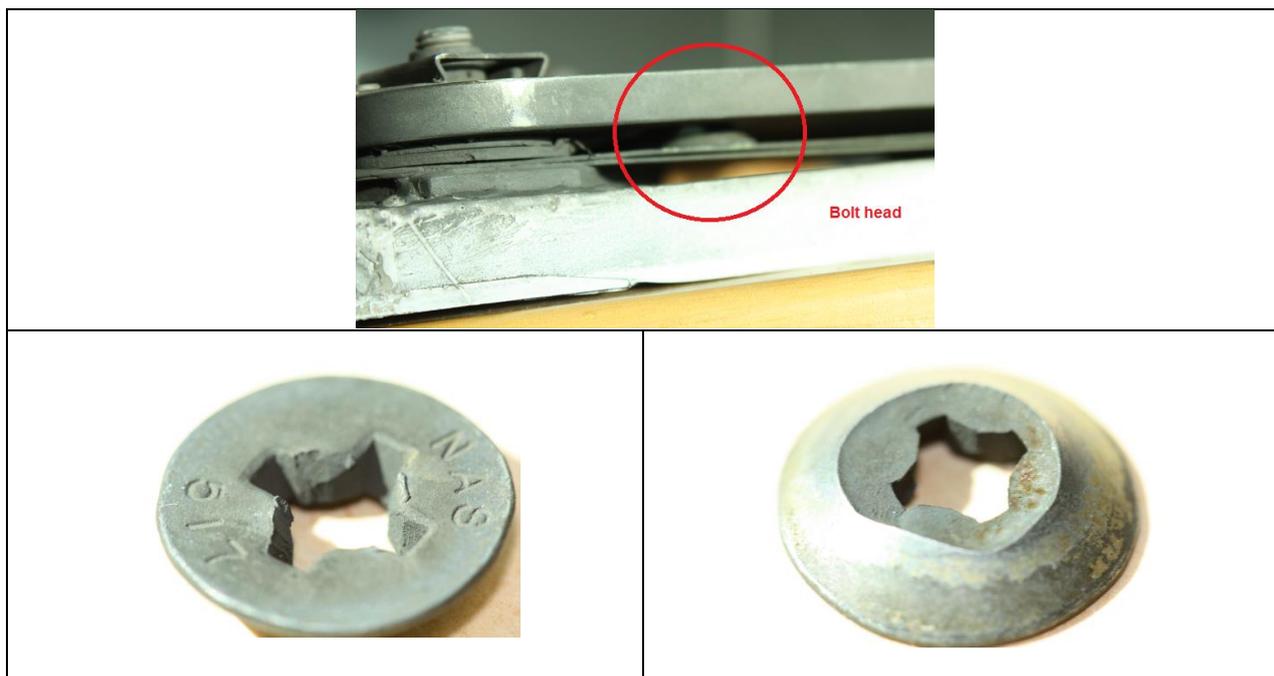
Figure 6

The fasteners are missing, although the remains of one is still lodged between the plate and the main body.

The bolt bears the identification of a NAS 517 bolt, is severed at the head, and shows some discoloration.

AMM 27-51-04-02 Fig 02 indicates that another type of bolt should be used.

AAIU(Be) advises the Belgian Part-147 Maintenance Training Organisations to use the content of this report to highlight the importance of following the IPC prescriptions when selecting fasteners.

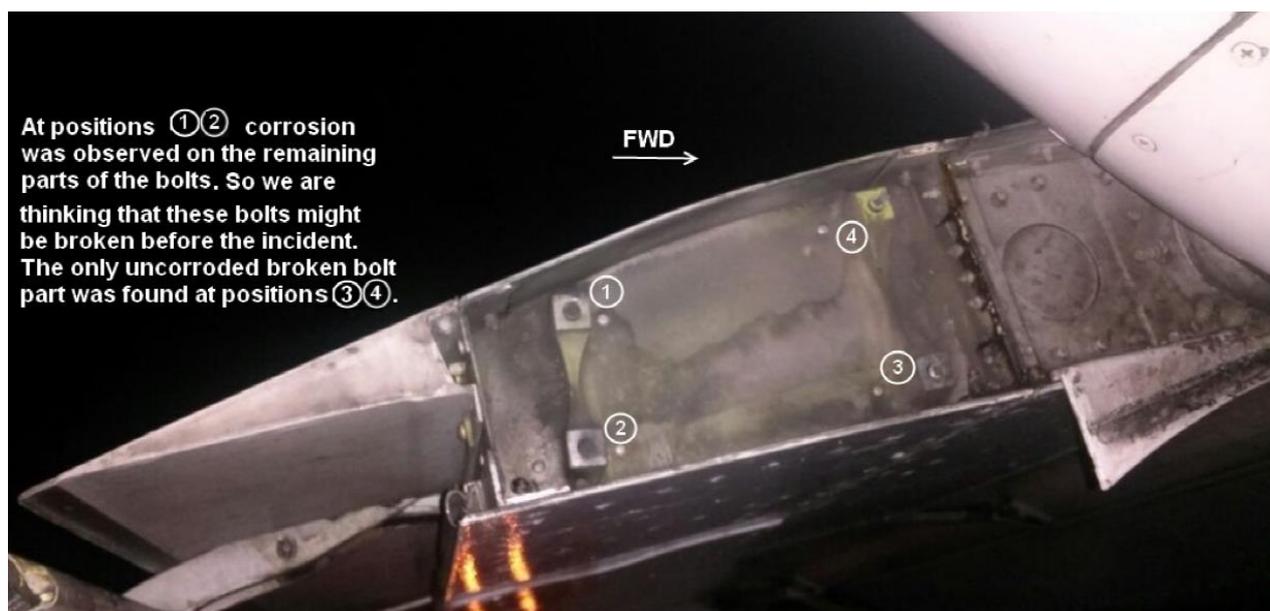
Figure 8

- All 4 fasteners holding the plate-adaptor were found broken at the base of the bolt head. Two of them were found corroded (dark aspect); two others were found not corroded (shiny appearance).
- The RH mid flap seal plate (in position) was found to be fastened with the correct bolts.

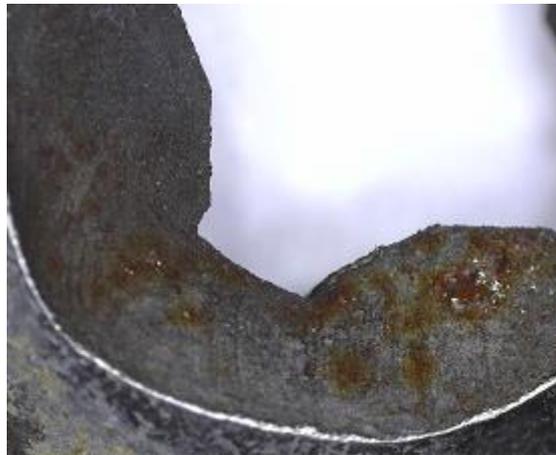
Figure 9

The close examination of the remaining bolt head shows the presence of corrosion and fatigue beach marks.

The maintenance program does not require a systematic removal of the plate adaptor pn 67279-7, and of the inboard flap, inboard seal plate. Therefore, these parts may remain installed for a very long period. Since the fasteners attaching the plate adaptor are hidden under the inboard flap, inboard seal plate, their deterioration can escape detection.

The in-flight and undesired detachment of the LH inboard flap/inboard seal plate was due to the failure of the attachment bolts of the pno 67279-7 plate adaptor. This was caused by the use of NAS 517 bolts instead of the Boeing-prescribed BACB30NN5K23.
