Interim Investigation Report

Ref. AAIU-2015-08
Issue date: 31 January 2017

Classification:	Serious incident
Date and time:	18 July 2015 at 10:48 UTC
Aircraft:	Lithuanian Aero Club LAK-17 AT, powered sailplane
Operator:	Private
Accident location:	Aerodrome of Maubray (EBTY)
Type of flight:	Glider – Cross country
Phase:	Lift-off phase of the winch launch
Persons on board:	1
Injuries:	Pilot seriously injured

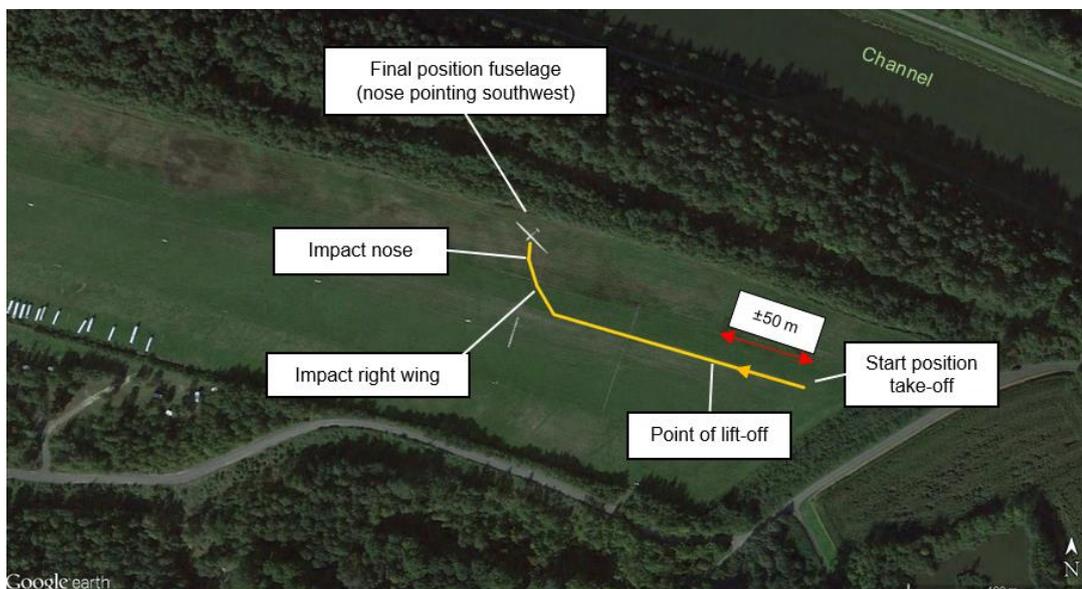
The winch launch just started when the sailplane took an extreme pitch-up attitude and stalled on its right-hand wing. The sailplane impacted the grass ground next to the runway with a steep angle. The pilot was seriously injured.

Damage to aircraft.

The aircraft is totally destroyed
