Federal Public Service
Mobility and Transport
Air Accident Investigation Unit

Safety Investigation Report

SERIOUS INCIDENT SOCATA TBM 700 A AT AERODROME GENK / ZWARTBERG ON 17 DECEMBER 2015

Ref.:
AAIU-2015-16

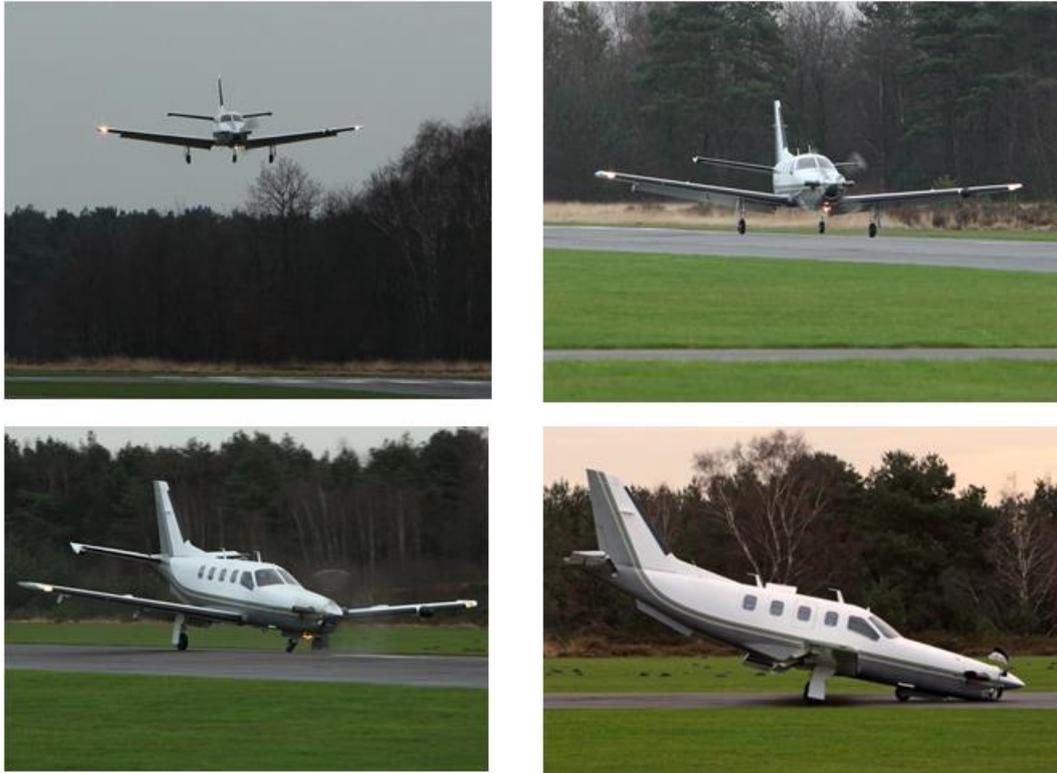
Figure 2: Pictures of the serious incident taken by a spotter

During the landing, the pilot felt an abnormal vibration accompanied by a noise when the nose gear touched the ground. He realized the nose landing gear was collapsing. The aircraft came to a stop after a 400m landing run. The pilot climbed out, uninjured.

A plane spotter took several pictures of the event as it unfolded. The photographer and other witnesses confirmed the landing gear were down long before the touchdown.

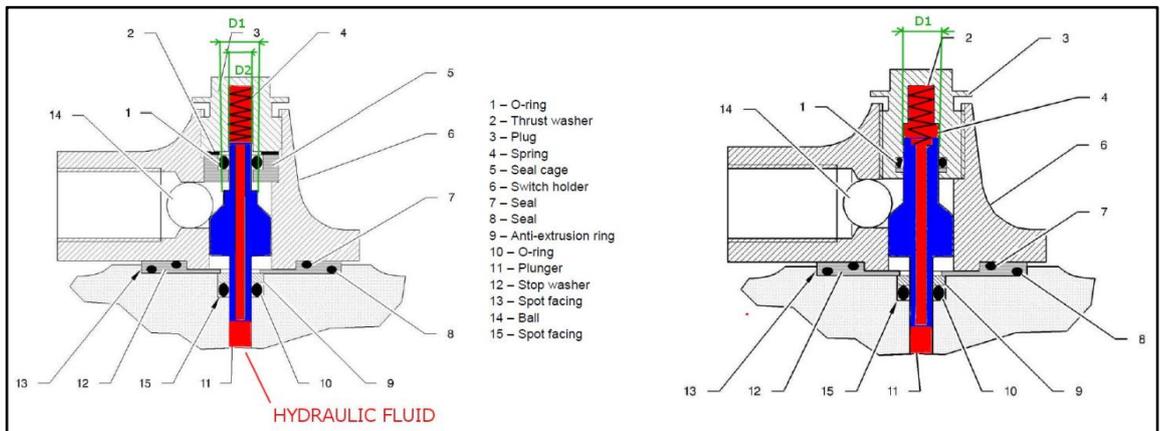
Figure 18: Installed plunger (Not modified)

Although the differential plunger modification is internally approved by the aeroplane manufacturer as MOD70-0334-32, the only technical information available for public is to be found in the actuator Component Maintenance Manual (CMM) T00.DMACMAEEEE0R7. Daher-Socata elected to systematically incorporate this improvement during overhaul only, because of the skills required (overhauls are due at 7 or 10 years depending on configurations). No specific Service Bulletin or similar document was released by Daher-Socata to allow aircraft owners to request this modification.

A latest improvement of the plunger was introduced in December 2012 (MOD70-0334-32) to replace the original design with an improved “differential” plunger intended to provide an additional load, helping the return course. As stated by Daher-Socata, this differential plunger offers a considerable improvement causing a reduction of the indicating kinematics malfunctions. However, Daher-Socata stated that residual malfunctions may still exist, although they are much limited in number.

Because no service bulletin or similar document was published to recommend or request the installation of an improved “differential” plunger, the actuators are only upgraded when they are sent for overhaul or repair.

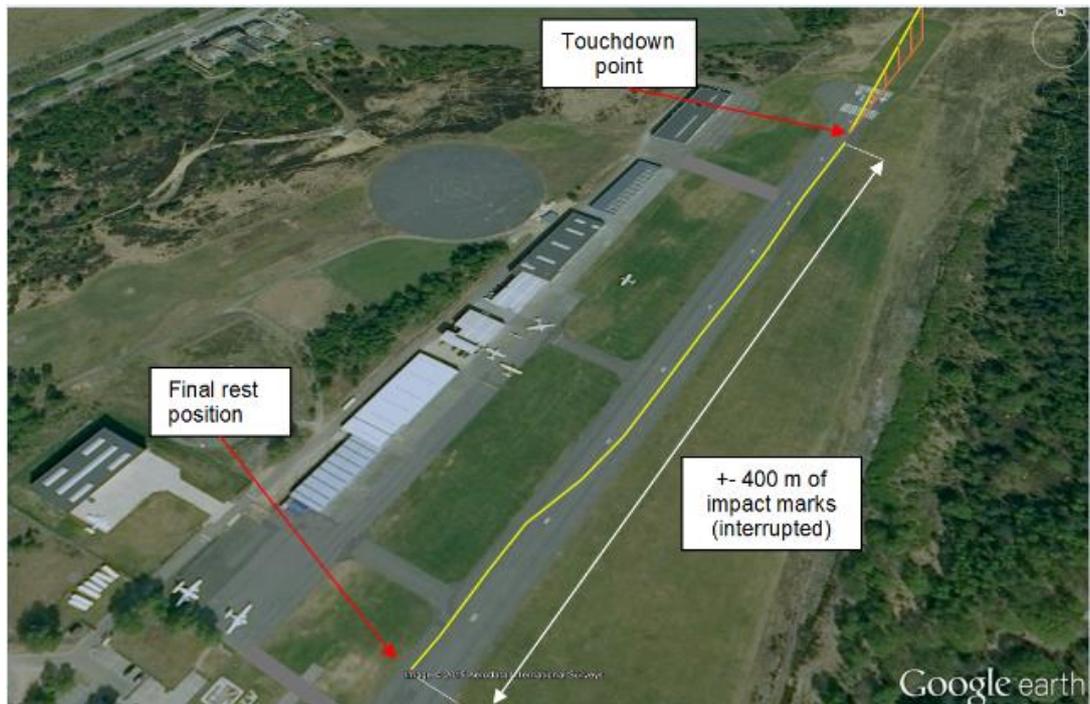
Figure 20: Aerial view of EBAW airfield showing the landing roll distance

The runway showed superficial scratches in the asphalt pavement due to the propeller touching the surface. The traces are starting 60 m from the runway threshold, and continue for 400 m.

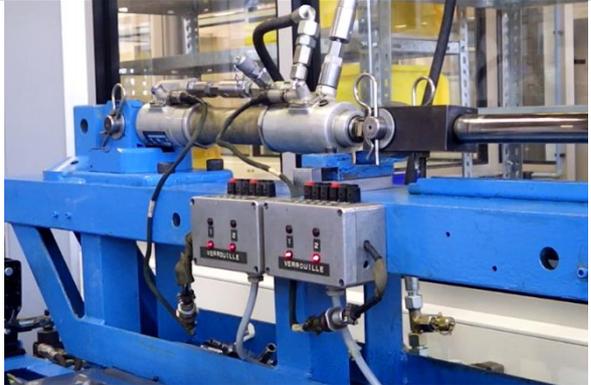
<p>At the end of the retraction phase, normal activation of the retract dual switch contacts.</p> <p>But almost at the same time both 2 extend dual switch contacts also activated to the locked position.</p> <p>Thus abnormal activation of the “extend” dual switch contacts when the actuator locked in retract.</p>

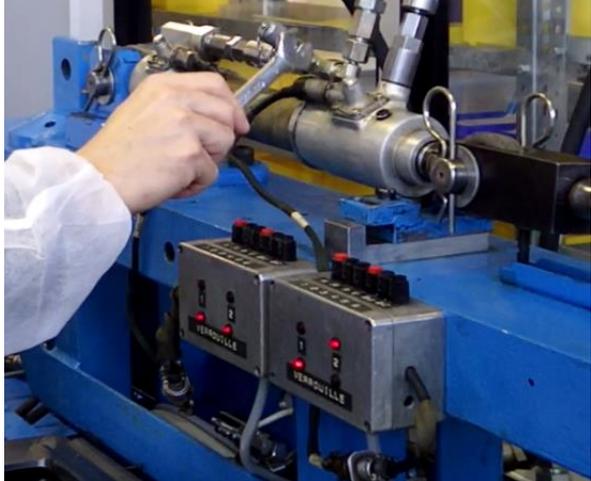
<p>The “extend” dual switch contact N°2 (used to control the electro-hydraulic generator) switches to the “unlock” position after a few minutes.</p> <p>The “extend” dual switch contact N°1 (used for the indication) switches to the “unlocked position” after “tapping” (with a wrench) a few seconds on the actuator around the switch body.</p>

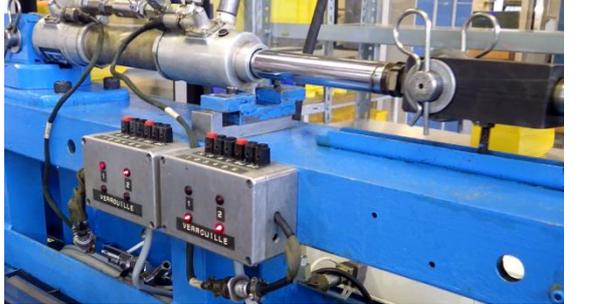
<p><u>RETRACTION</u> 3rd Retraction of the actuator to the “fully retracted” position.</p> <p>The “extend” dual switch contacts don’t switch OFF at the beginning of the retraction.</p>

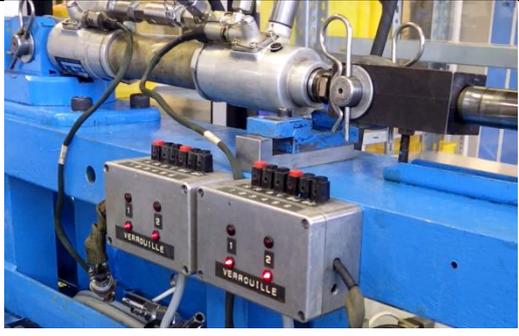
<p>Normal activation of the retract dual switch contacts at the end of the retraction.</p> <p>Both “extend” dual switch contacts, supposed to move to the unlocked position as soon as the mechanical unlocking occurs, remain in the locked position.</p>

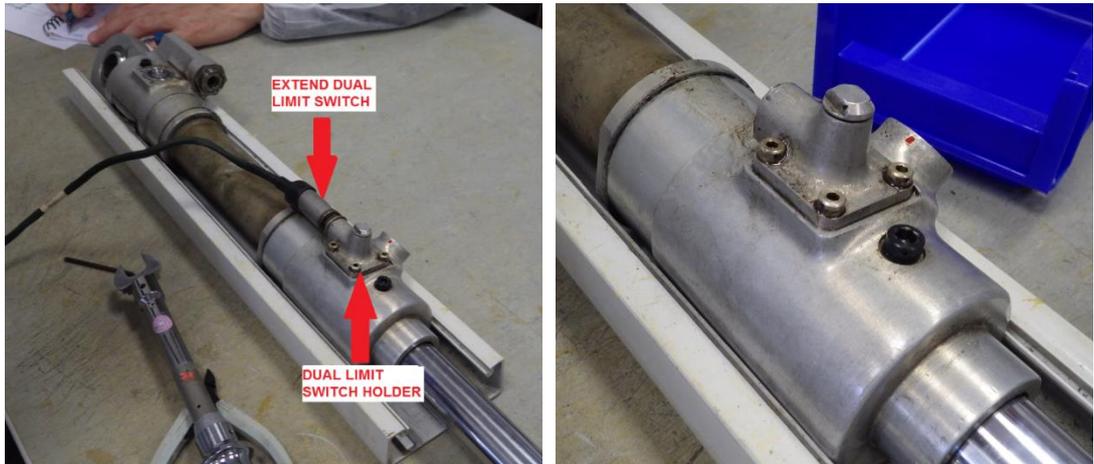
Figure 22: Pictures of the NLG actuator extend dual limit switch

External examination of the actuator showed that a lock plate washer used to secure the assembly of a guide rod with the casing of the actuator was not bent, but the parts were not loose. The plug of one plunger holder was also found to be damaged by a previous use of an inadequate wrench for unscrewing it. Finally, traces of hydraulic oil seepage were visible around the extend dual switch holder.

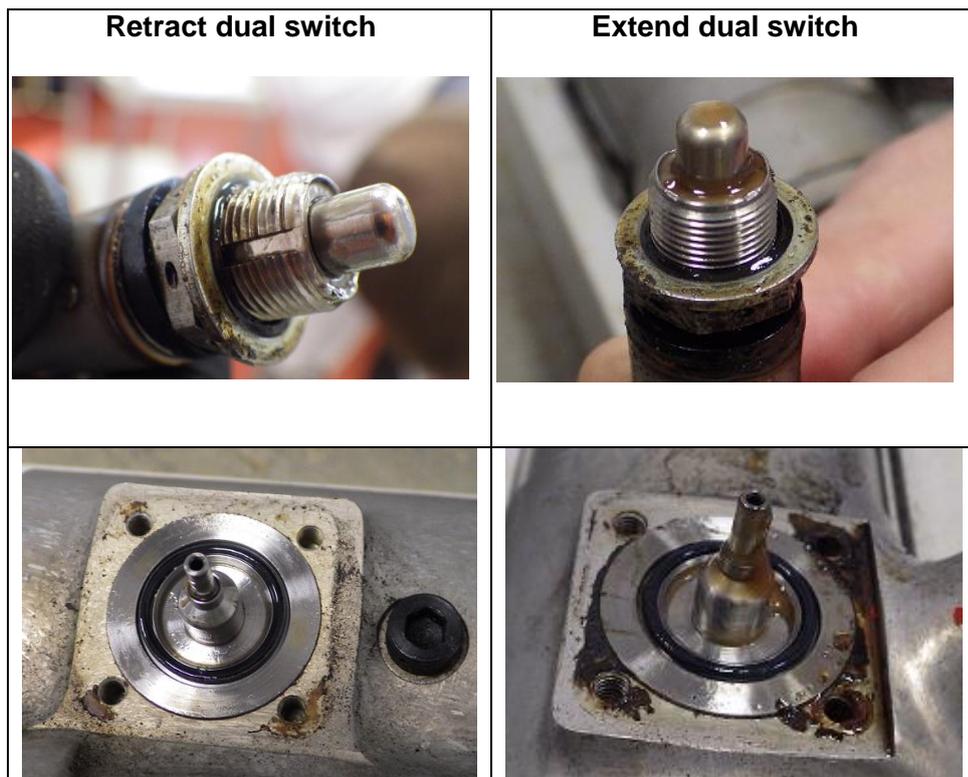
Figure 23: retract limit switch and plunger

As shown on figures 23 and 24, the dual switches and switch holders were removed and disassembled. The extend dual switch showed the presence of what seemed to be a low viscosity light brown grease around the plunger and its surrounding parts.

Low viscosity grease was found on the plunger and its surrounding parts that could be the result of a small internal hydraulic fluid leak at one or both plunger O-ring(s) combined with the grease placed on the plunger and its ball during installation.

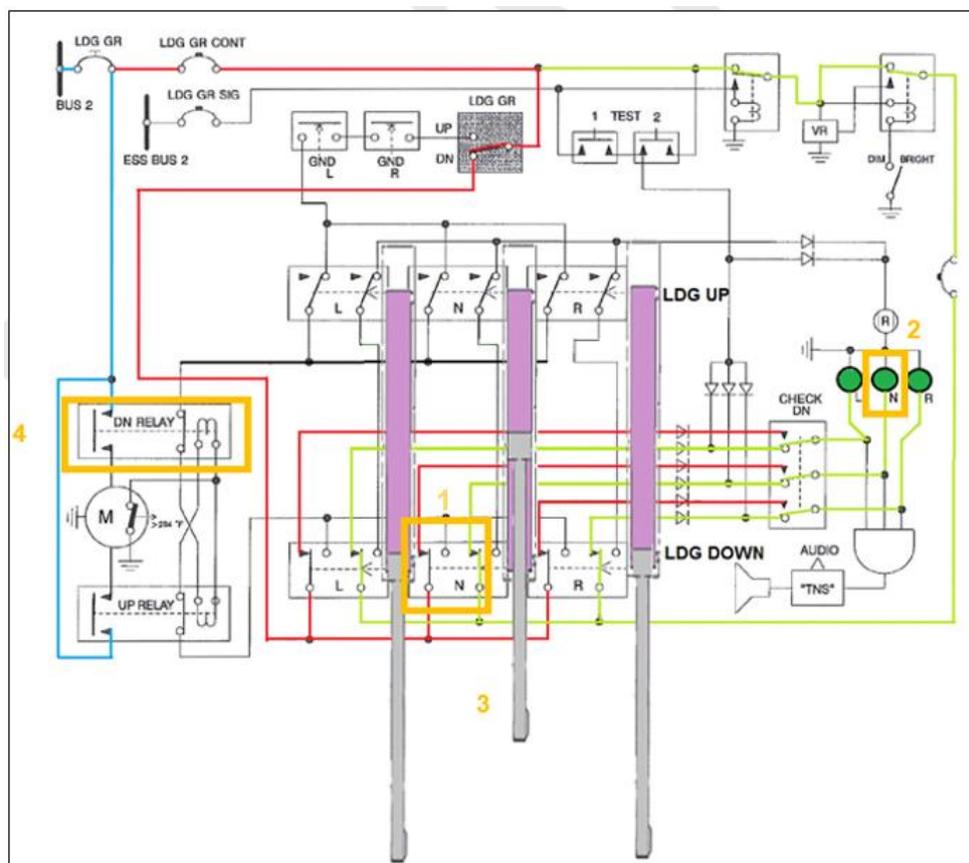
Figure 26 : Three greens are lit while the NLG is not locked

The NLG would therefore collapse when the weight of the aircraft would be applied to it during the ground roll. Thus, the same consequence as in this event.

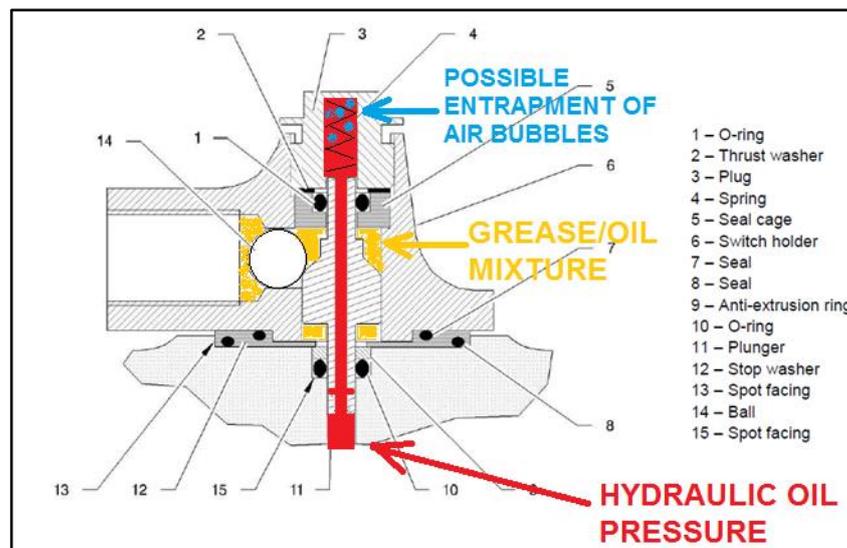
Figure 27: Drawing of the dual switch holder

During the last retraction performed after the take-off at EBLG airport, it is likely that the plunger did not move fully down. This might have been caused by the presence of abundant low viscosity grease on the underside of the plunger, causing a cushion effect and reducing the movement of the plunger.

In this case, a very small upwards movement of the plunger, possibly caused by a pressure spike, has the potential to cause an early activation of the dual switch.

It is also possible that air bubbles were present on the top end of the plunger, facilitating the unwanted upwards movement of the plunger. In this case, the plunger can be submitted to pressure unbalance originating from pure hydraulic fluid on one end and fluid containing air bubbles on the other end.
