# Safety Investigation Report

## ACCIDENT B&F TECHNIK, MODEL FK12 COMET AT AVERNAS ON 18 OCTOBER 2015

**Ref.:**  
AAIU-2015-AII-12

**Issue date:**  
05 January 2017

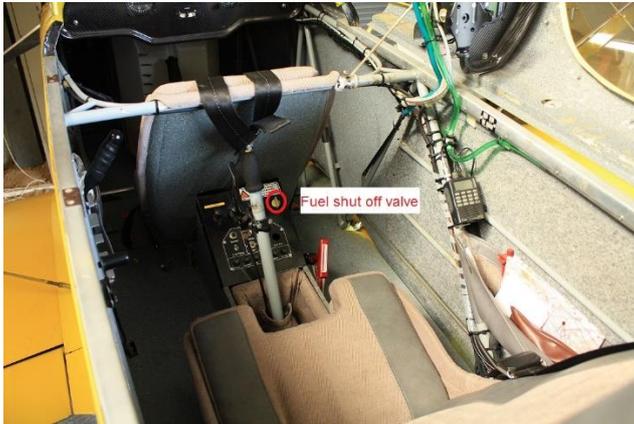
Figure 1: view of the shut off valve control knob

During the investigation it was found that the fuel shut off valve of ultralight aeroplanes is rarely actuated and tested, unless the shut off valve is combined with a fuel tank selector valve. The lack of regular test has the potential for an undetected stuck fuel shut off valve situation to develop and also the potential for keeping in service an undetected internally leaking valve. Both types of deficiencies could make it impossible to interrupt an impending engine fire caused by a fuel leak in the engine compartment. Therefore:

It is recommended that the Belgian Ultralight Federation promotes regular actuation and test of the fuel shut off valve.

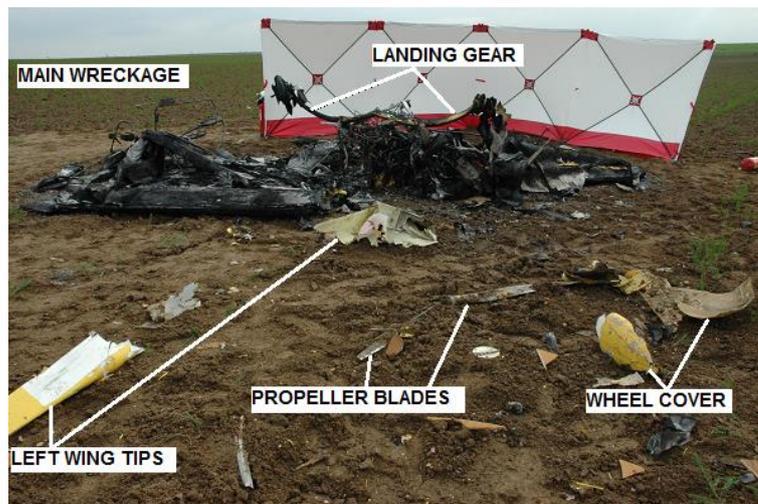
The impact and the wreckage distribution show that the aeroplane was heading south when it impacted the ground. The first impact area was located at 3 m from the final resting place. The wreckage was lying upside down, almost completely consumed except the metallic parts and other small parts scattered some distance from the fire.

Small debris originating from the engine cowling and the canopy were distributed up to 48 meters in front of the main wreckage with respect to the impact direction. Pieces of transparent plastic found on the ground, out of reach of the smoke produced by the post impact fire, showed smoke deposit on both internal and external sides.

Figure 5: distribution of the wreckage

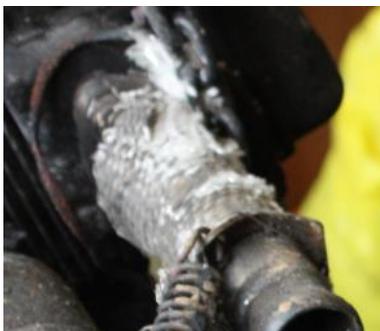
Figure 6: pipe wrapped with a heat resistant tape

The exhaust pipes were surrounded by a thermal protection which consisted in a special heat resistant tape coiled around the pipes.

Some part of the protection suffered obvious mechanical damage during the ground collision and some lengths of the pipes were found unprotected. It could not be determined if the protection was present on the whole length and in good condition before the crash.

- Examination of the remains of the exhaust system found that most pipes were wrapped in a heat resistant tape which the installation was not original and/or not approved by the aeroplane designer/manufacturer.

Some ultralight owner and ultralight maintenance organization have altered the exhaust system by wrapping heat resistant tape around the exhaust pipes. The purpose of this modification would be to minimise the heat radiation and conduction inside the engine compartment in order to reduce the risk of fuel vapour lock in the fuel system and heat damage to the engine cowlings.

However, the main disadvantage of this modification is to increase the risk of overheating of the exhaust pipe, causing possible premature heat deformation and cracks. This can also increase the risk of corrosion damage if the heat resistant tape retains some moisture. Additionally, the wrapping prevents the pipes being visually inspected. However, these disadvantages can be mitigated by regular removal of the tape and thorough inspection of the entire exhaust system. Therefore:

It is recommended that the Belgian Ultralight Federation provides some warnings about the wrapping of the exhaust pipe with heat resistant tape, in particular if it is not originally installed and/or recommended by the aeroplane manufacturer.

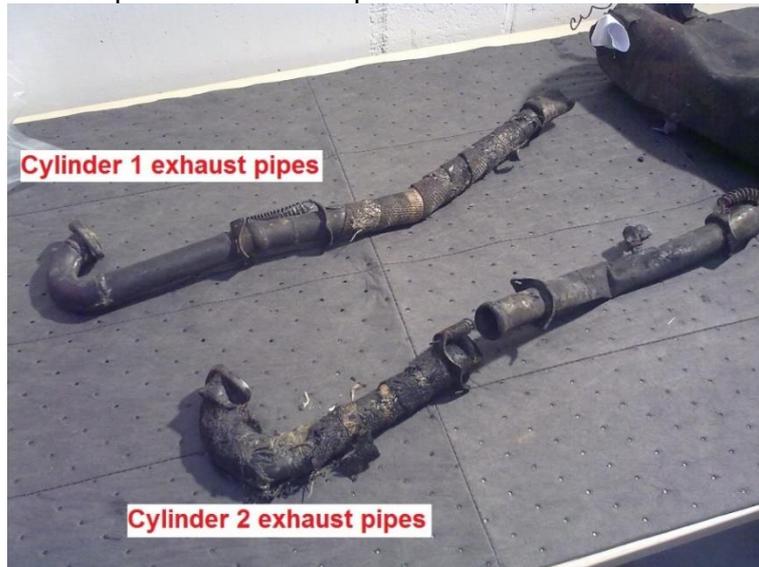
- Cylinder 1: minor deformation
- Cylinder 2: pipe torn open near the cylinder head fixture
- Cylinder 3: Straight pipe recently repaired and found in good condition. The bent pipe is deformed at the ball and cone connection and 2 big holes are observed in the middle of the curve.
- Cylinder 4: The straight pipe, equivalent to these recently repaired at the cylinder 3, is deformed and separated into three parts.

Figure 7: cylinder N°1 and N°2 exhaust pipes

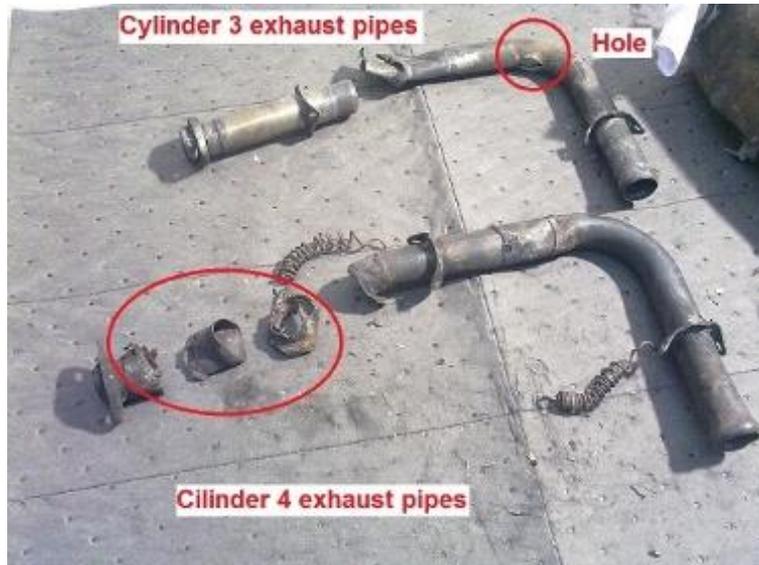
Figure 8: cylinder N°3 and N°4 exhaust pipes

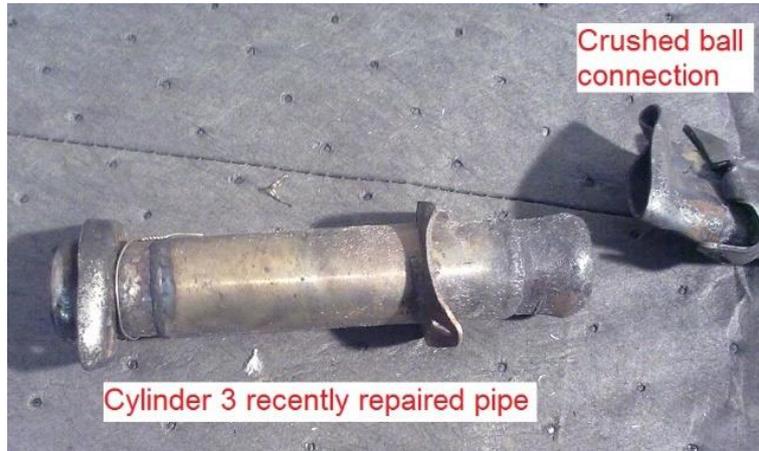
Figure 9: cylinder N°3 recently repaired straight pipe

Two weeks before the accident, the owner removed N°3 cylinder straight exhaust pipe (right rear cylinder) for repair. He asked assistance from a professional welder to overhaul this exhaust pipe. Based on the interview with the welder, the damaged pipe was separated into several pieces and the material was in such bad condition that a local repair was not possible. Therefore, they cut the damaged section and welded a new one onto the ends that were still in good condition. The spring support was also reused and welded onto the new section of the pipe. This exhaust pipe was recovered in the wreckage, showing that the repair had been properly performed and it did not suffer much from the accident.

- Two weeks before the accident, the cylinder N°3 exhaust pipe had been removed, properly repaired by a qualified welder and reinstalled by the owner. Removal of the right side carburettor and its associated fuel line was necessary to gain access to this exhaust pipe.

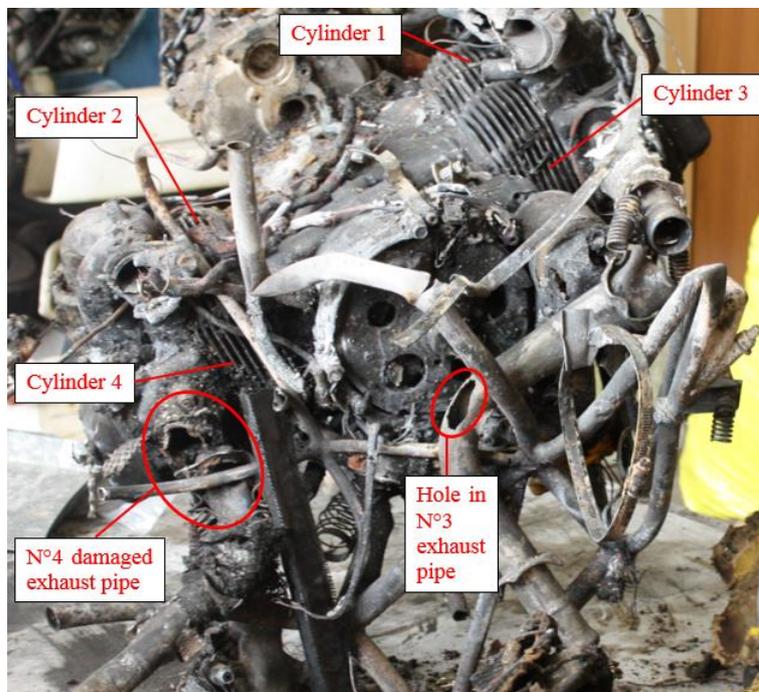
Figure 10: backside of the engine showing damage to the rear exhaust pipes

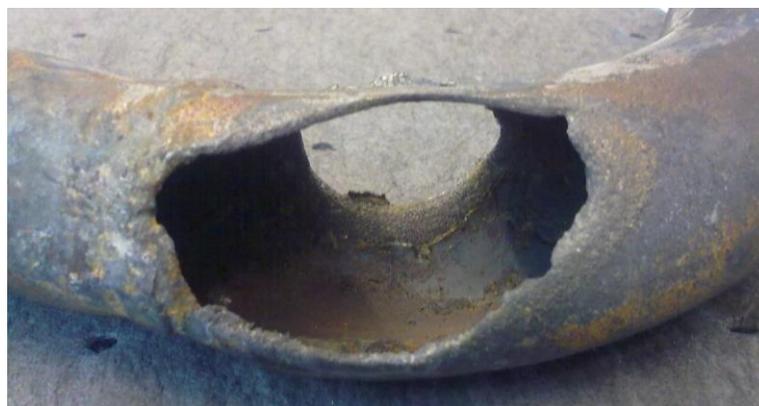
Figure 11: detail of holes in the N°3 exhaust pipe

The perforations in the N°3 bent exhaust pipe had been analysed by the laboratory of the Royal Military Academy (“Department of Civil & Materials Engineering”) in order to determine the cause of the perforations and to possibly establish a relationship between the exhaust pipe damage and the post-crash firing of the BRS rocket trapped in the wreckage.

At the beginning of the investigation, it was suspected that the perforations found in the curve of N°3 bent exhaust pipe could have been the cause of the inflight fire.

The investigation of the laboratory determined that the perforation clearly shows proof of fusion caused by an external heat source. The laboratory stated that the observed element (contaminants) on the perforation surfaces can be probably linked to the heat source that caused the melting of the tube. Comparison of the contaminants on the exhaust tube with the residue from the burned rocket shows the presence of similar elements (magnesium, silicon, aluminium and phosphor).

In summary, it is very likely that the perforations found on this exhaust tube were caused by a flame coming out the BRS rocket.

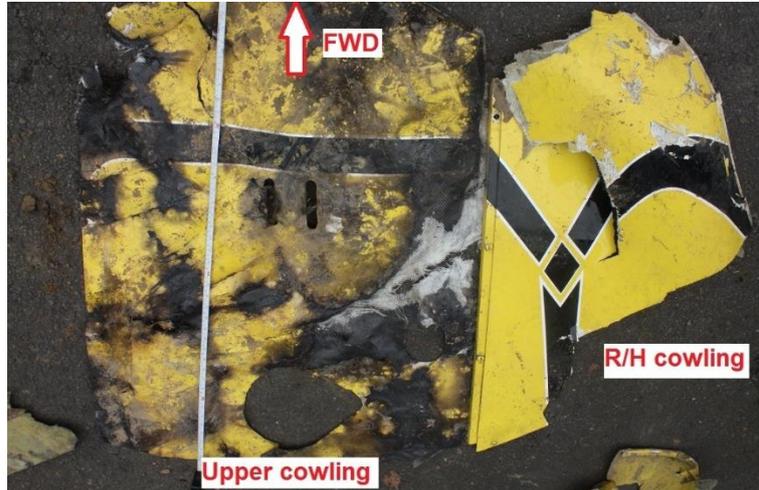
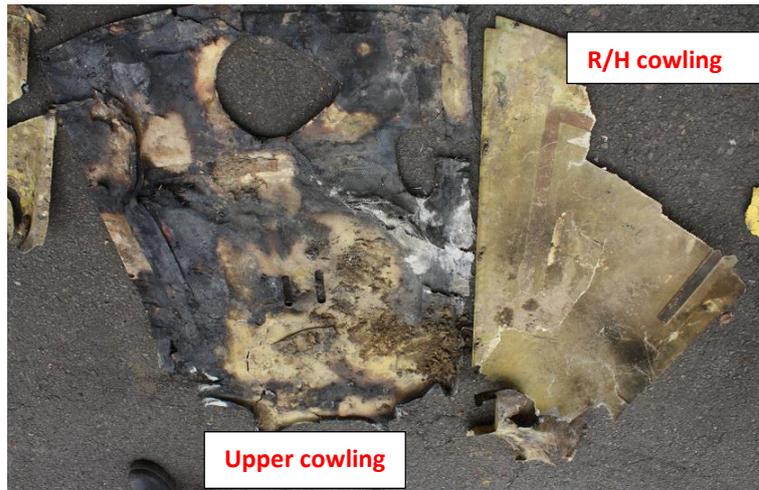
Figure 12: outside view of both the upper and the R/H engine cowlings

Figure 13: inside view of both the upper and the R/H engine cowlings

The upper and the right side engine cowlings had been retrieved as well as the lower part of the ducting used to route the ram air through the water cooler.

When looking for shaped traces of smoke/fire, no obvious sign of in-flight fire inside and outside these cowlings was found. All burning signs found indicated a stationary fire.

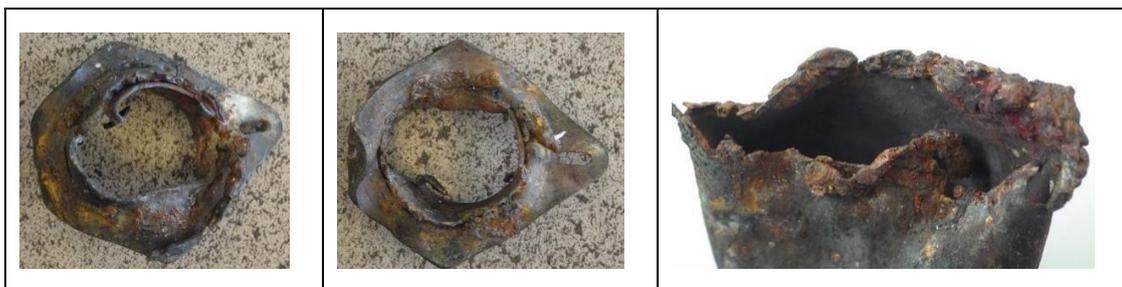
Reconstruction of the remains of the N°4 straight exhaust pipe (showing a design which is similar to the above mentioned pipe N°3) showed it was separated into 3 parts at the springs support plate. Although a part of this pipe suffered deformation due to the accident, close examination of the ruptures determined that the exhaust pipe was already in very bad condition before the accident. The ruptured areas showed multiple old poor weld repairs and material degradation precisely at the place where the pipe separated into 3 parts. Close examination of these remains concluded that it was possibly already separated before the aeroplane hit the ground.

Therefore, it is possible that hot exhaust gases escaping from the separated exhaust pipe had set the left carburettor feeding line or the left side engine cowling on fire. Taking into account that the fuel pump capacity is significantly higher than the fuel consumption, it is not excluded that although the presence of a leak at the feeding line, the carburettor fuel supply remained sufficient to operate the engine.

Figure 15: remains of the cylinder N°4 straight exhaust pipe

- The N°4 cylinder exhaust pipe was determined to be in very bad condition before the crash, to the extent that the possibility exists that it failed in flight.

- The poor condition of the N°4 exhaust and the lack of extensive maintenance entry in the aeroplane log book tends to show that the quality of the maintenance was insufficient.
